BRIDGE NO. 17.44 MILWAUKEE SUB
ACCIDENT OF JULY 4, 2012
INSPECTION OF BRIDGE SPANS
ACCIDENT OPINION

Bridge No. 17.44 Milwaukee Sub
Accident of July 4, 2012
Inspection of Bridge Spans
Appended Report

Bridge No. 17.44 Milwaukee Sub Accident of July 4, 2012 Inspection of Bridge Spans

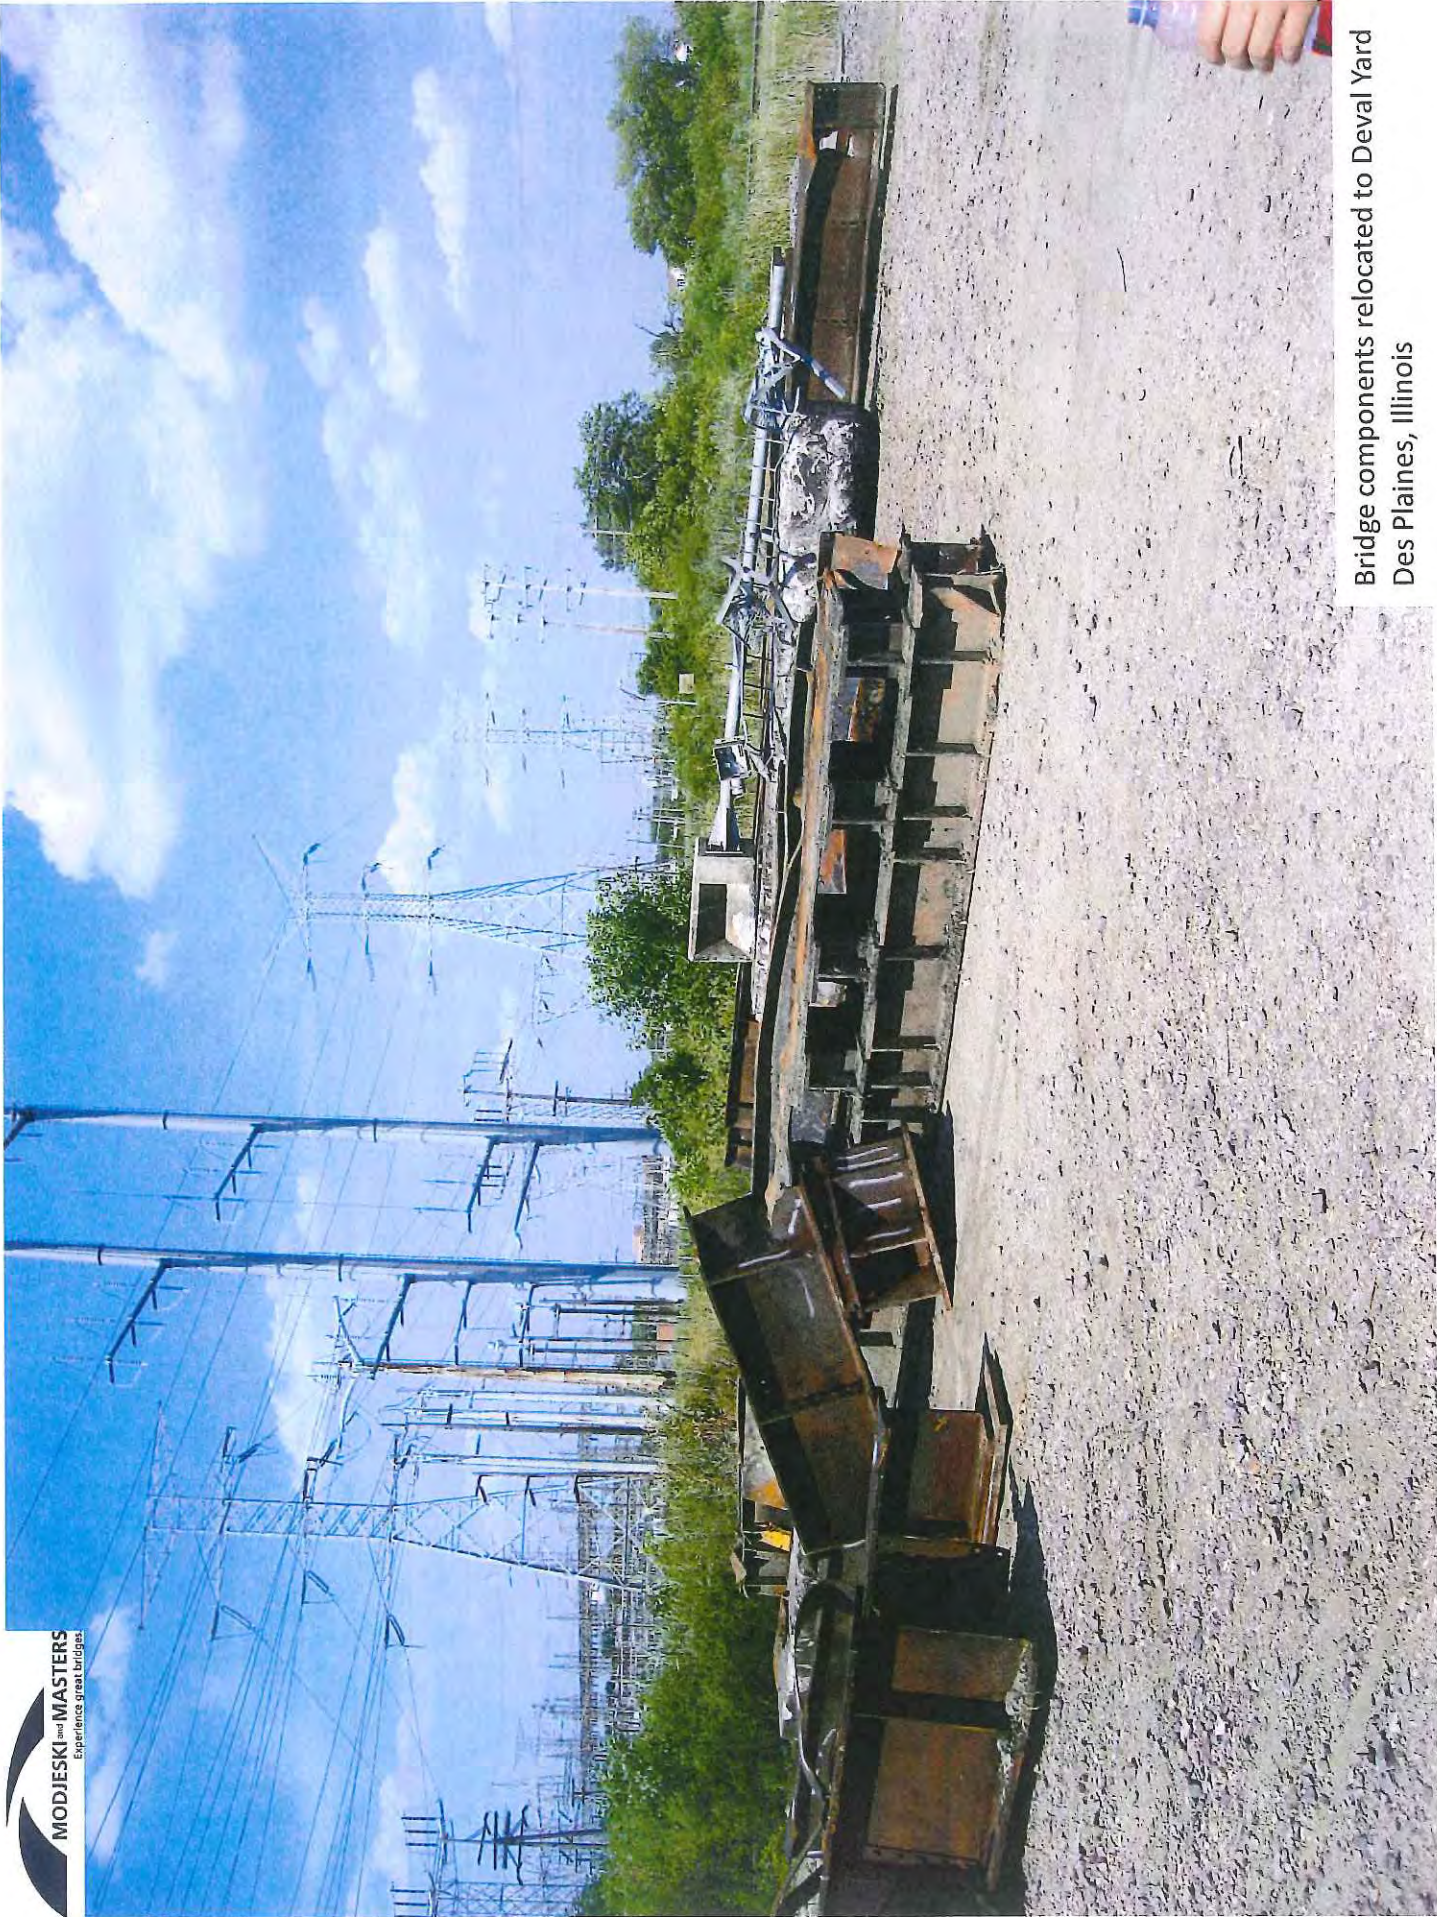
Bridge components relocated to Deval Yard
Des Plaines, Illinois

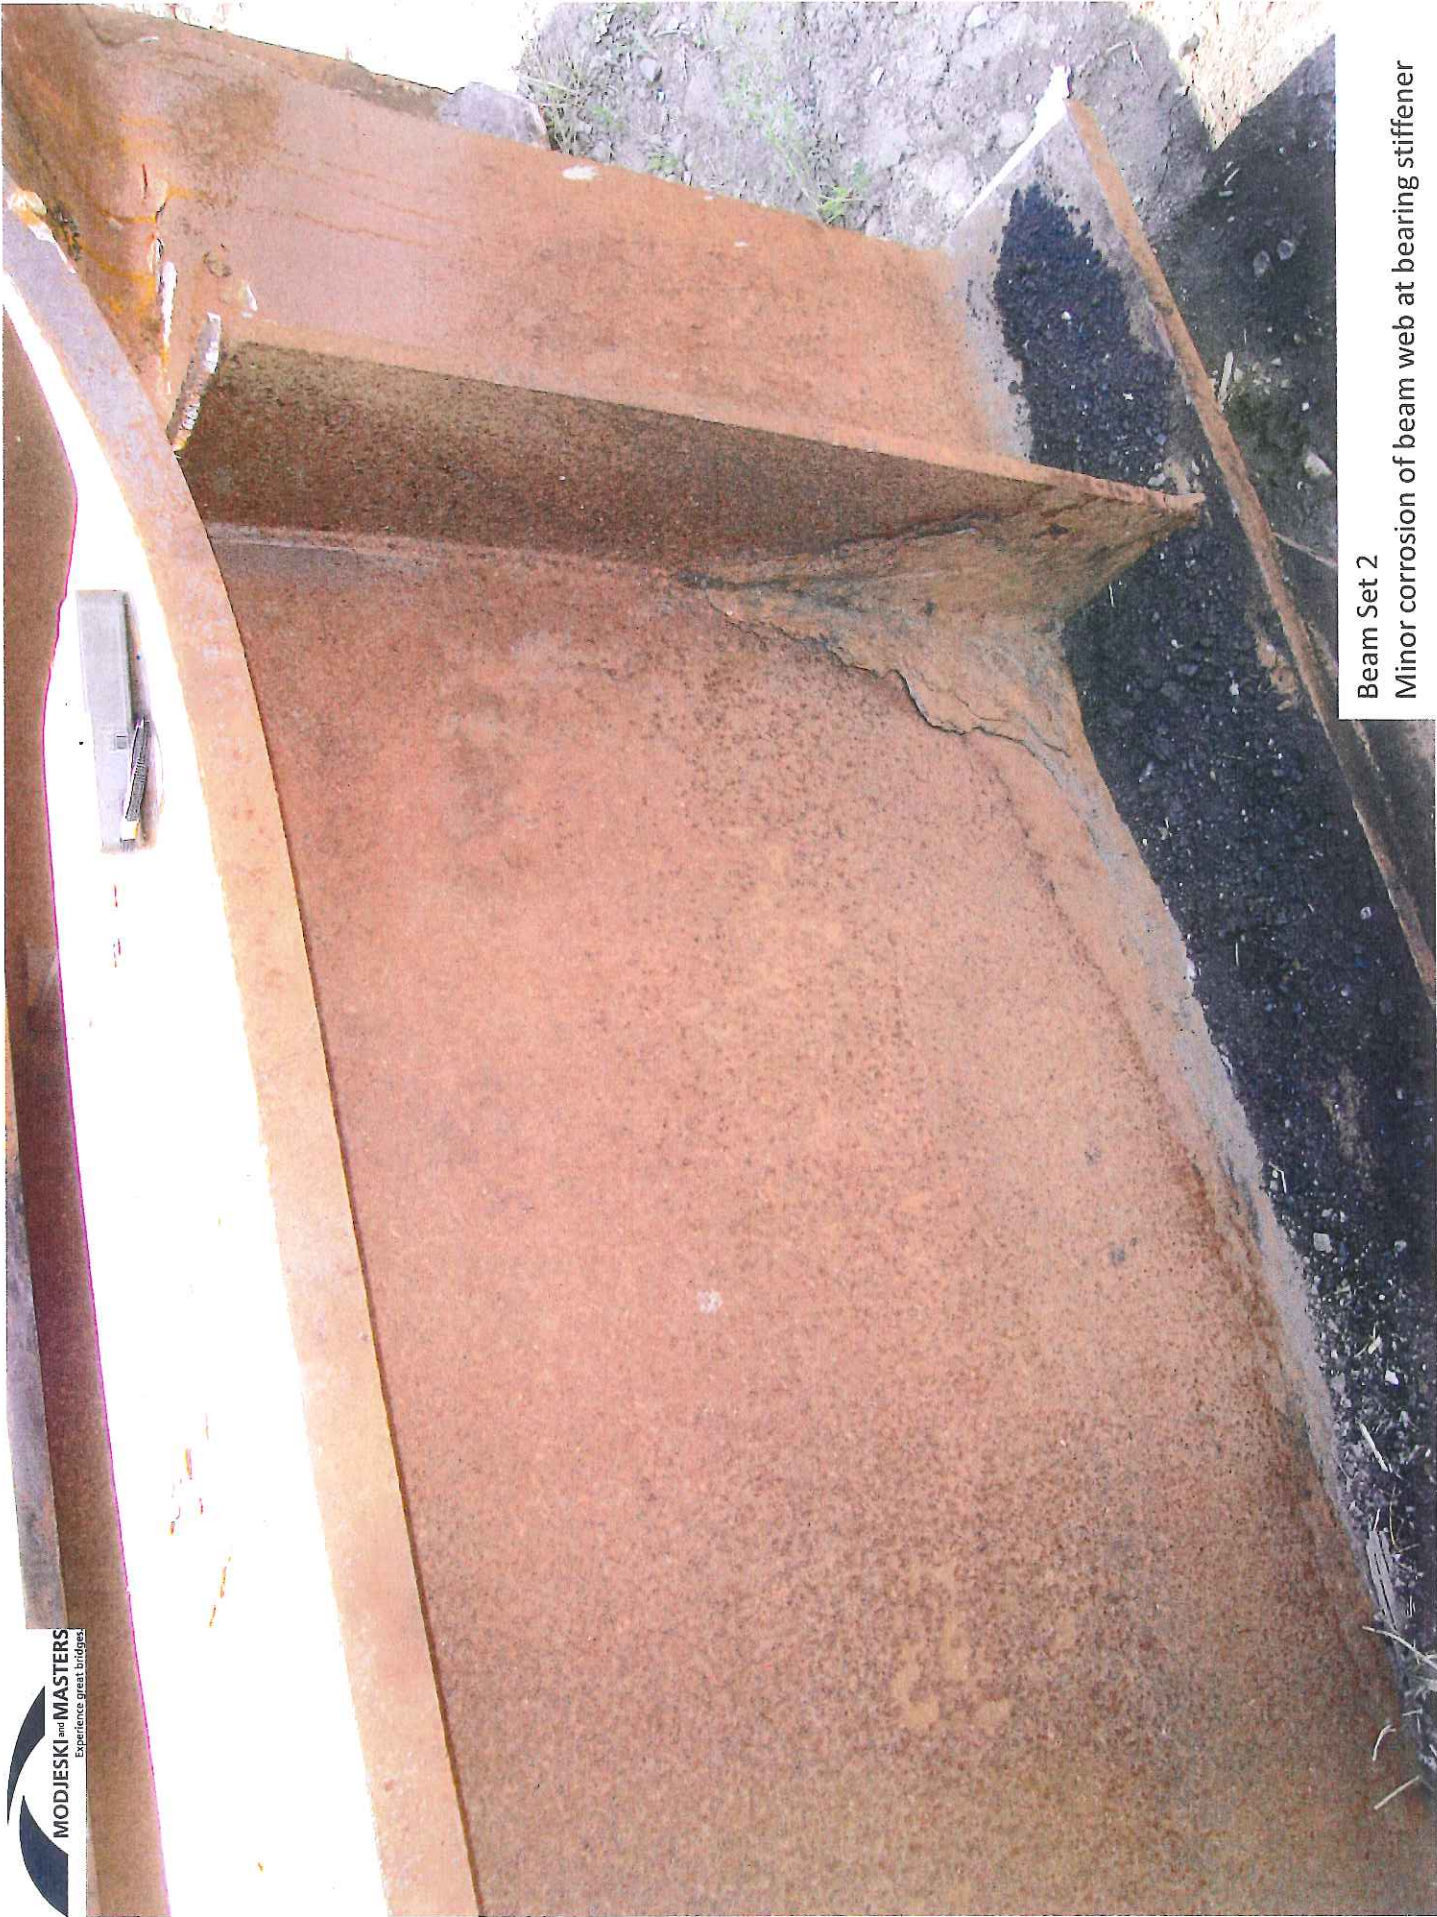
Beam Set 2
Minor corrosion of beam web at bearing stiffener

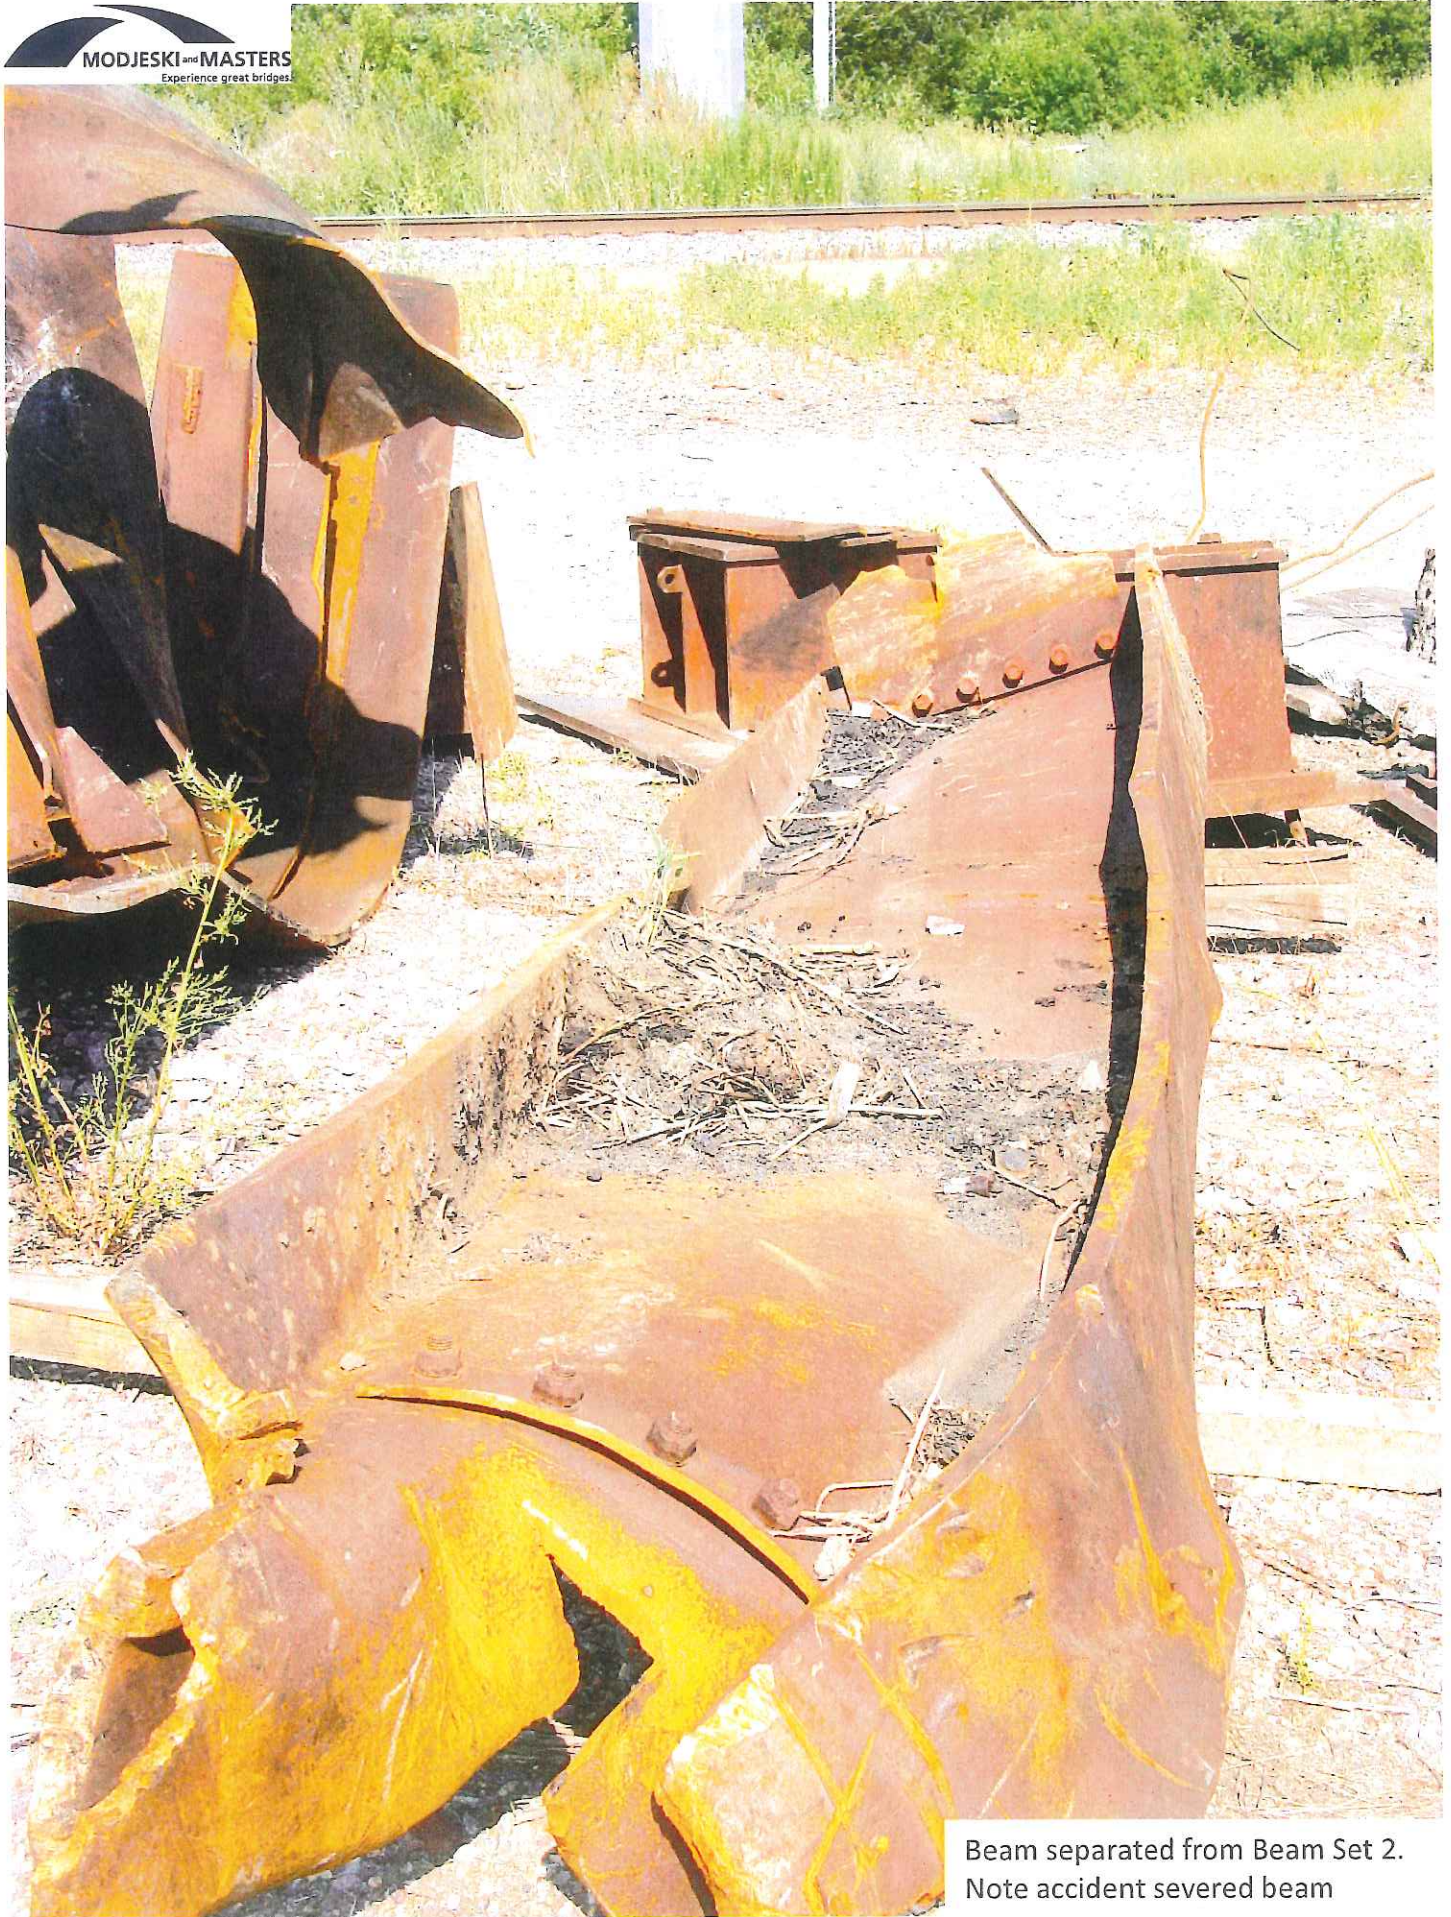
- **Beam Set No. 1**
 - Two diaphragms disconnected
 - Yellow "O" painted on outside face of an exterior beam and one end also painted yellow
 - Span is presently positioned upside down
- **Beam Set No. 2**
 - Center beam of three beams at far end, small pocket of corrosion
 - Fourth beam, separated from other three was severed by the accident and in two parts. Beam remained relatively straight.

Beam separated from Beam Set 2.
Note accident severed beam

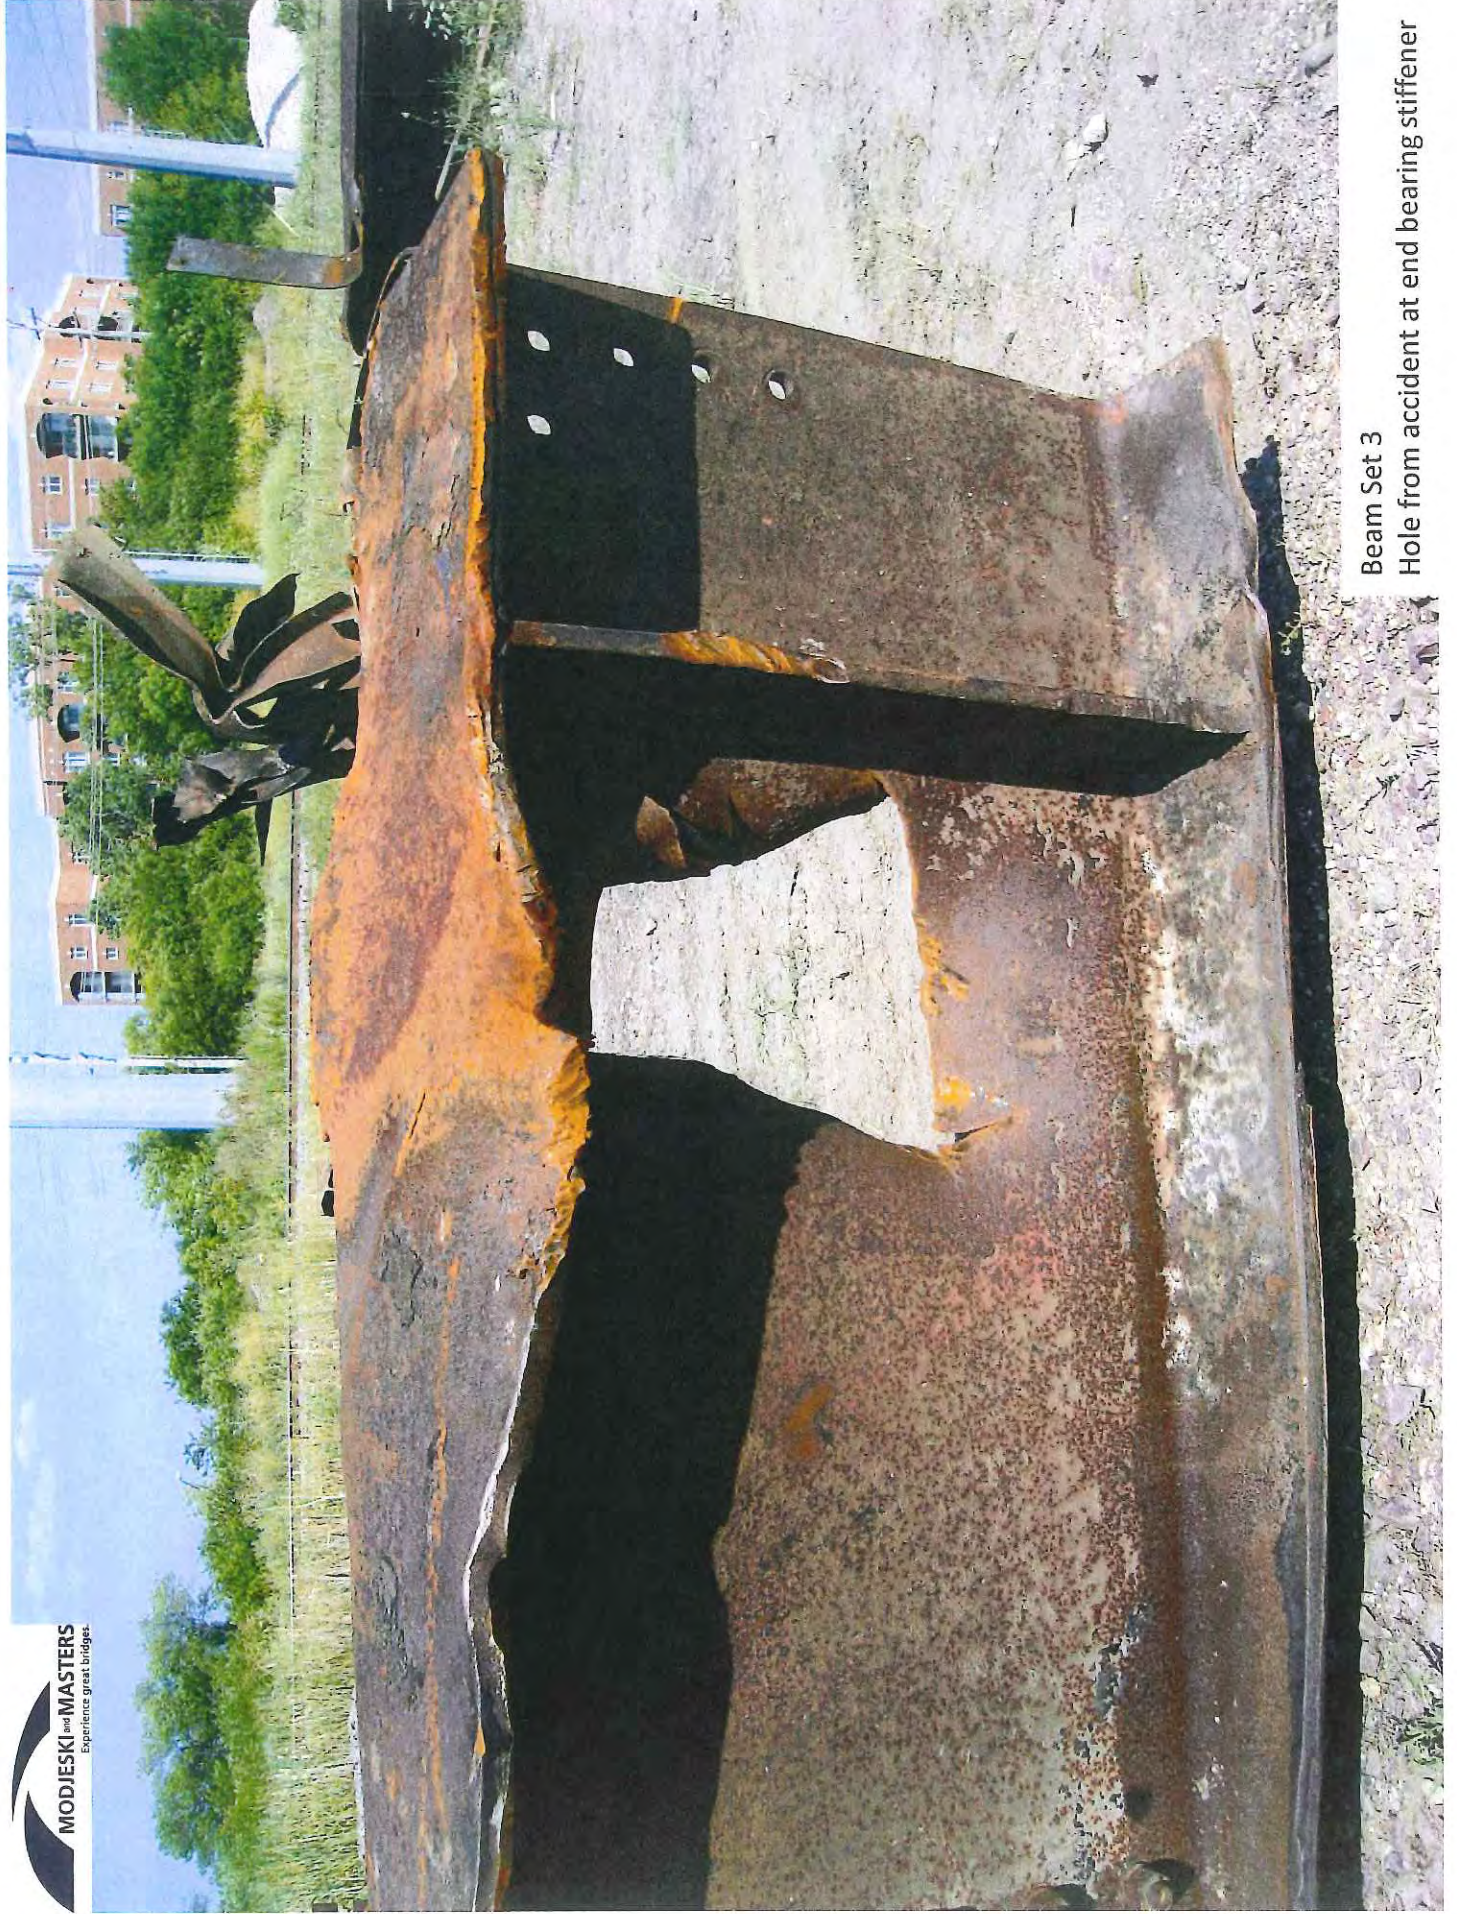
- **Beam Set No. 3**
 - Span is presently upside down
 - Yellow clearance sign on exterior beam 14'-0"
 - Beam with two holes through web from accident
- **Beam Set No. 4**
 - No new findings

Beam Set 3
Hole from accident at end bearing stiffener

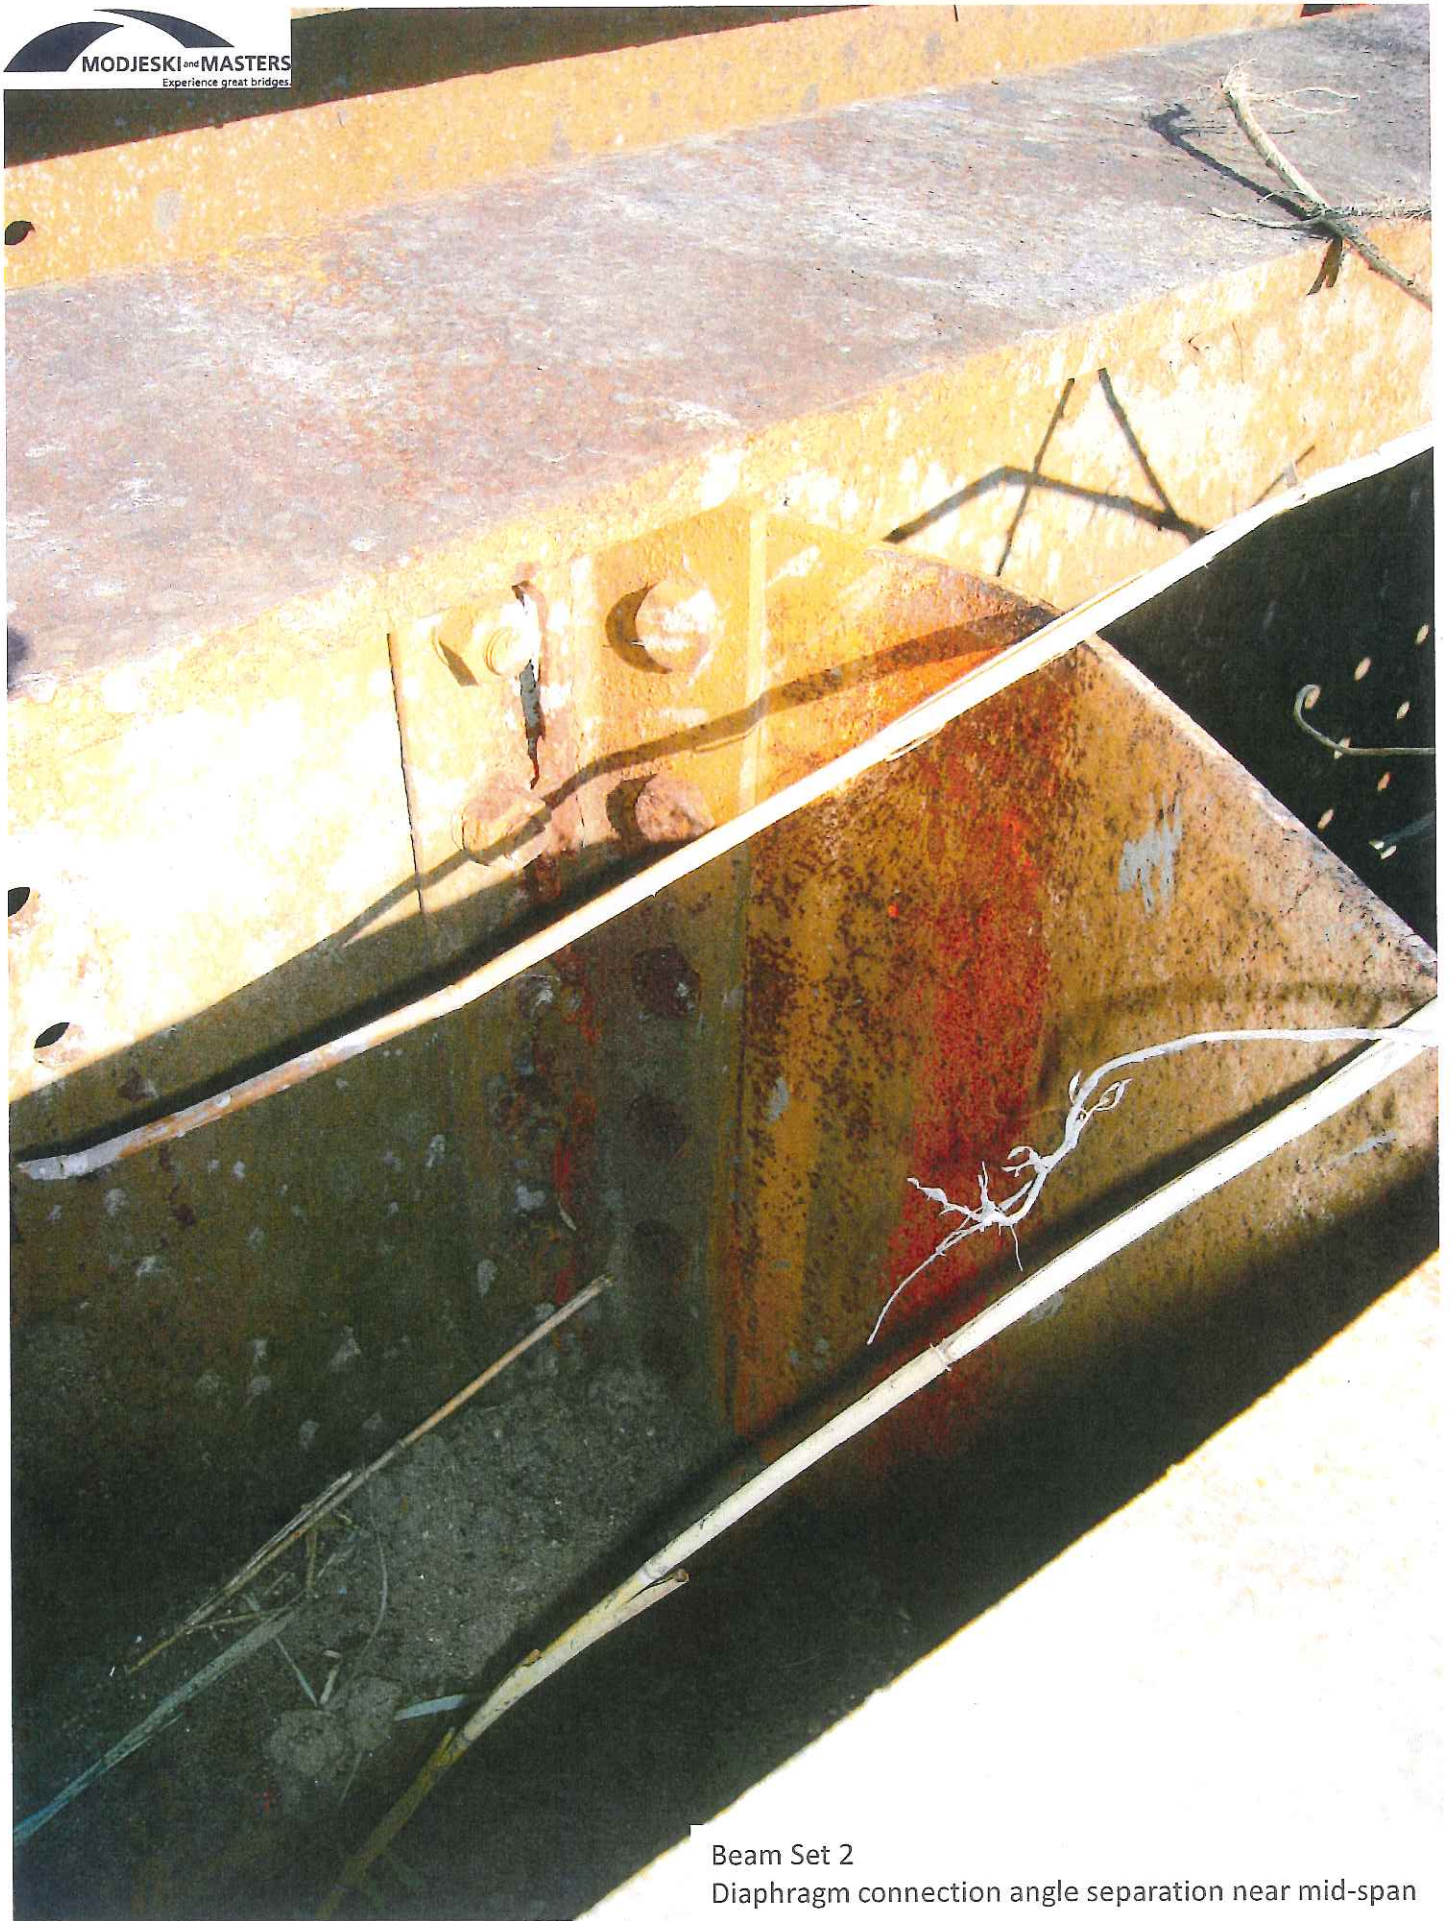
Beam Set 2
Diaphragm connection angle separation near mid-span

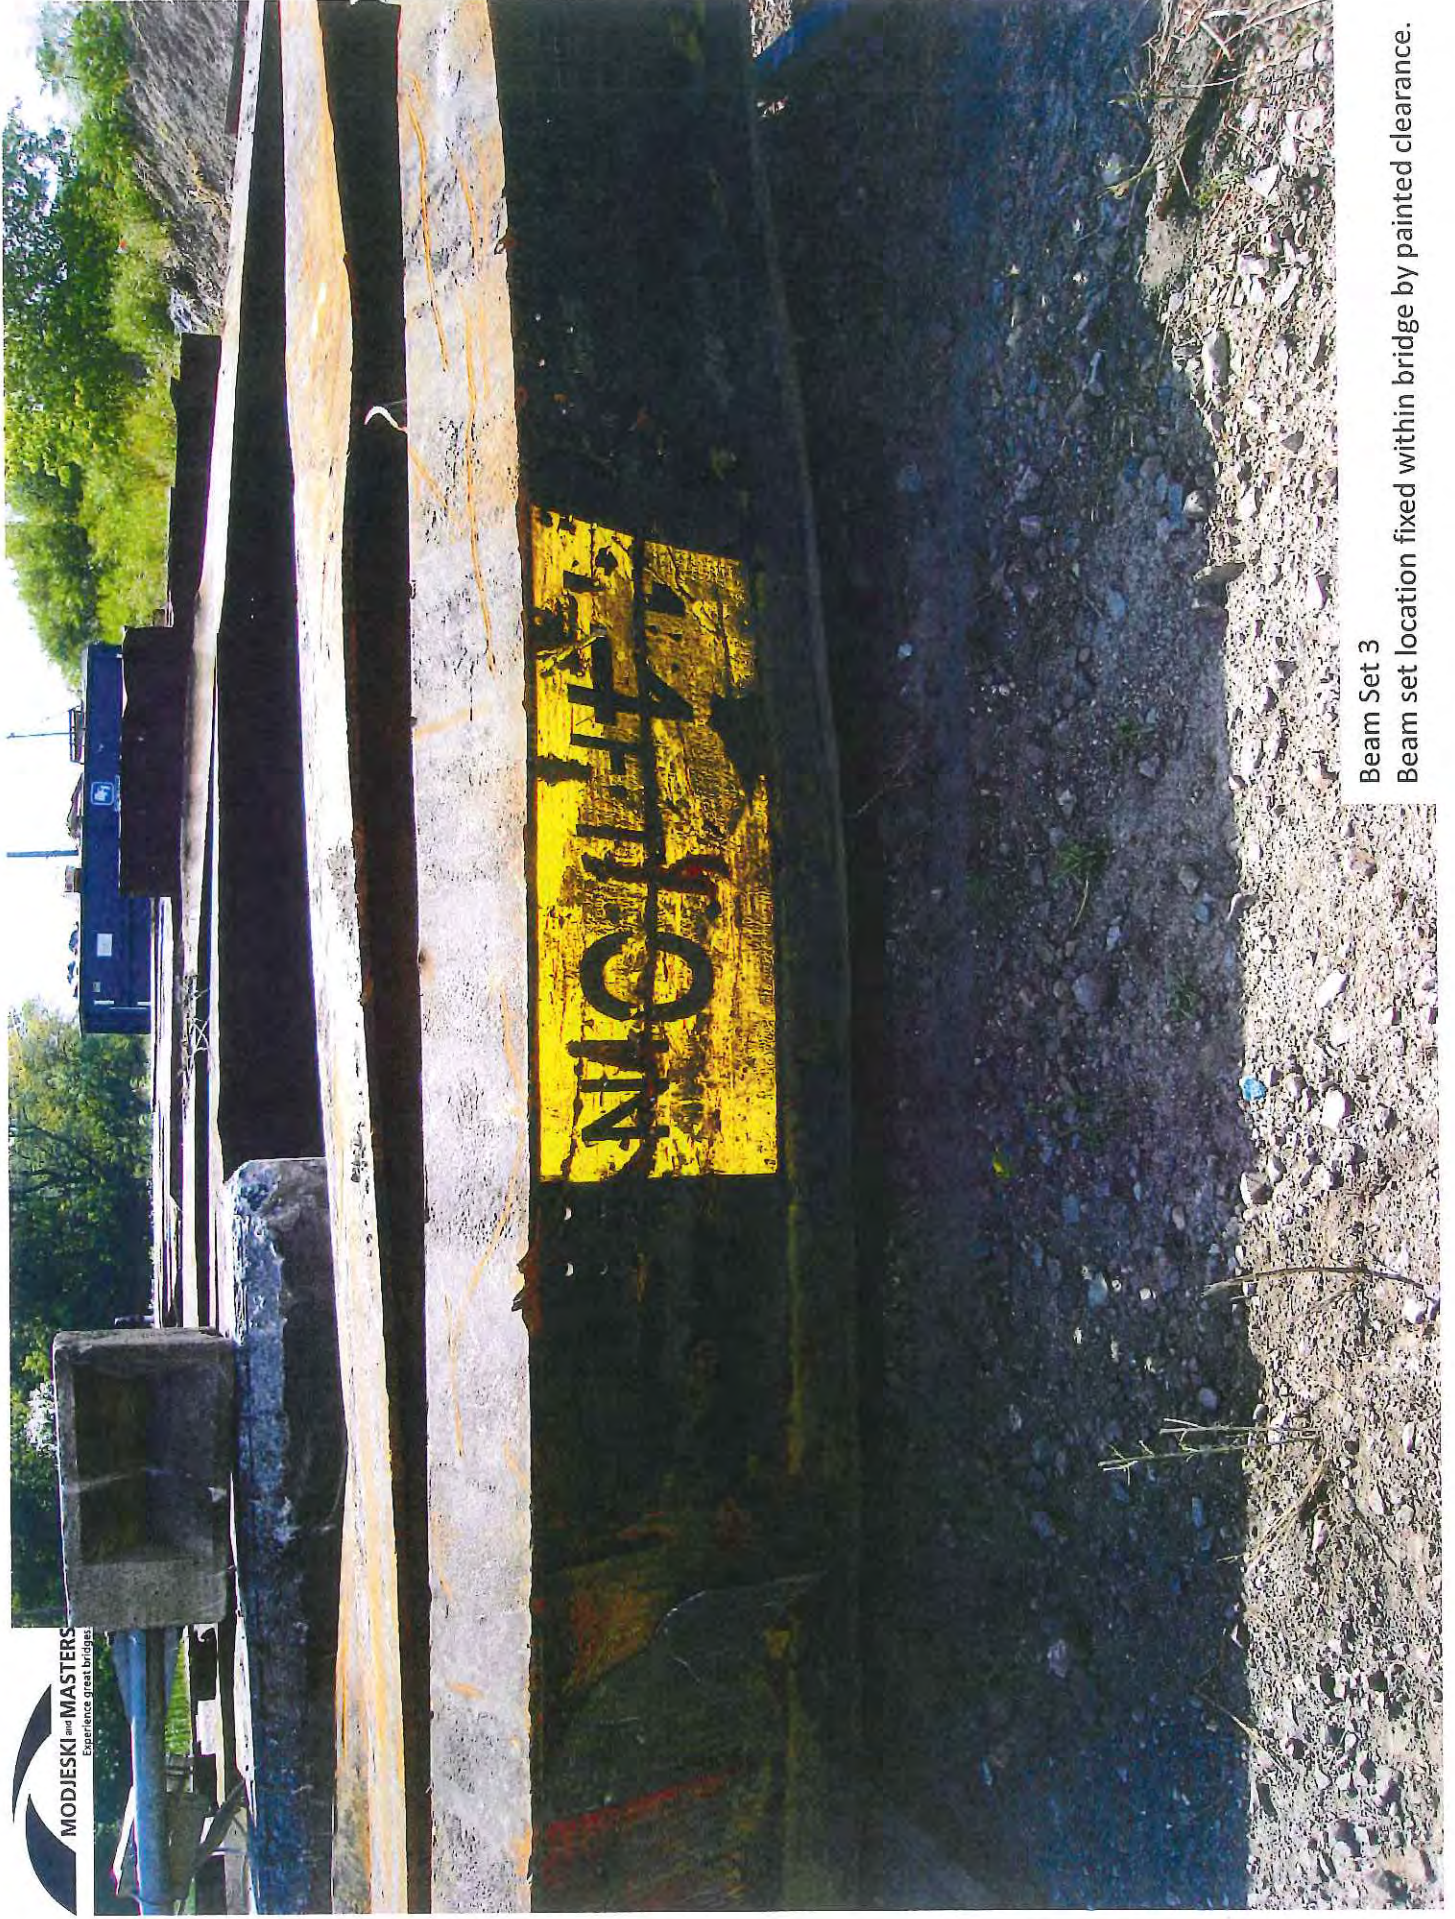
Beam Set 3
Beam set location fixed within bridge by painted clearance.

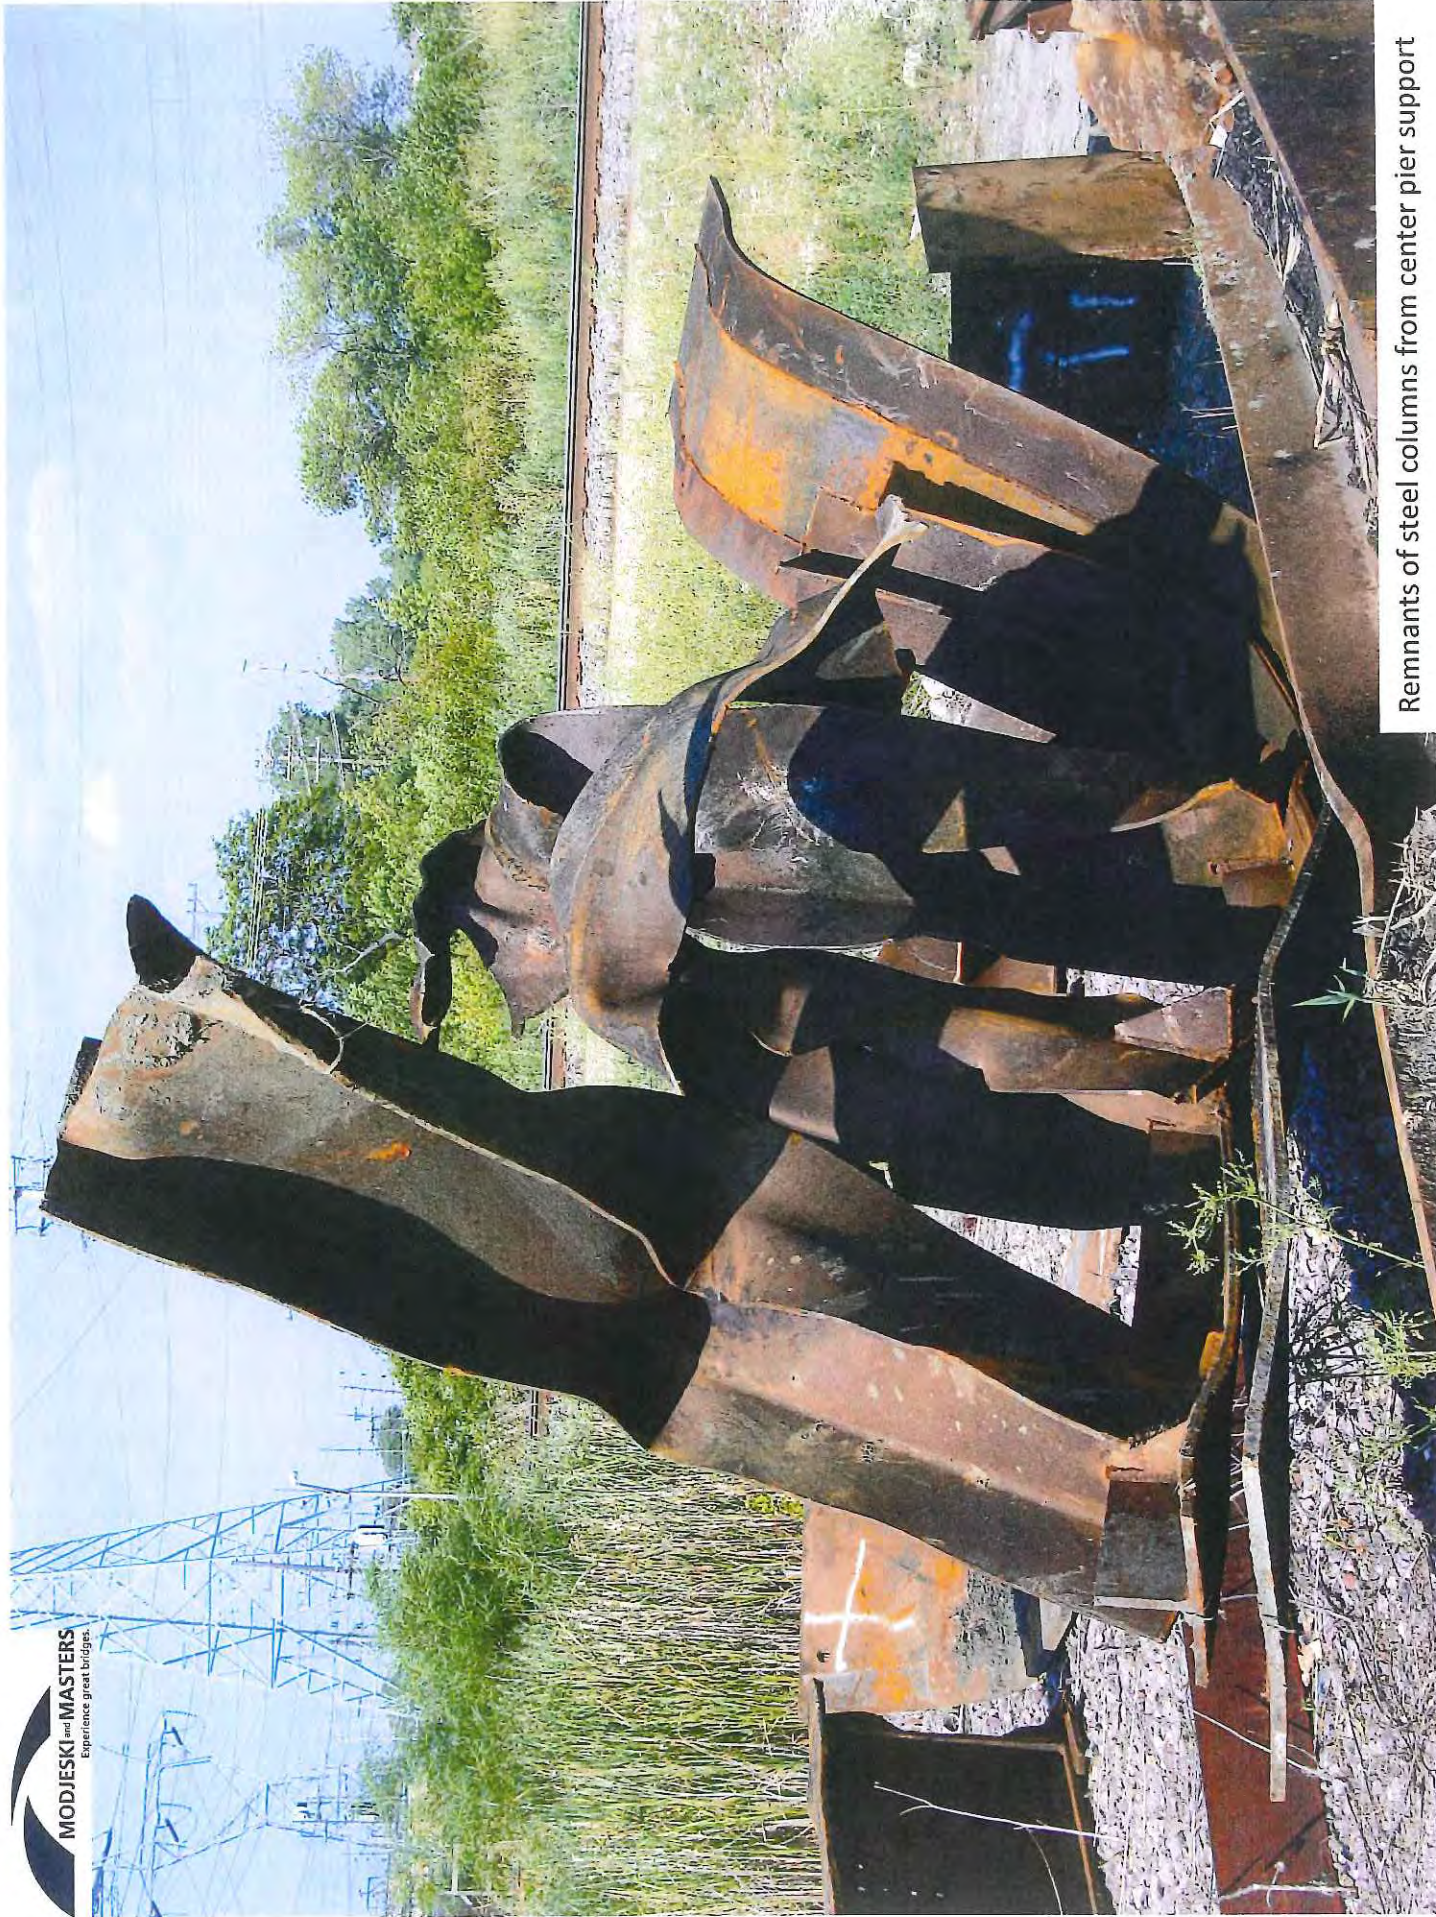
- **Center Pier Steel**
 - Series of steel columns remain weld attached to connection plate
 - Column sections heavily damaged and without losses from corrosion
 - Columns are rolled section

Remnants of steel columns from center pier support

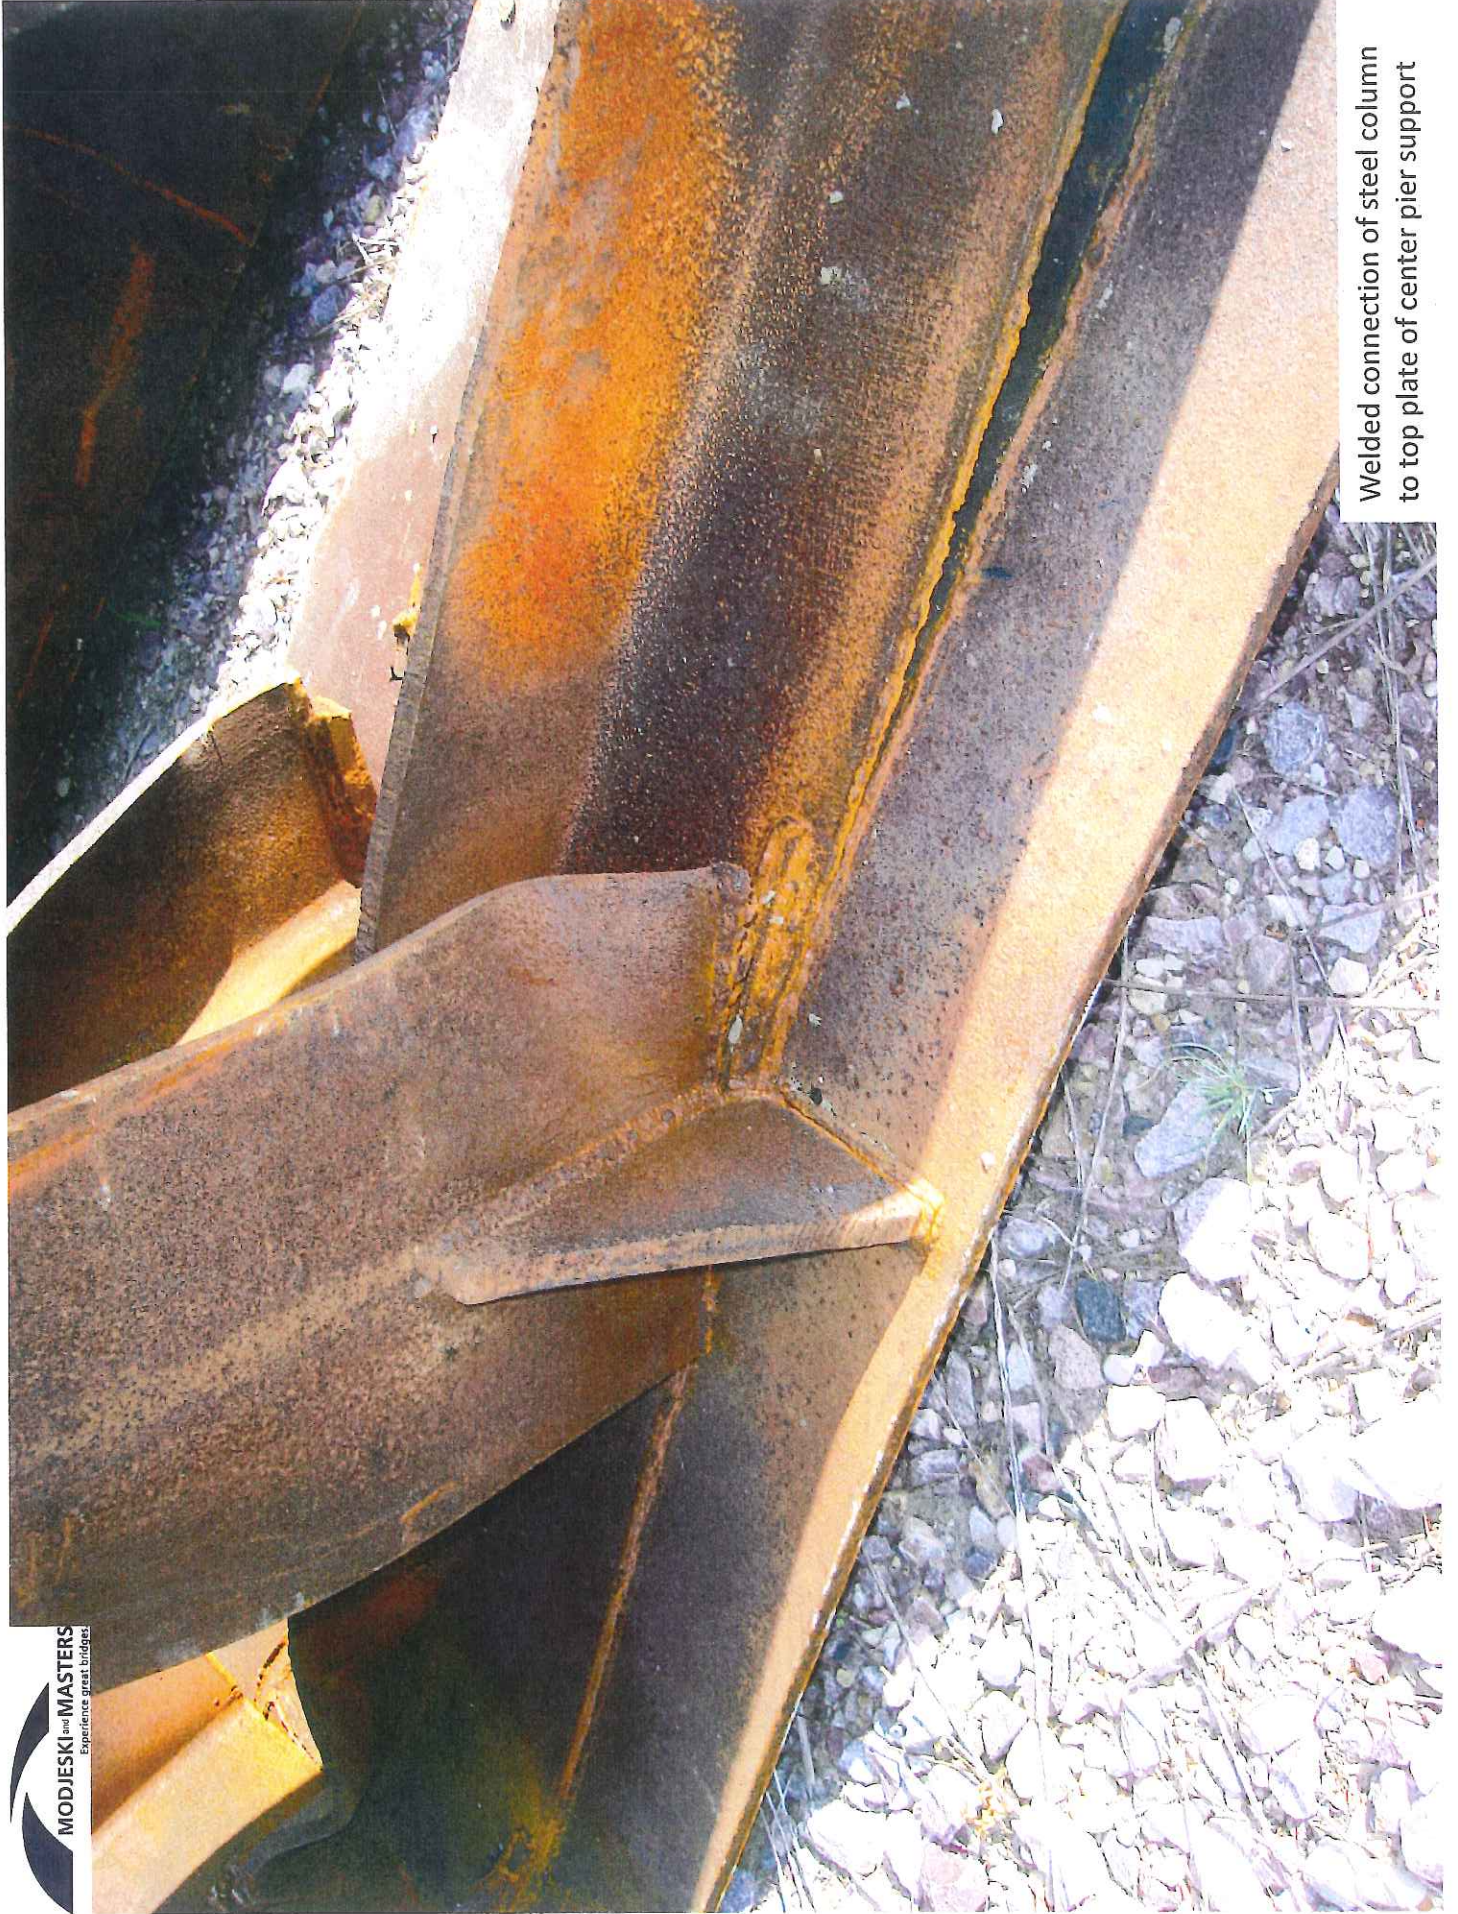
Welded connection of steel column to top plate of center pier support
