BRIDGE NO. 17.44 MILWAUKEE SUB
ACCIDENT OF JULY 4, 2012
INSPECTION OF BRIDGE SPANS
ACCIDENT OPINION

Bridge No. 17.44 Milwaukee Sub
Accident of July 4, 2012
Inspection of Bridge Spans
Appended Report

Bridge No. 17.44 Milwaukee Sub Accident of July 4, 2012 Inspection of Bridge Spans

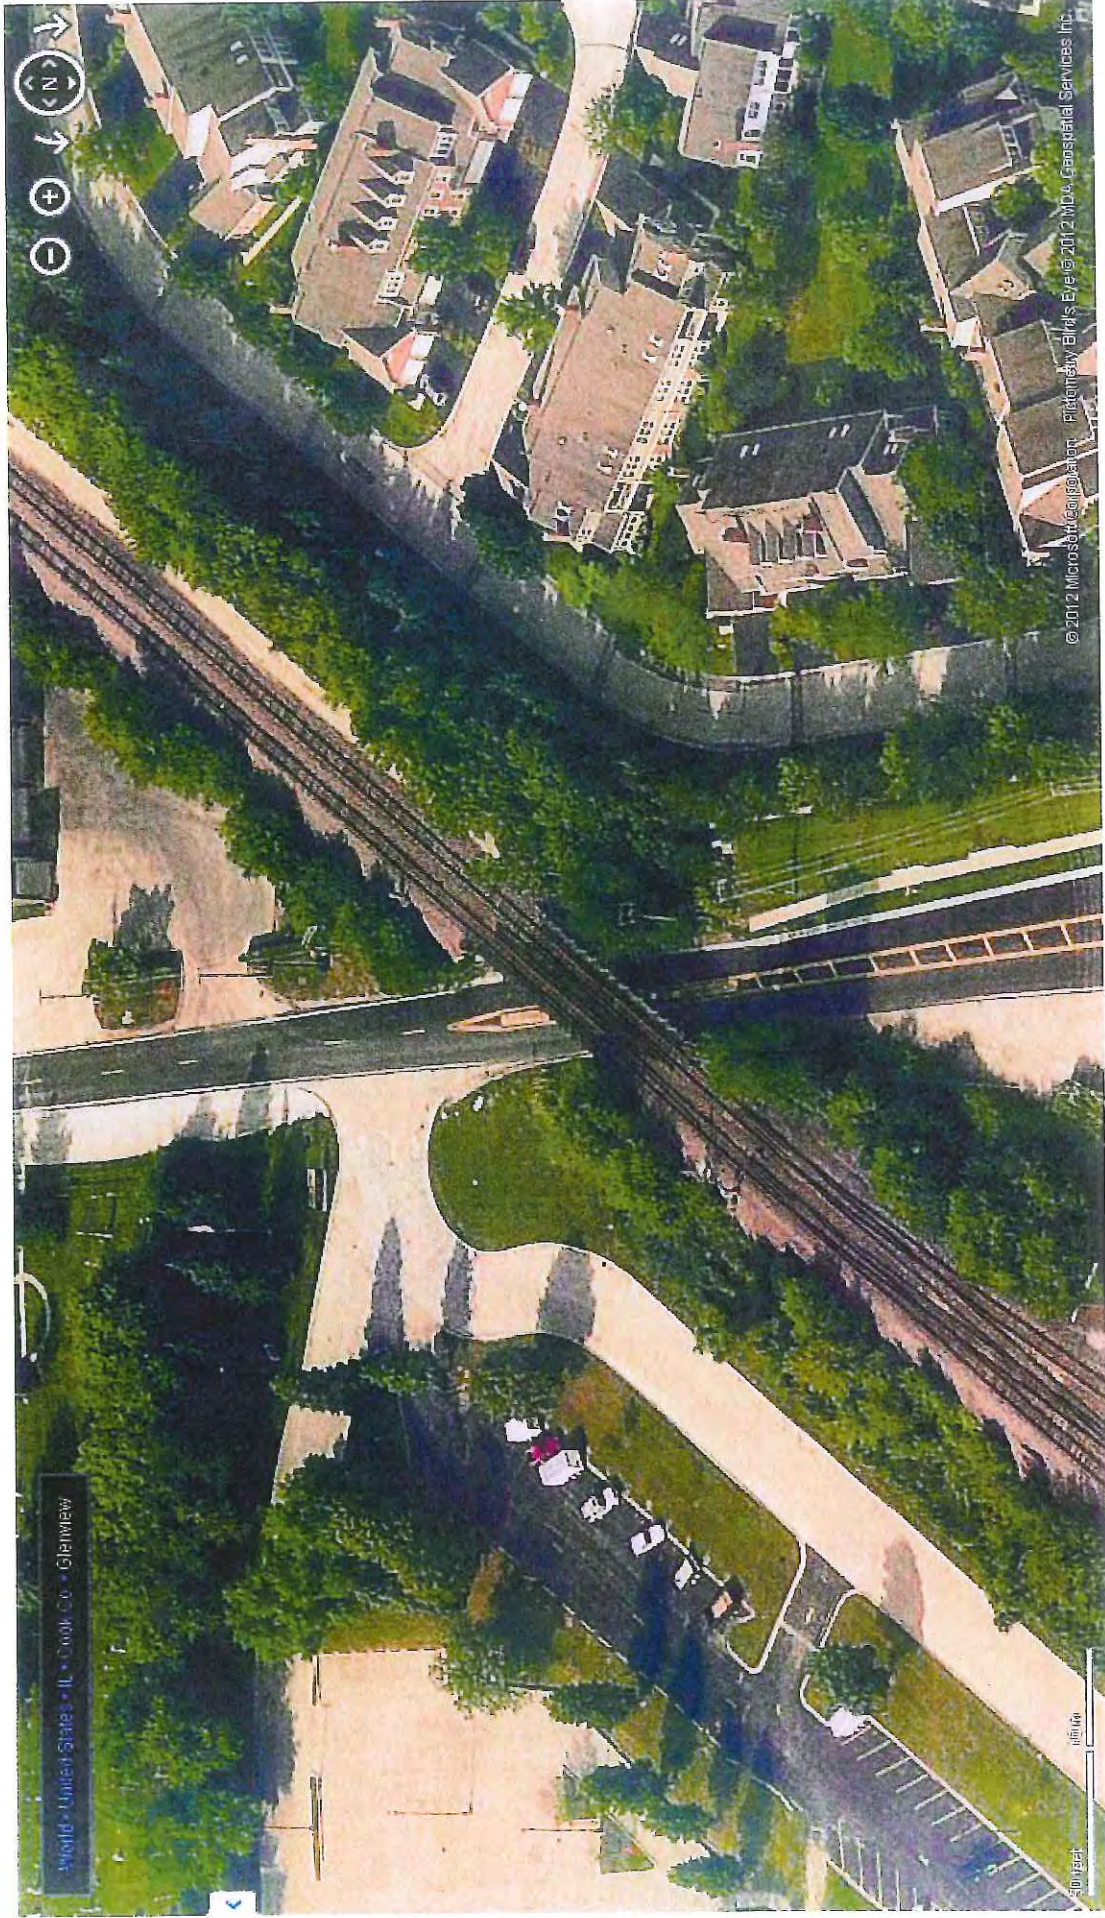
Bridge 17.44 Crossing Shermer Road, Glenview, IL at a skew

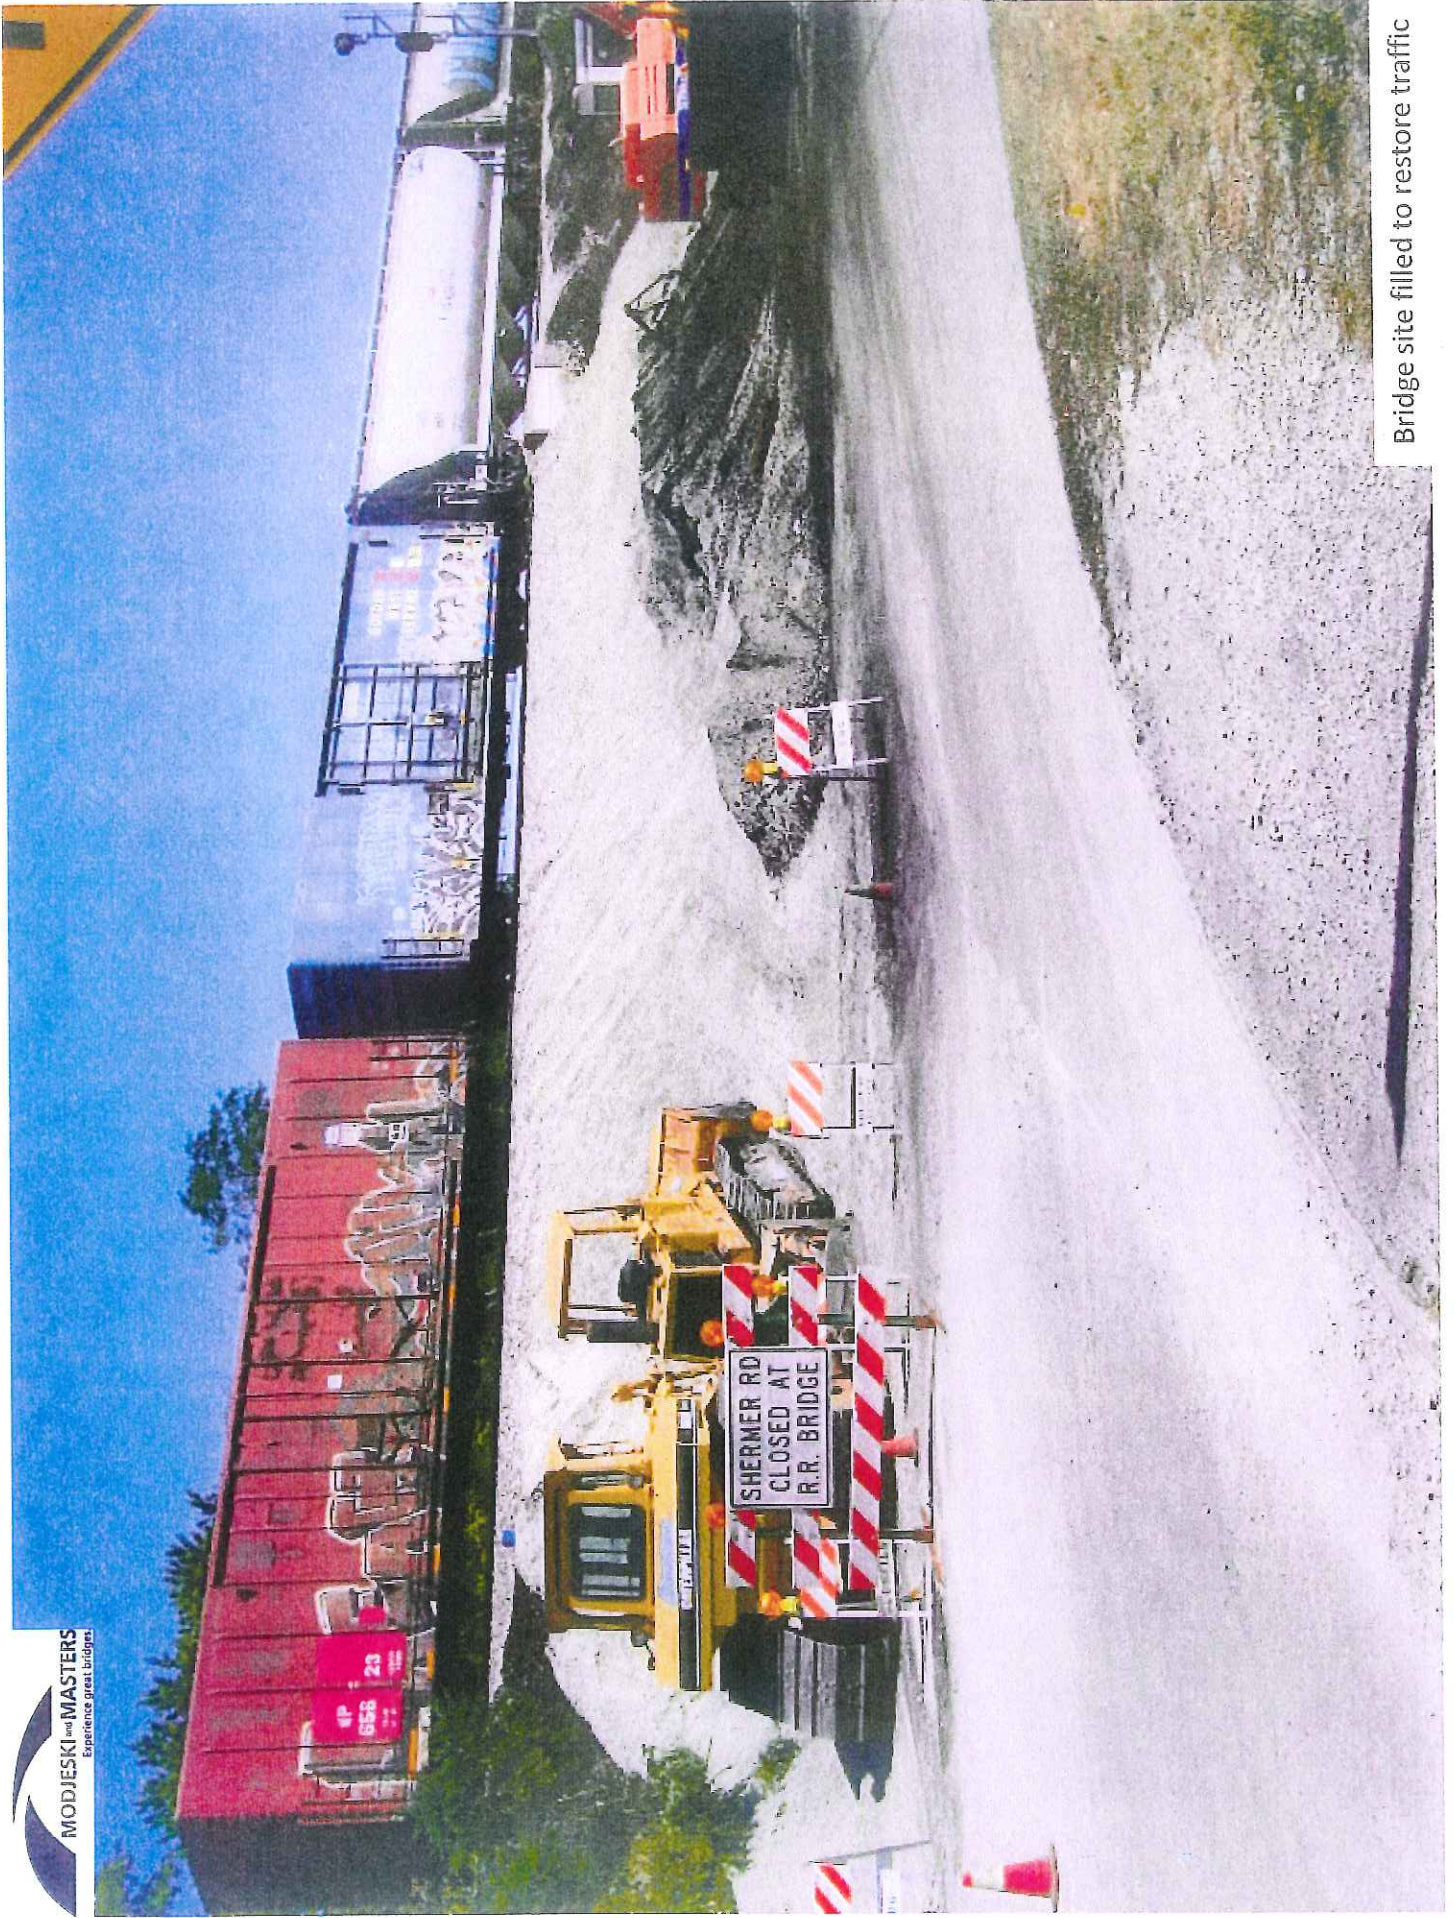
Bridge site filled to restore traffic

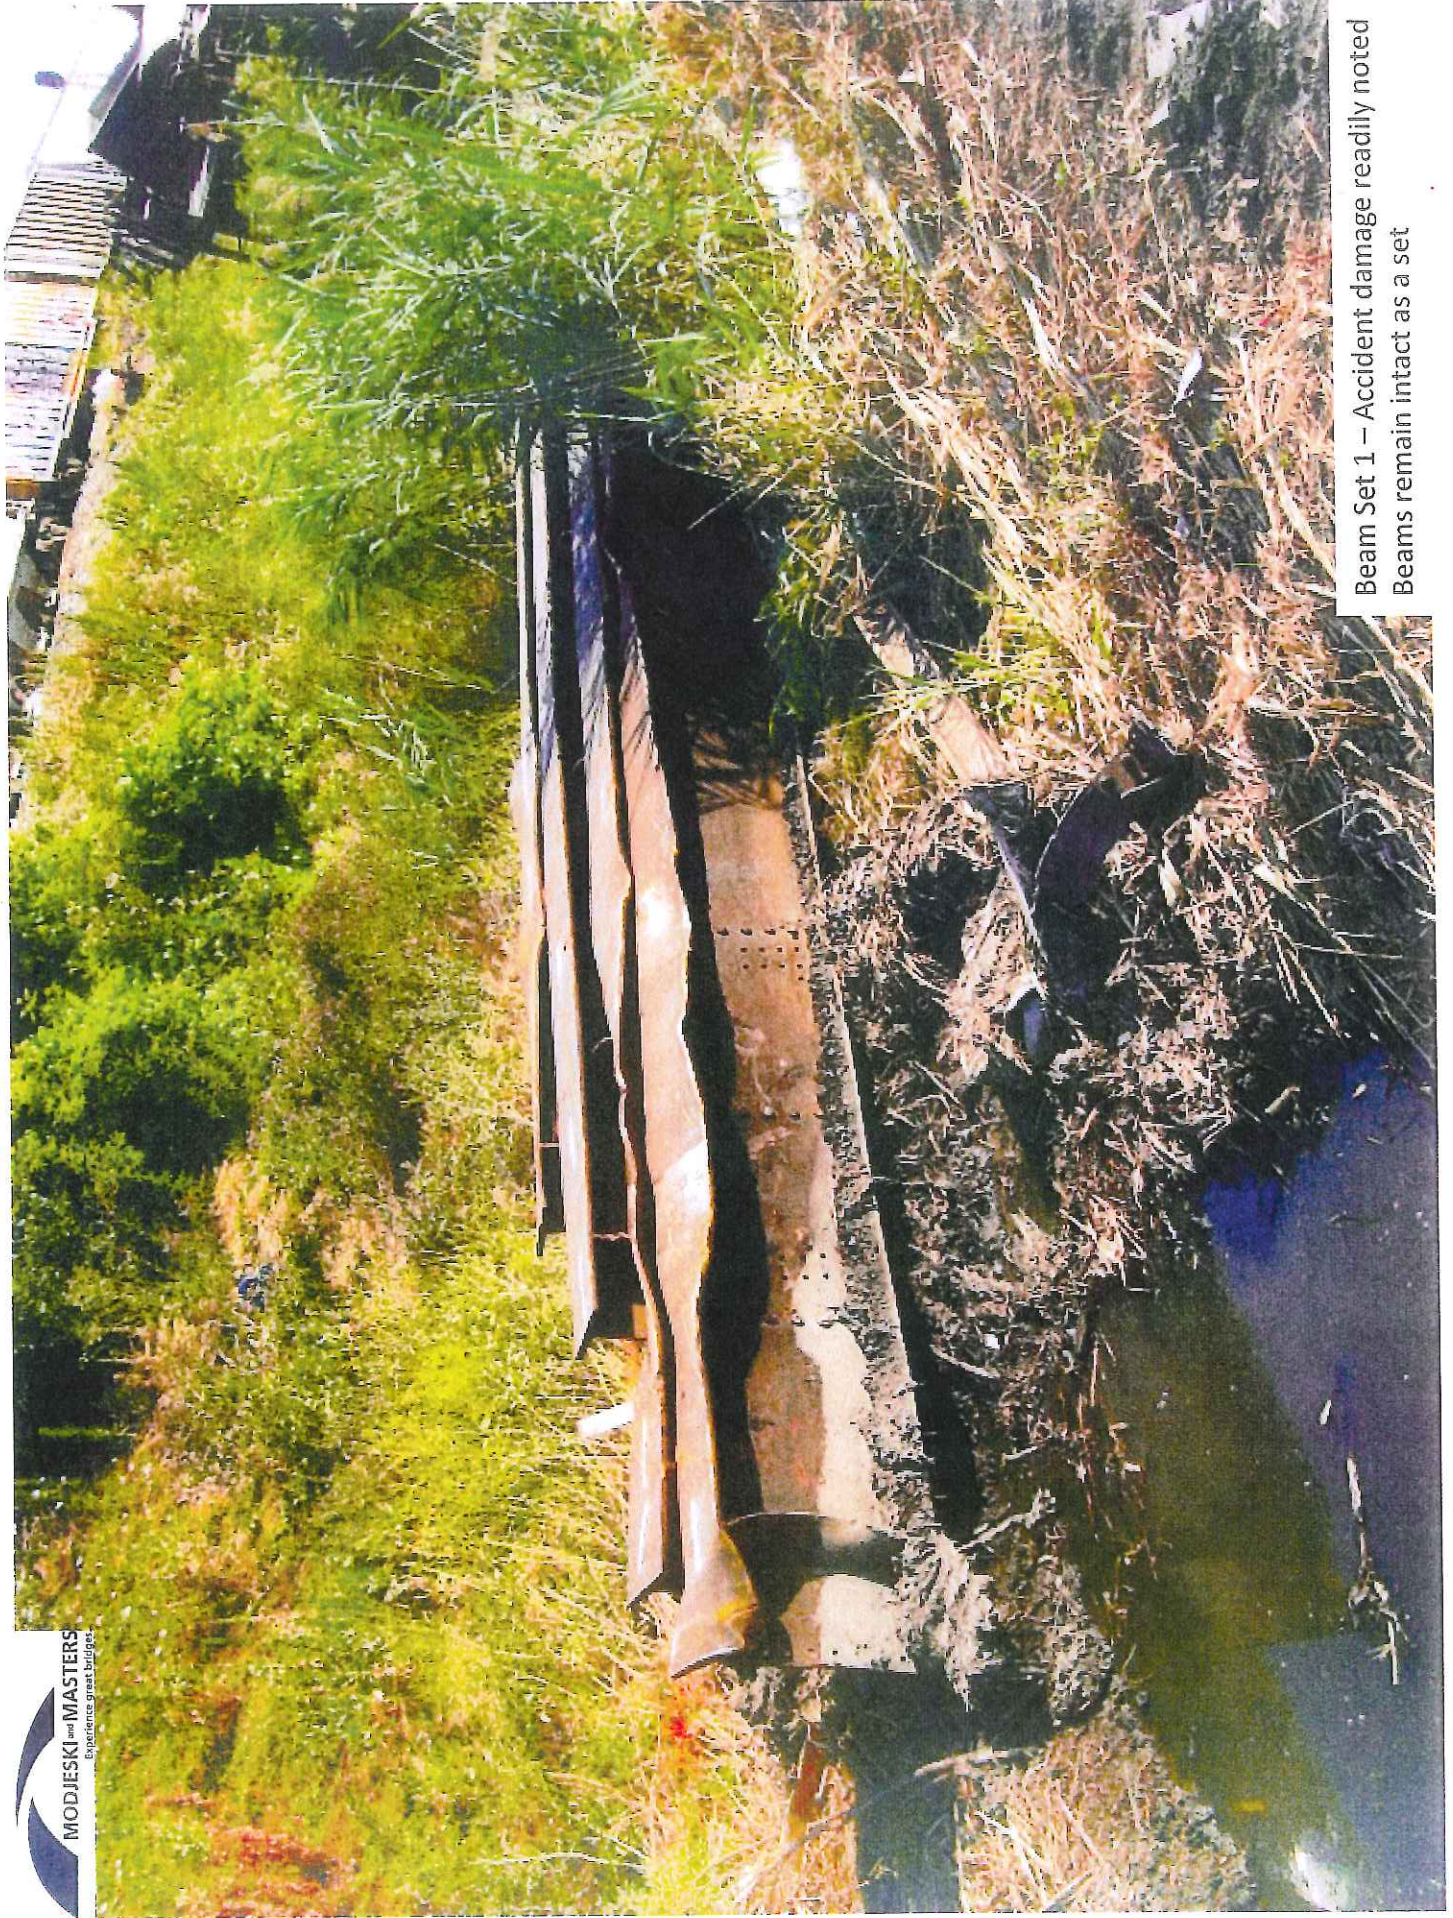
- A set of four “S” type beams remained diaphragmed together as a unit and generally straight with wavy top flanges at one end
- Prior position location within bridge not known at this time
- Significant accident damage from objects sufficient to bend thick flanges
- Beams in full section, no loss of metal from corrosion
- One full depth severed diaphragm connection angle remaining in place and one partially severed connection angle
- One fresh tear in a top flange of several inches in length
- Beam bearing areas in good condition
- No indications of beam span failure

Beam Set 1 – Accident damage readily noted
Beams remain intact as a set

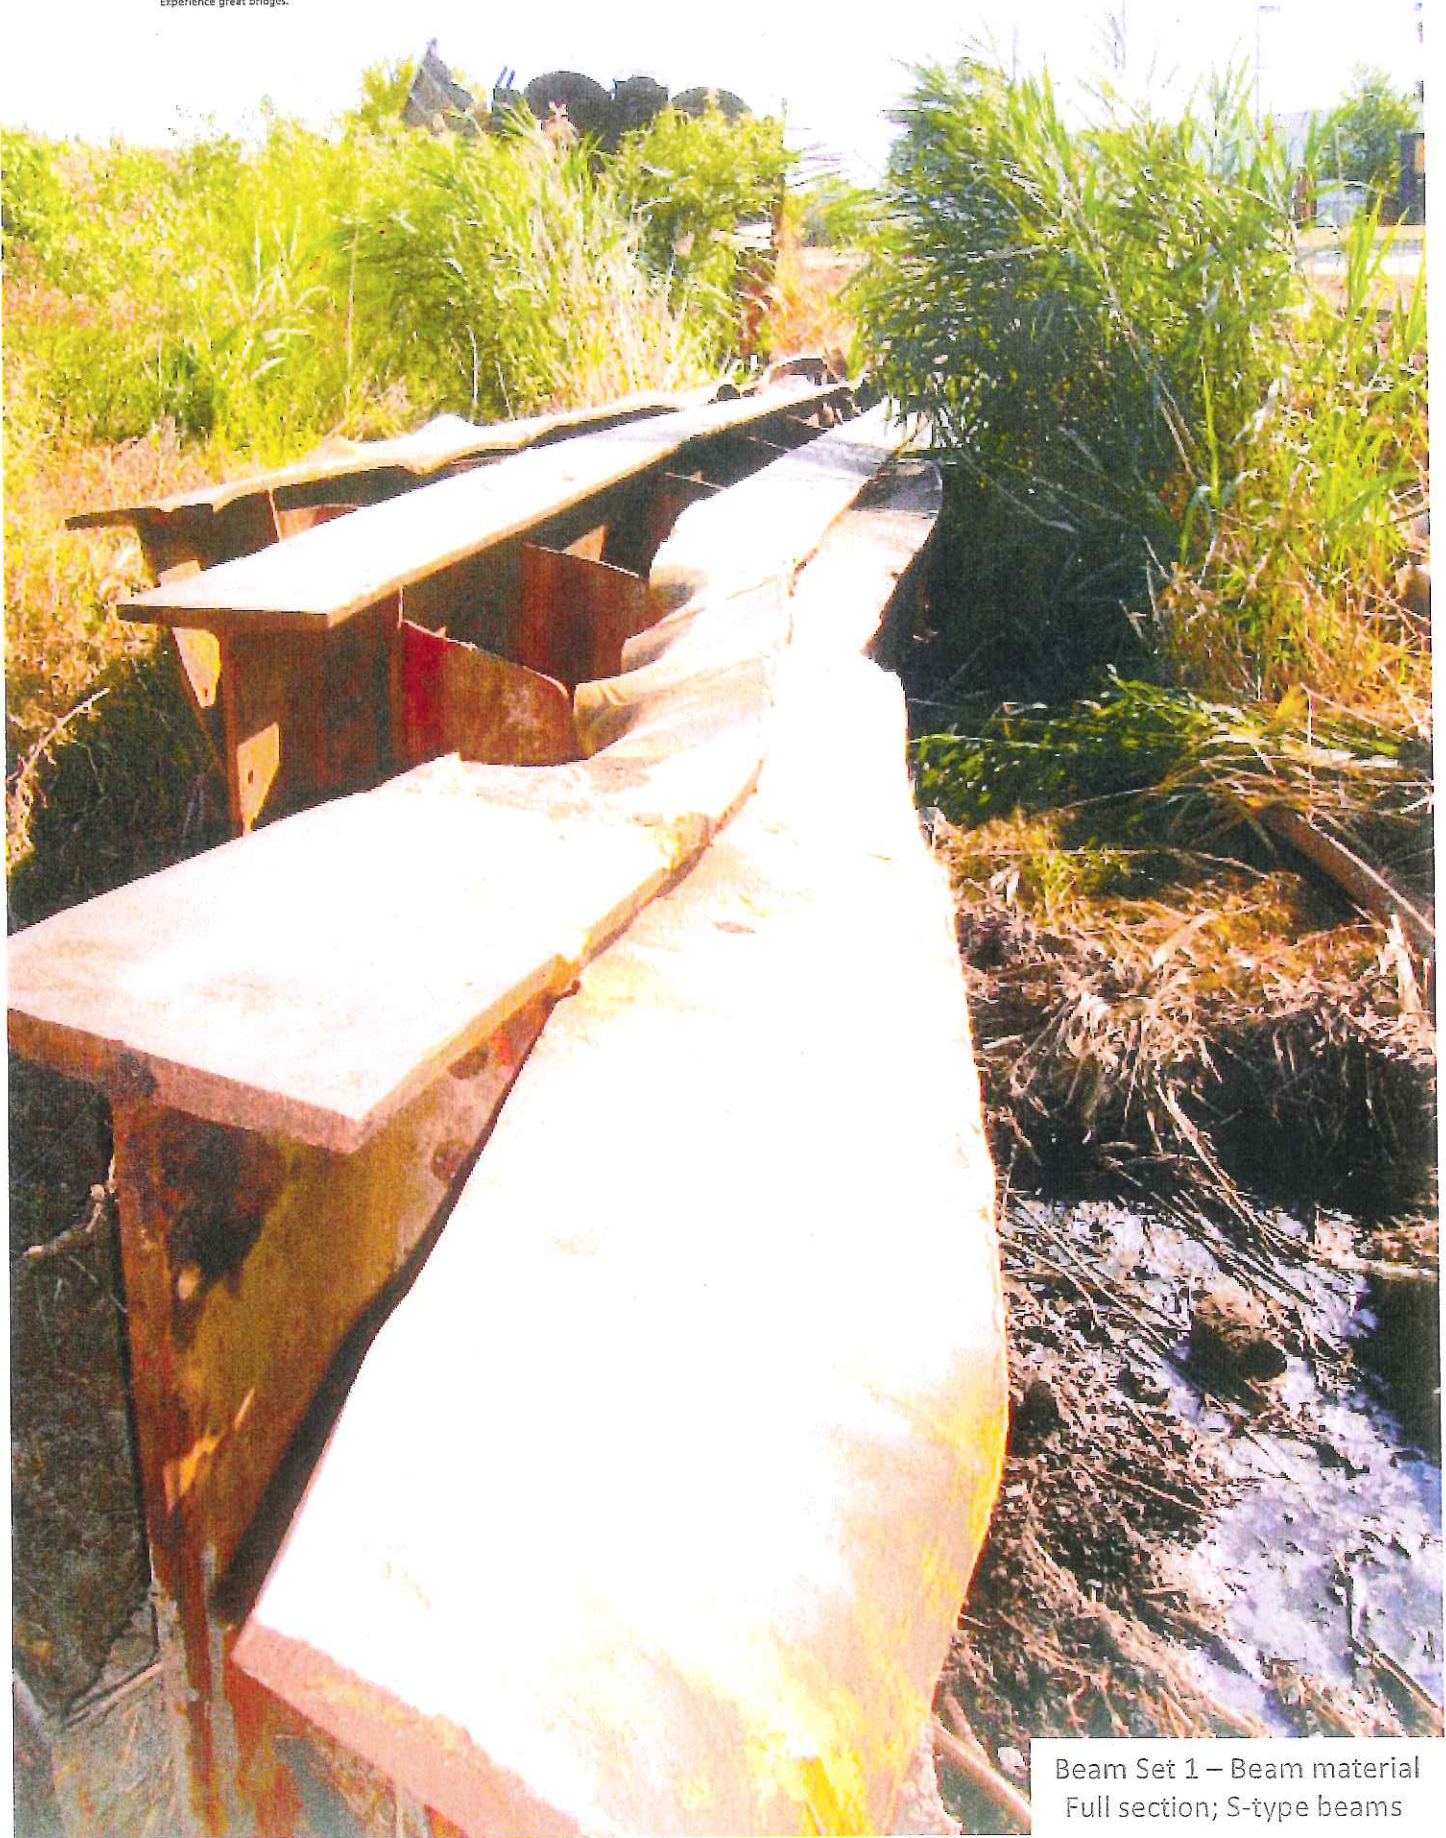
Beam Set 1 – Beam material
Full section; S-type beams

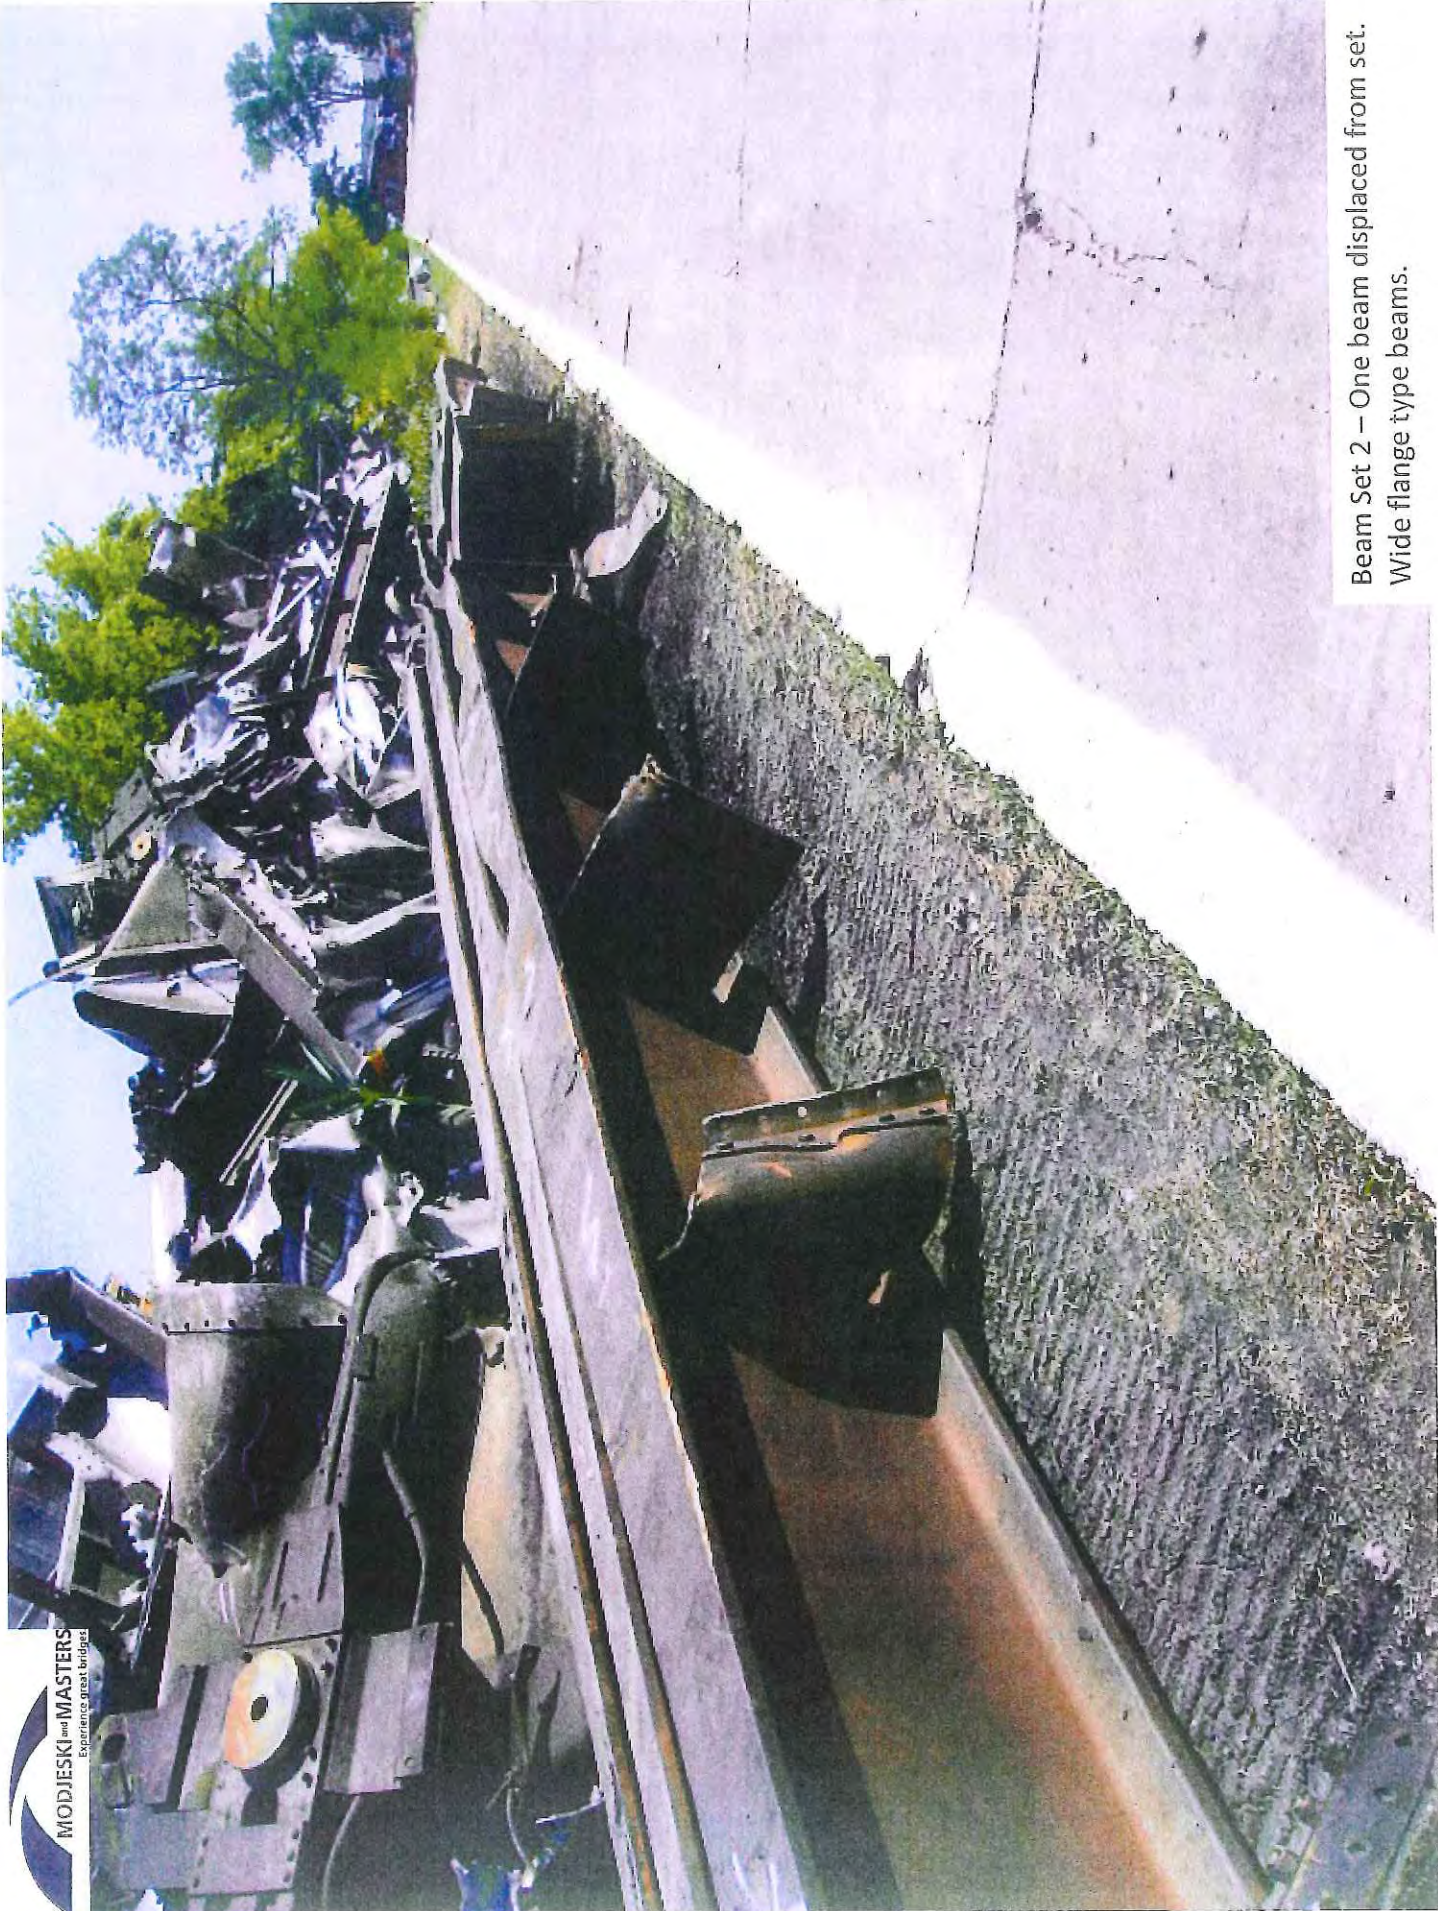
- A set of three wide flange type beams diaphragmed together as a unit with fourth beam not attached to extended diaphragms (beam found elsewhere on site)
- Prior position location within bridge not known at this time
- Localized bends in flanges from objects, beams generally straight
- Beams in full section, no loss of metal from corrosion
- Beam bearing areas in good condition
- No indications of beam span failure

Beam Set 2 – One beam displaced from set.
Wide flange type beams.

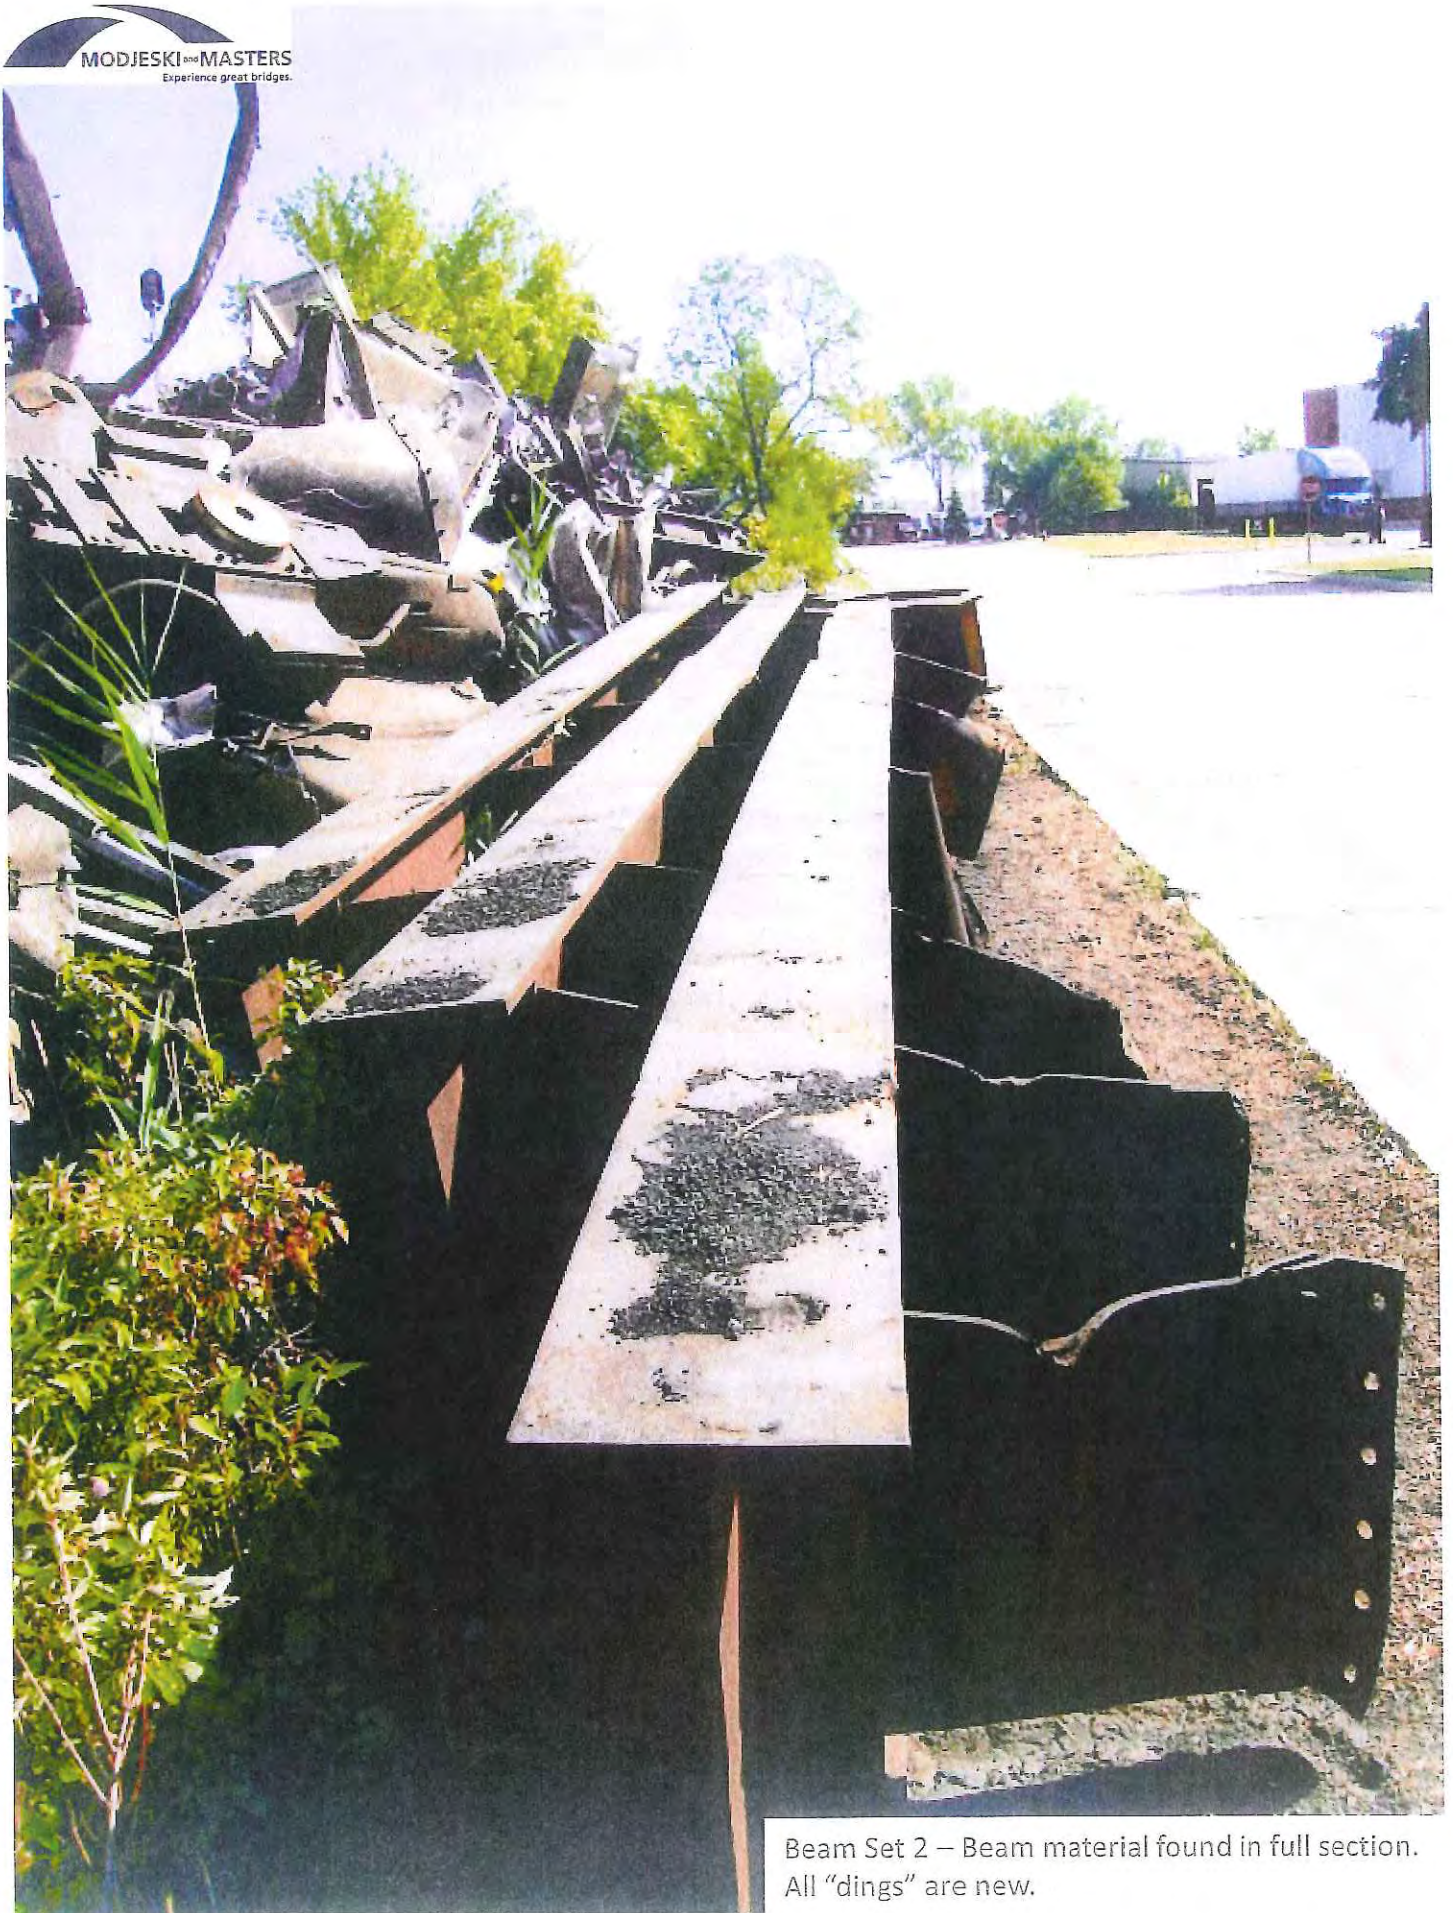
Beam Set 2 – Beam material found in full section.
All “dings” are new.

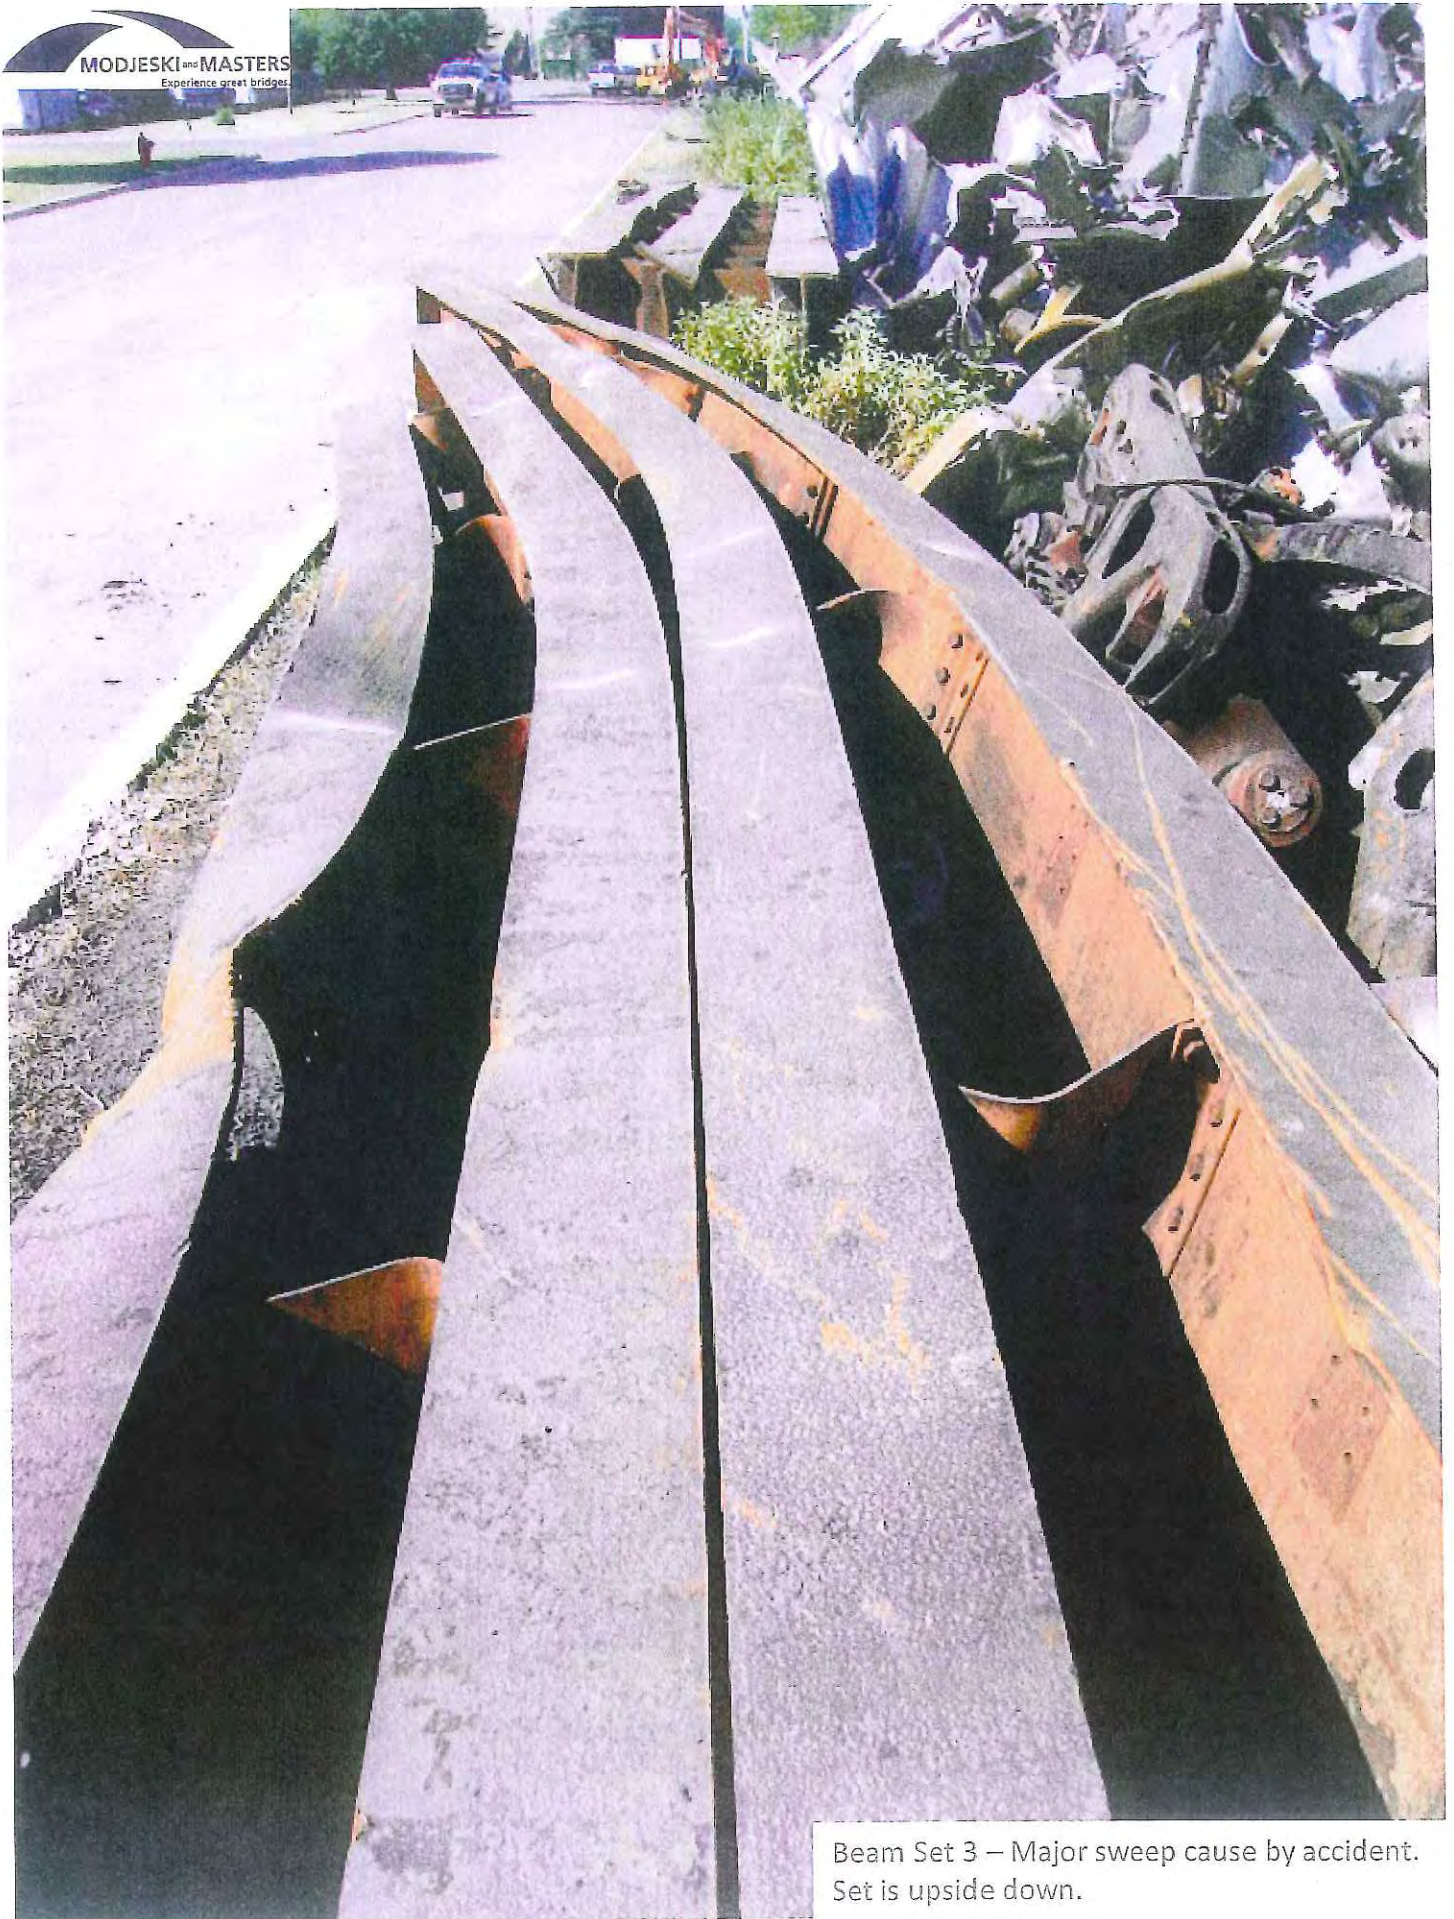
- A set of four “S” type beams diaphragmed together as a unit
- Prior position within bridge not known at this time
- Major lateral sweep in set of beams
- Beam set in the field is positioned upside down
- Beams in full section, no loss of metal from corrosion
- Beam bearing areas in good condition
- No indication of beam span failure

Beam Set 3 – Major sweep cause by accident. Set is upside down.

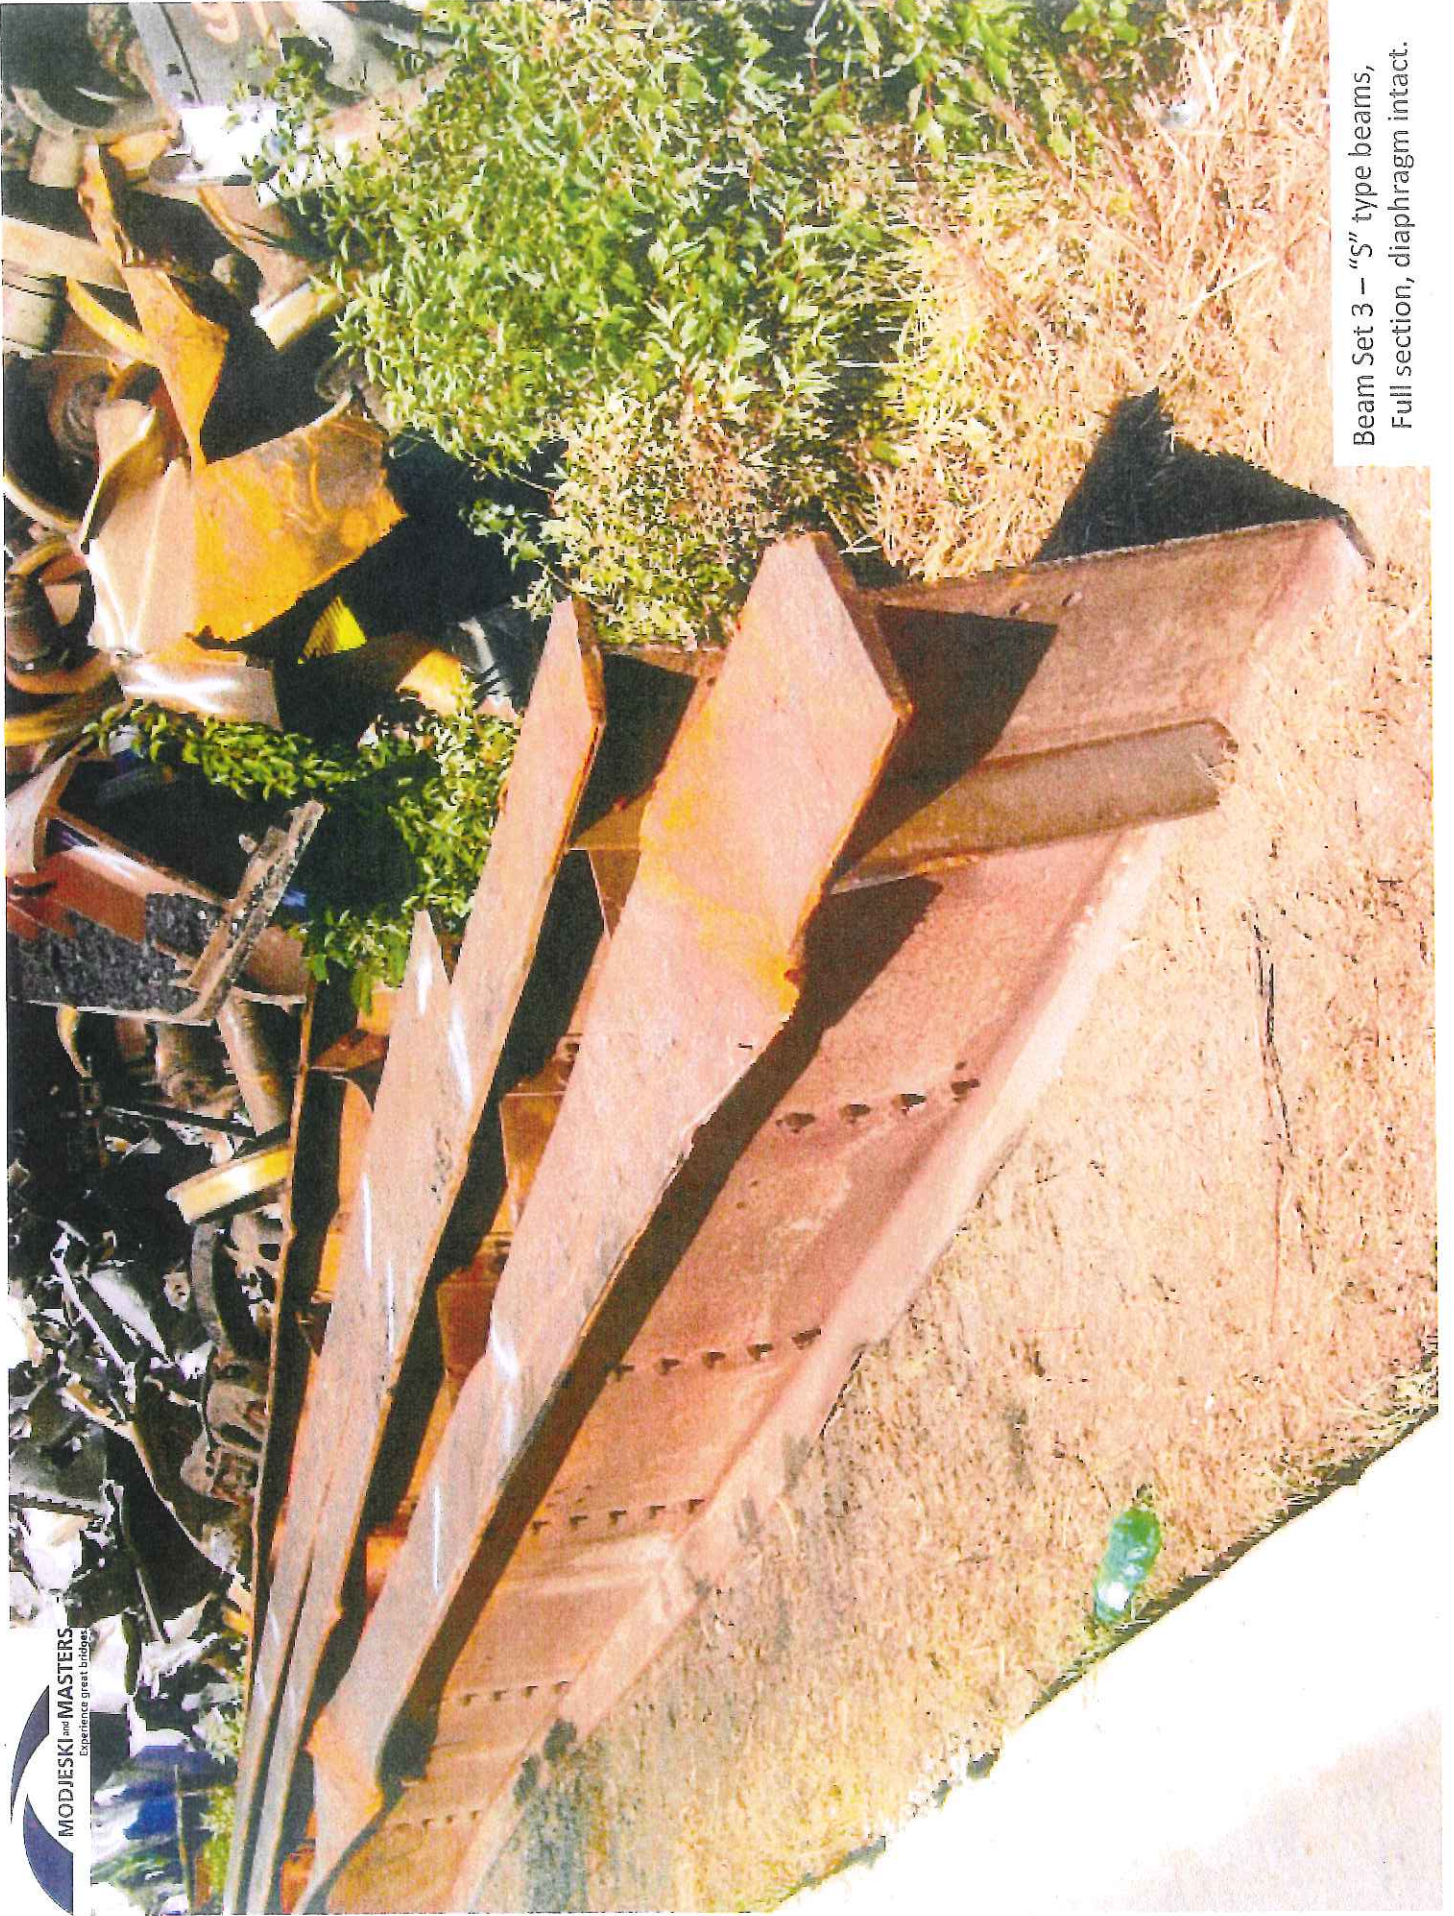
Beam Set 3 – “S” type beams,
Full section, diaphragm intact.
