BRIDGE NO. 17.44 MILWAUKEE SUB
ACCIDENT OF JULY 4, 2012
INSPECTION OF BRIDGE SPANS
ACCIDENT OPINION

Bridge No. 17.44 Milwaukee Sub
Accident of July 4, 2012
Inspection of Bridge Spans
Appended Report

Bridge No. 17.44 Milwaukee Sub Accident of July 4, 2012 Inspection of Bridge Spans

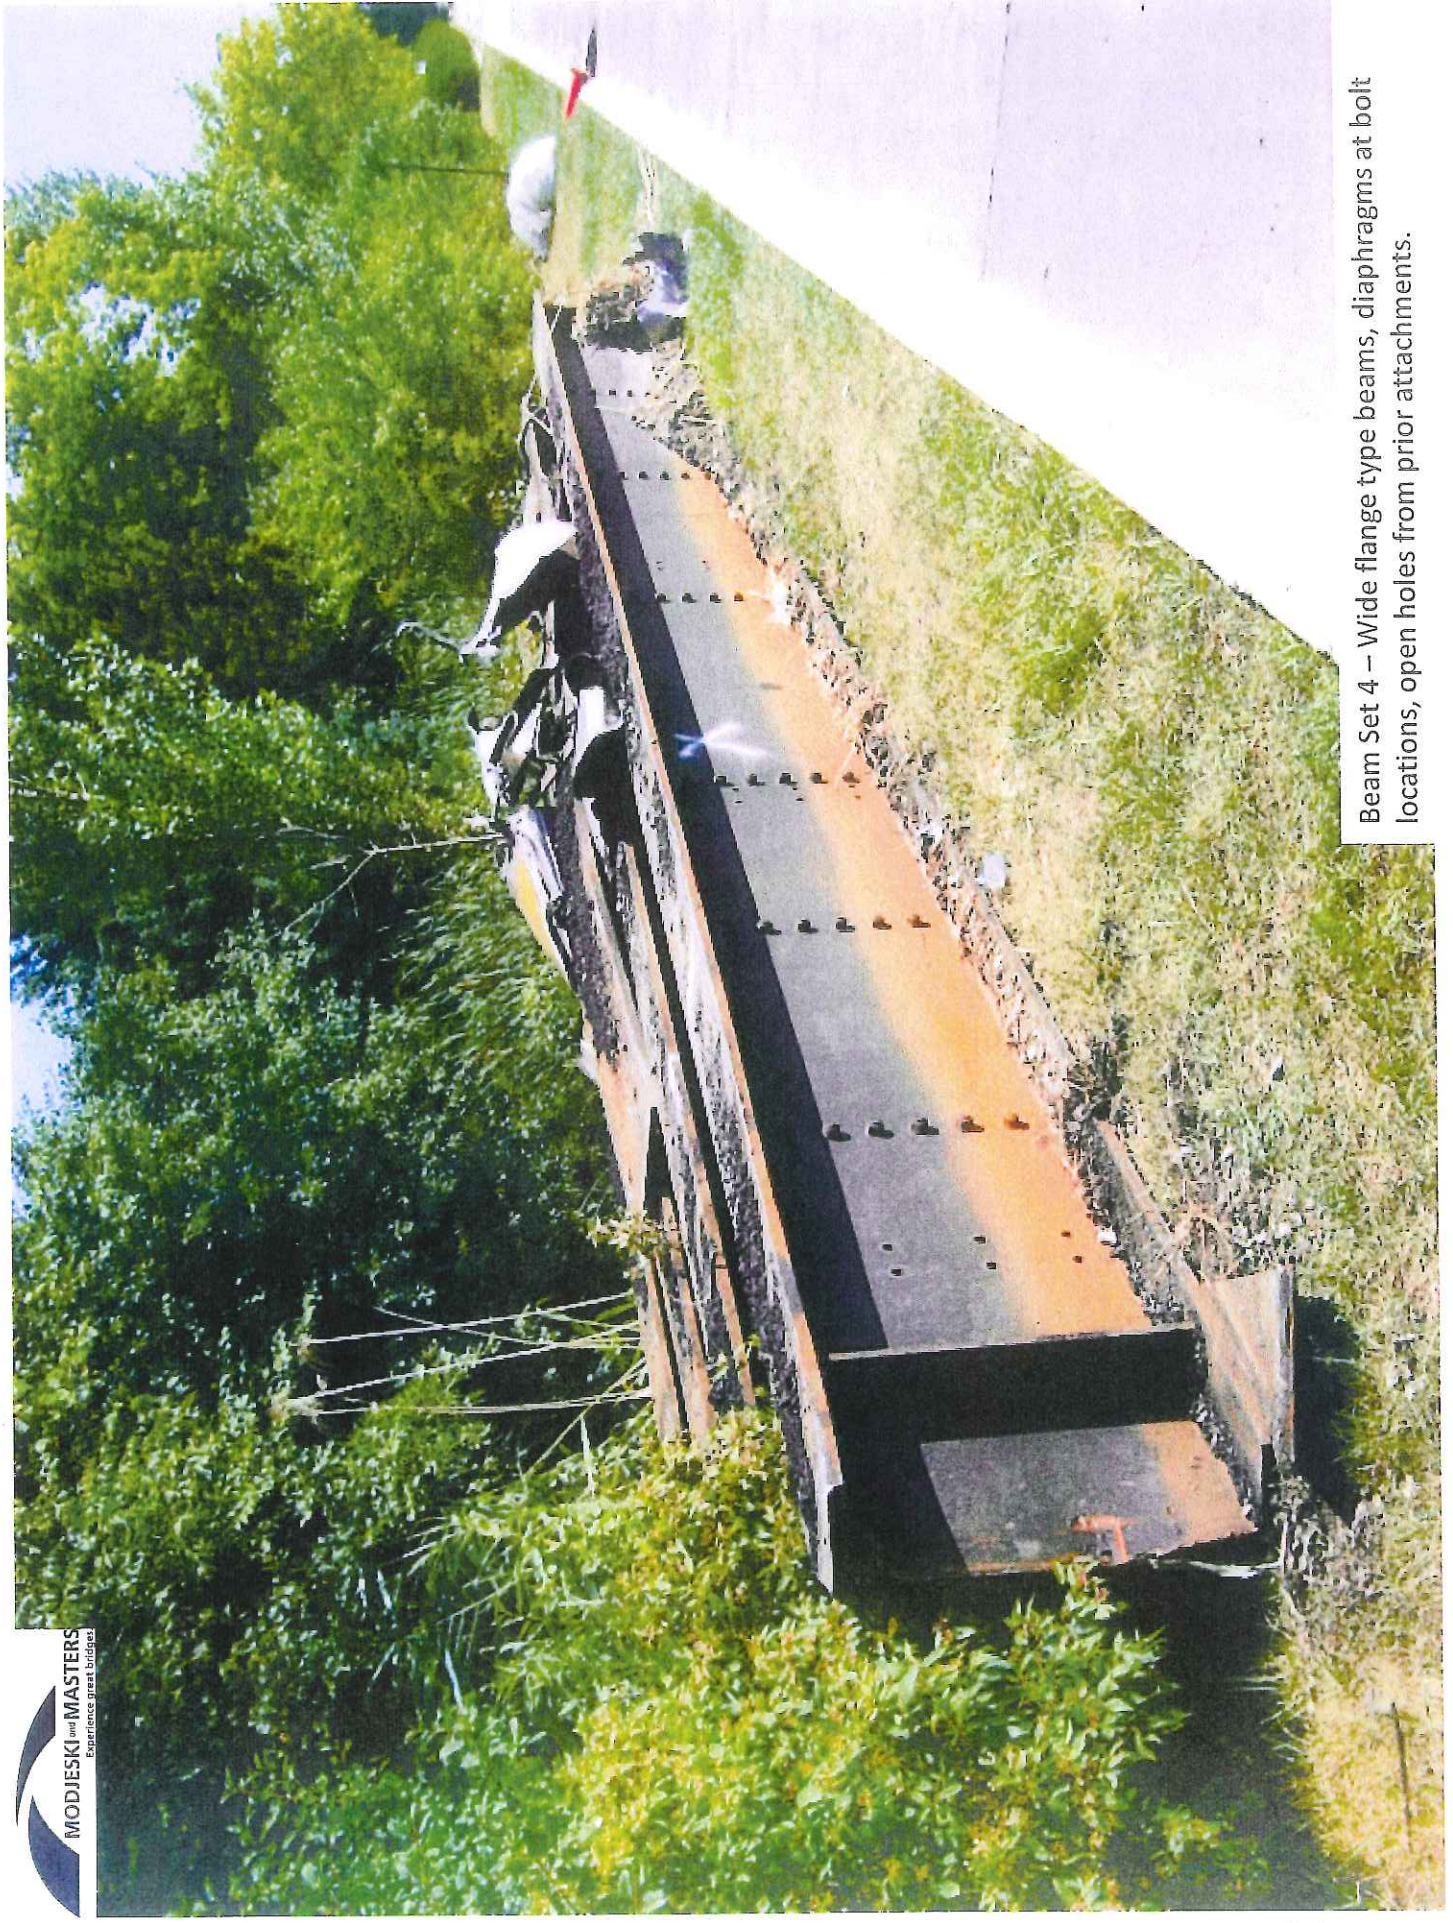
- A set of four wide flange type beams diaphragmed together as a unit
- Prior position within bridge not known at this time
- Beams generally straight with flange bends from object impacts
- Beams in full section, no loss of metal from corrosion

- Beam bearing areas in good condition
- Extra holes in beams from prior attachments
- No indication of beam span failure

Beam Set 4 – Wide flange type beams, diaphragms at bolt locations, open holes from prior attachments.

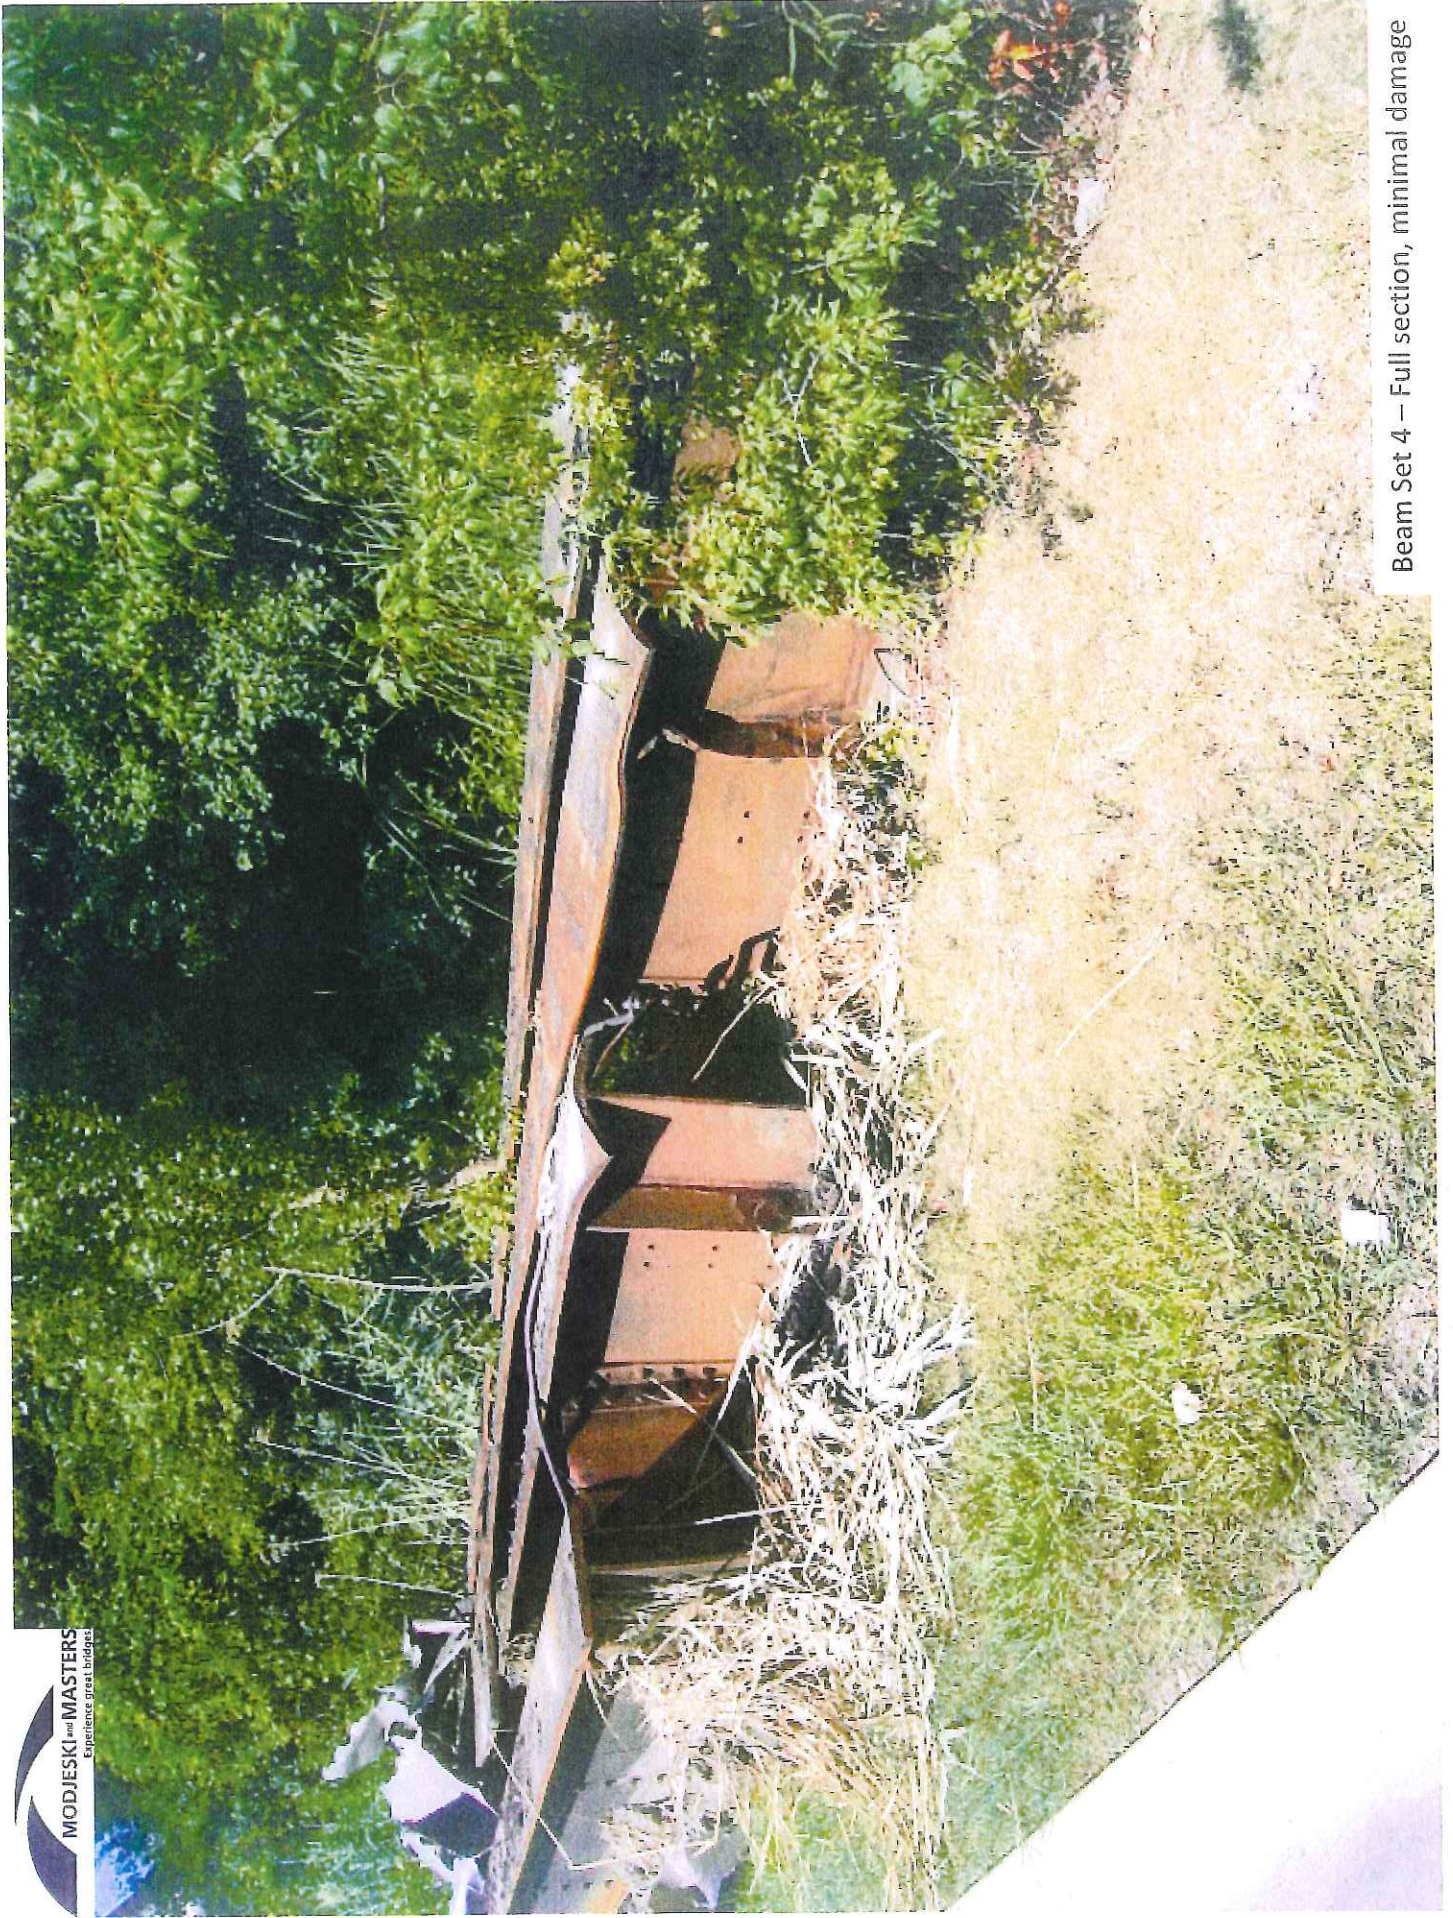
Beam Set 4 – Full section, minimal damage

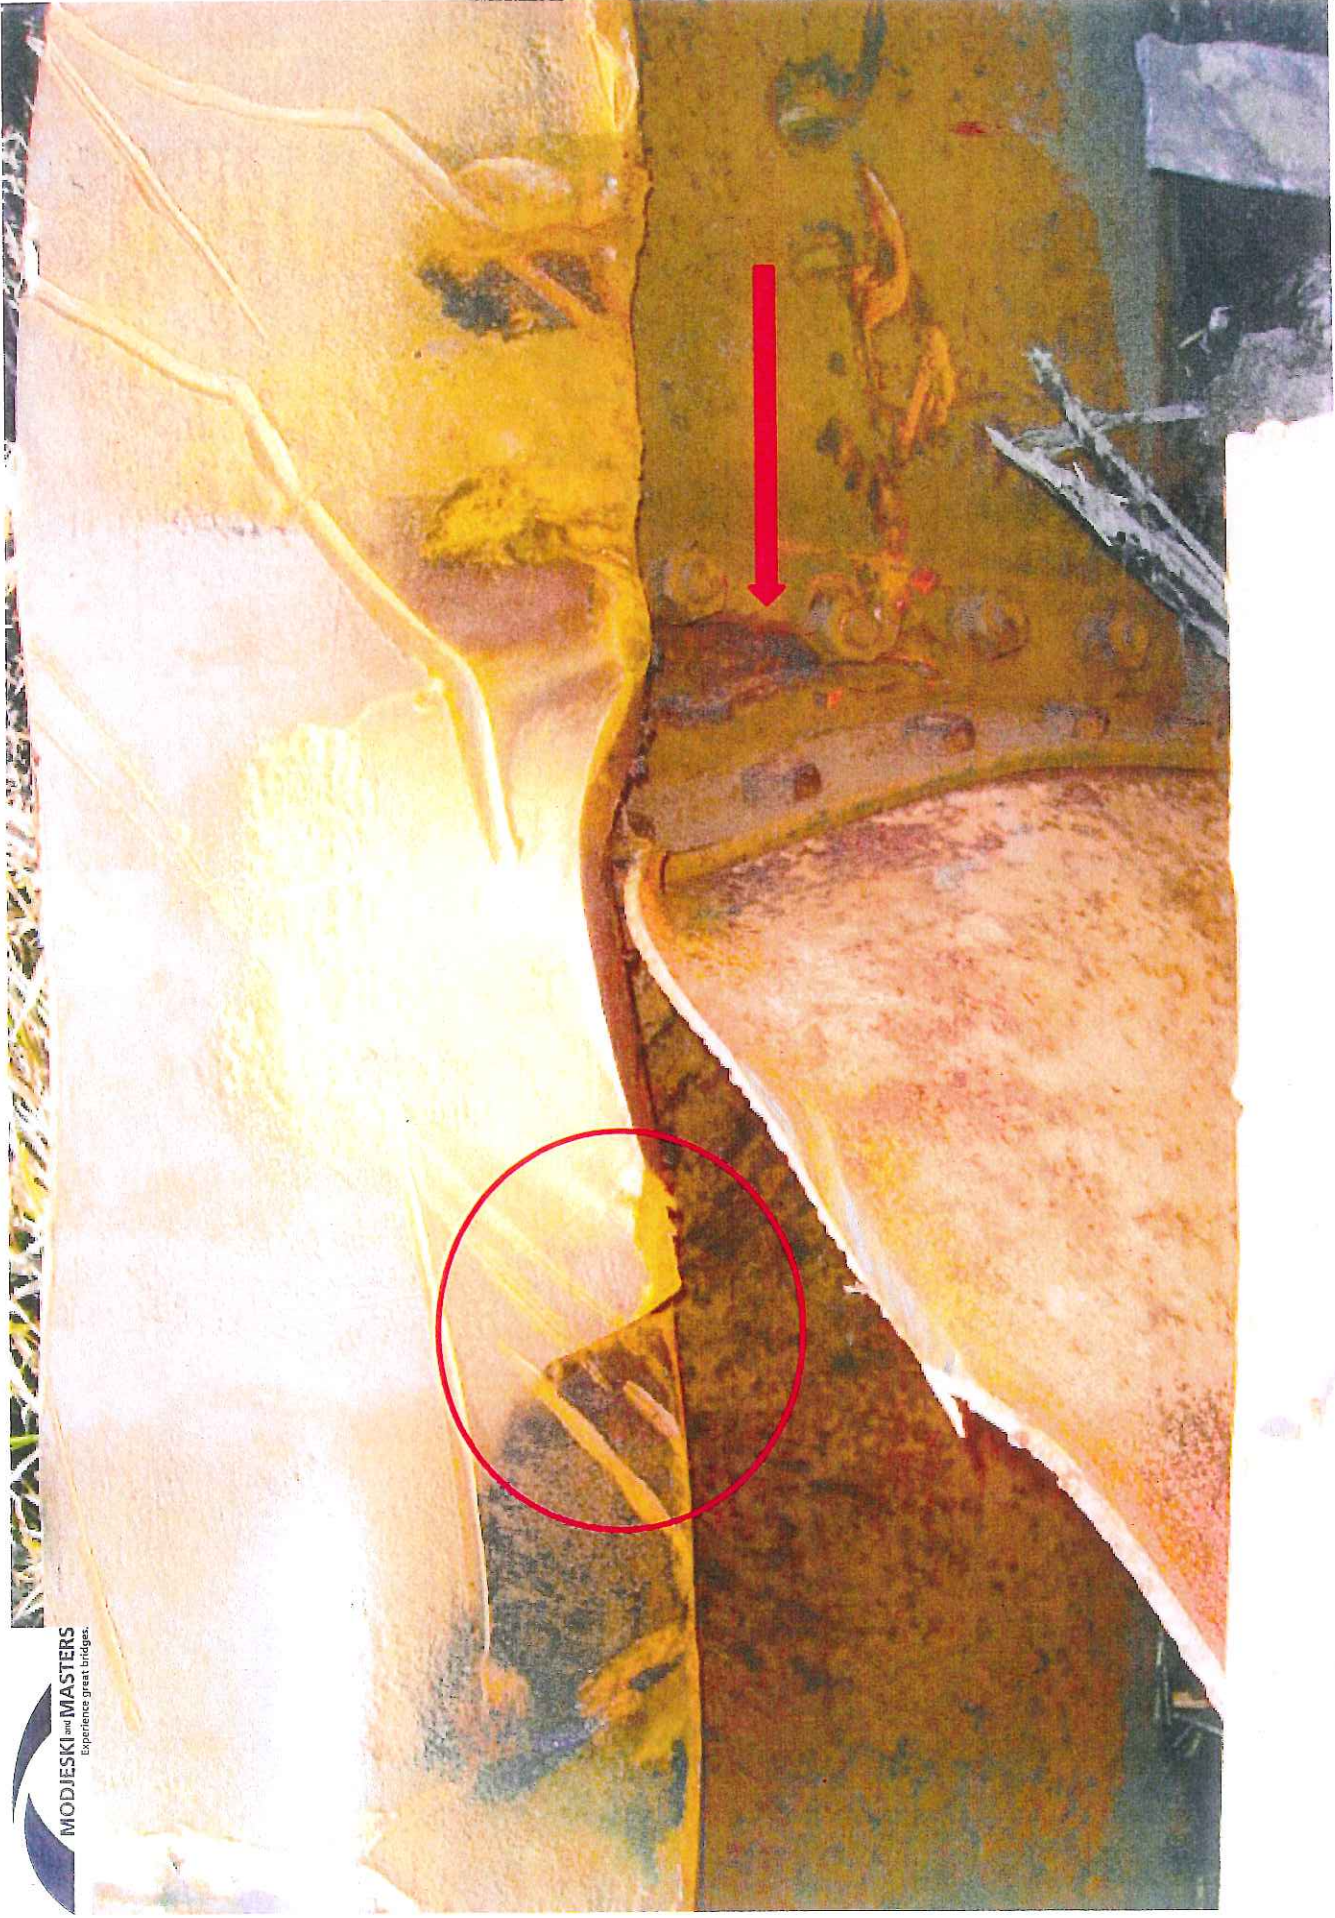
Beam Set 1 – Tear in flange with fresh rust indicating accident damage (circle);
Diaphragm connection angle torn in accident (arrow)

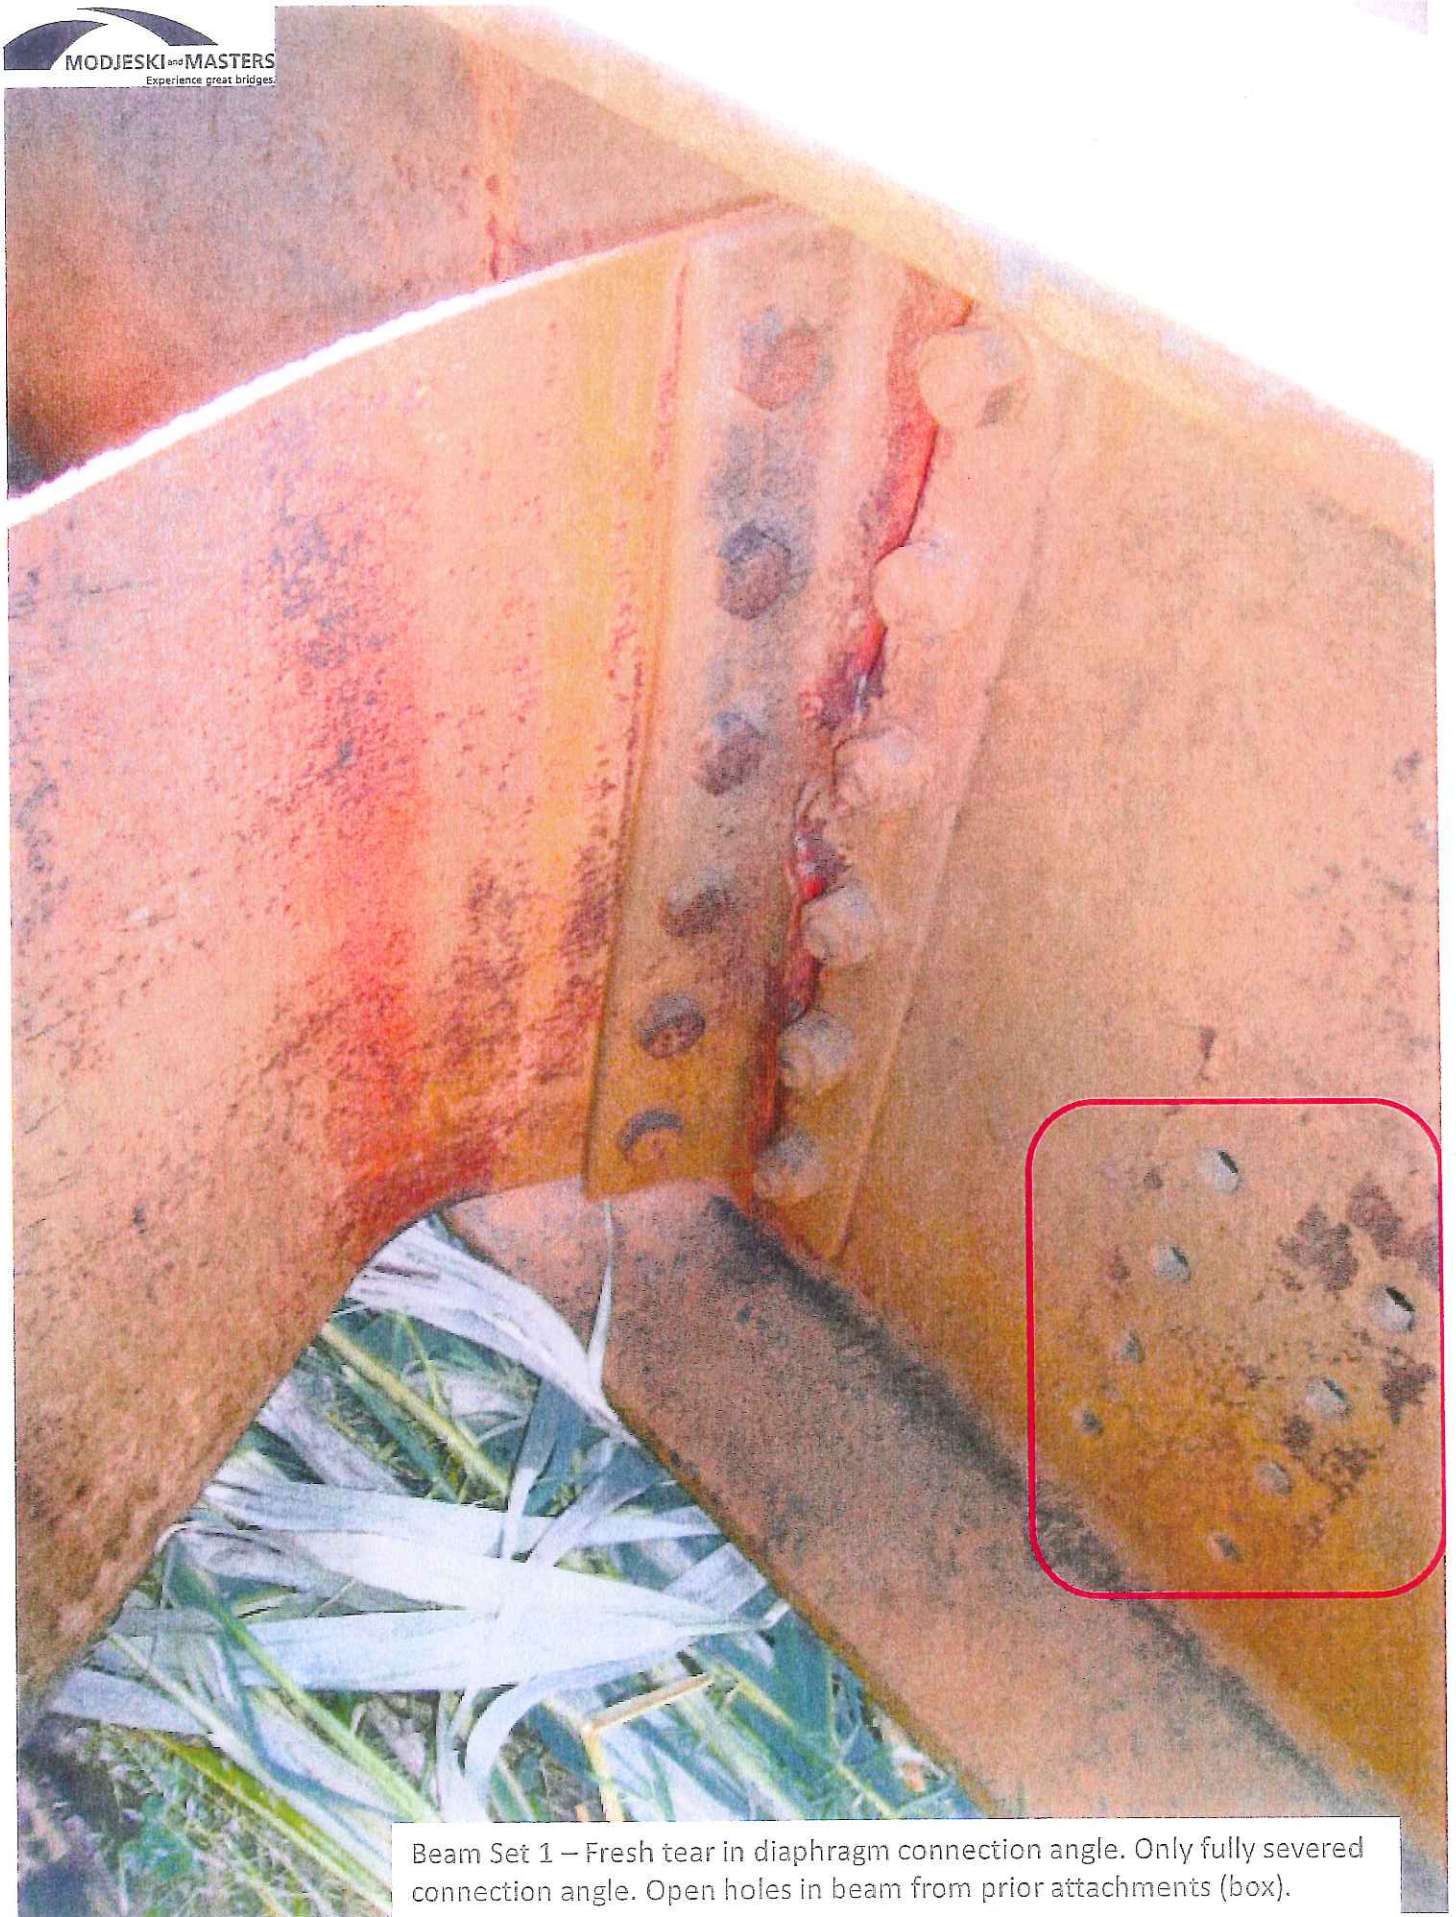
Beam Set 1 – Fresh tear in diaphragm connection angle. Only fully severed connection angle. Open holes in beam from prior attachments (box).

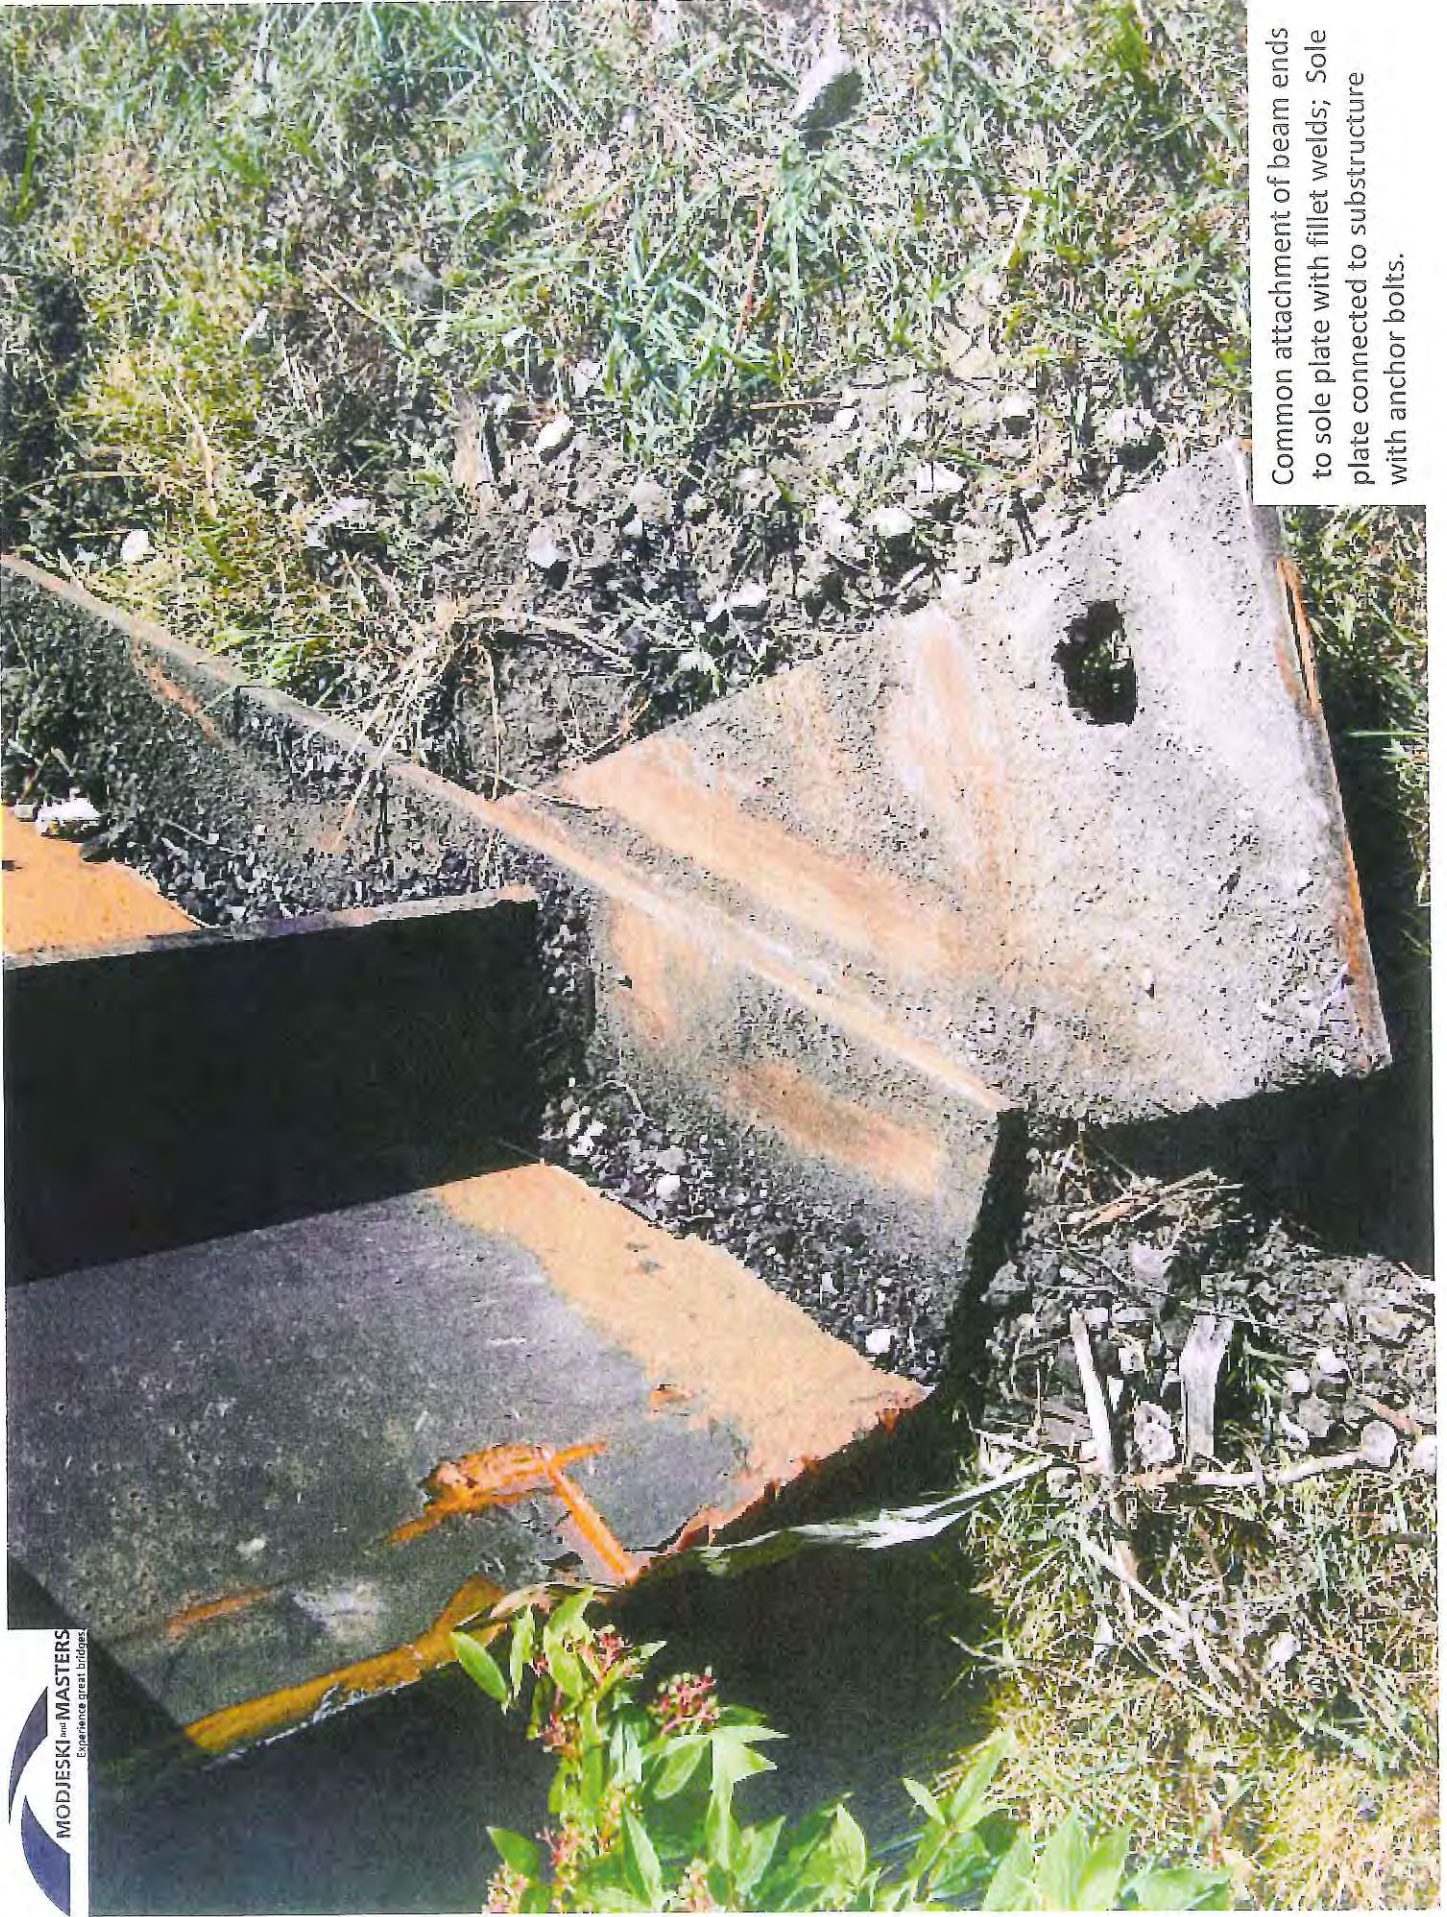
Common attachment of beam ends to sole plate with fillet welds; Sole plate connected to substructure with anchor bolts.

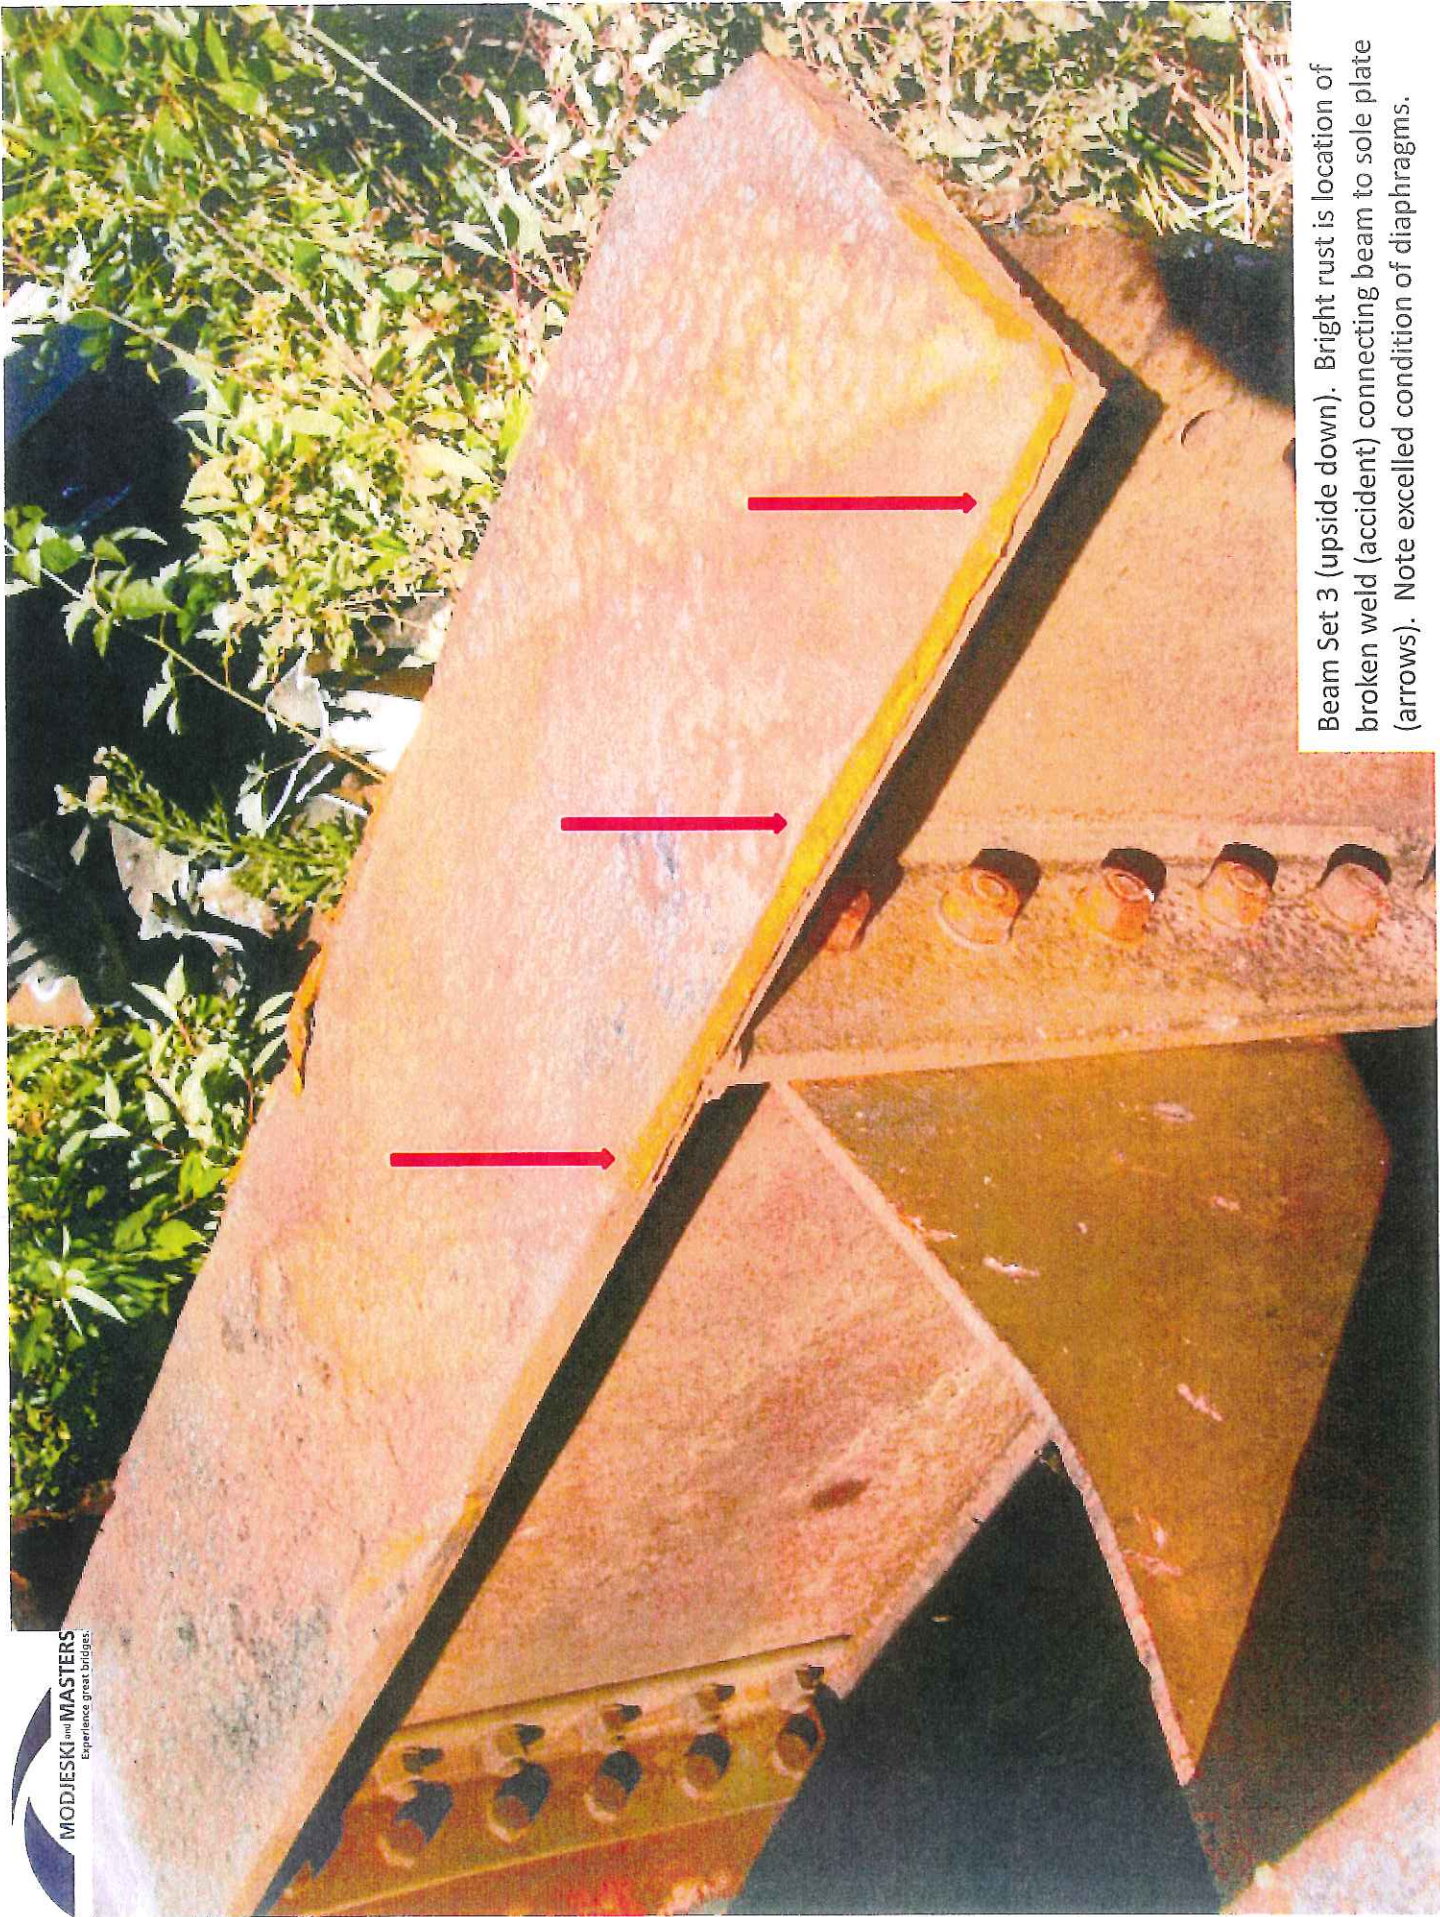
Beam Set 3 (upside down). Bright rust is location of broken weld (accident) connecting beam to sole plate (arrows). Note excellent condition of diaphragms.

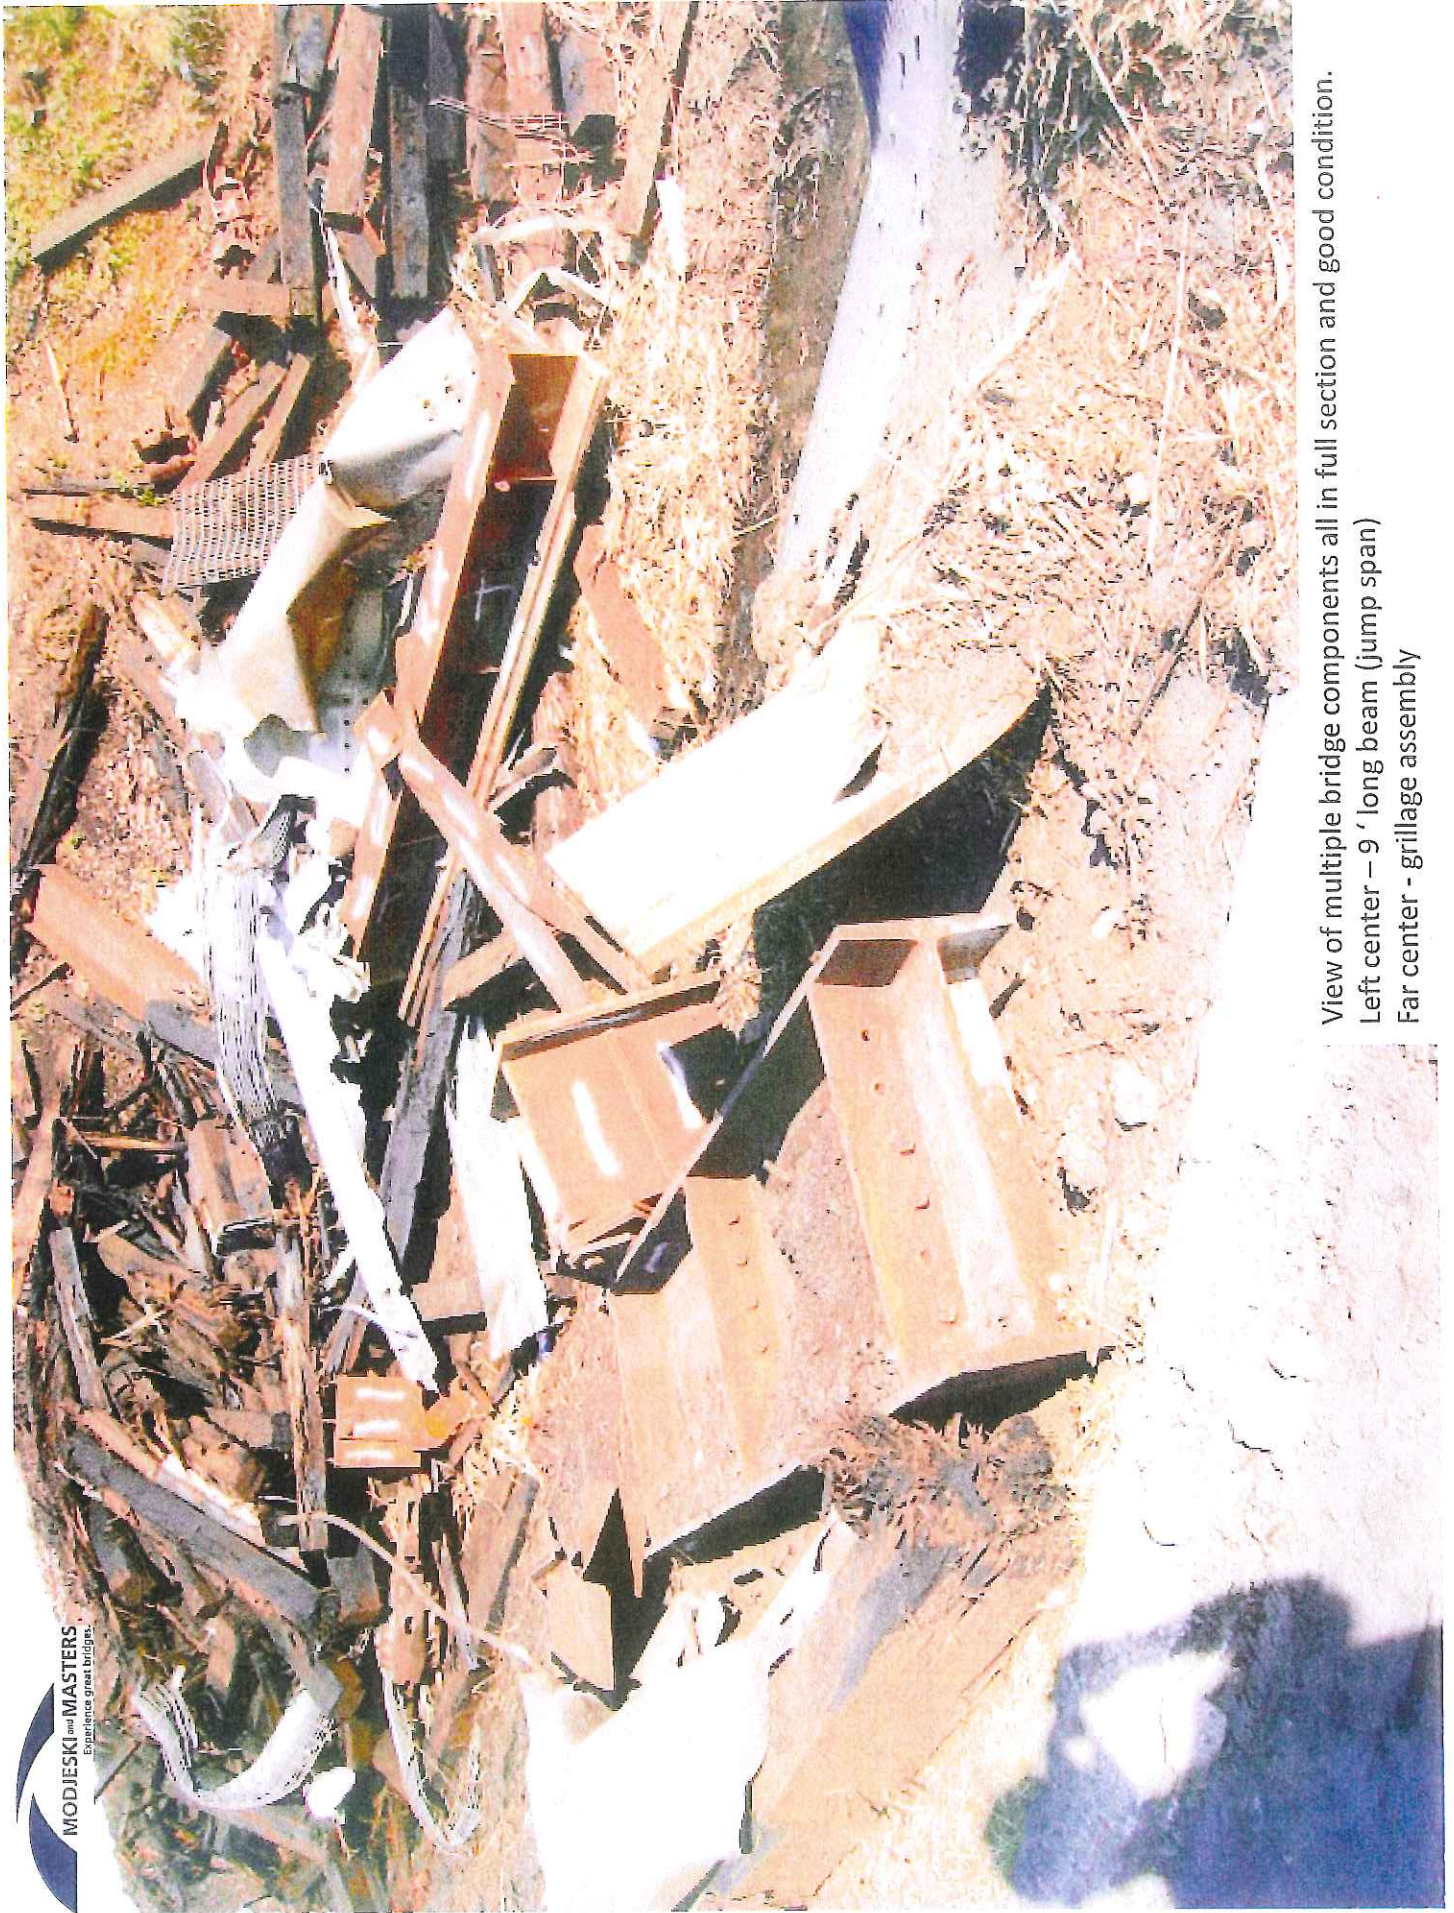
View of multiple bridge components all in full section and good condition.
Left center - 9' long beam (jump span)
Far center - grillage assembly

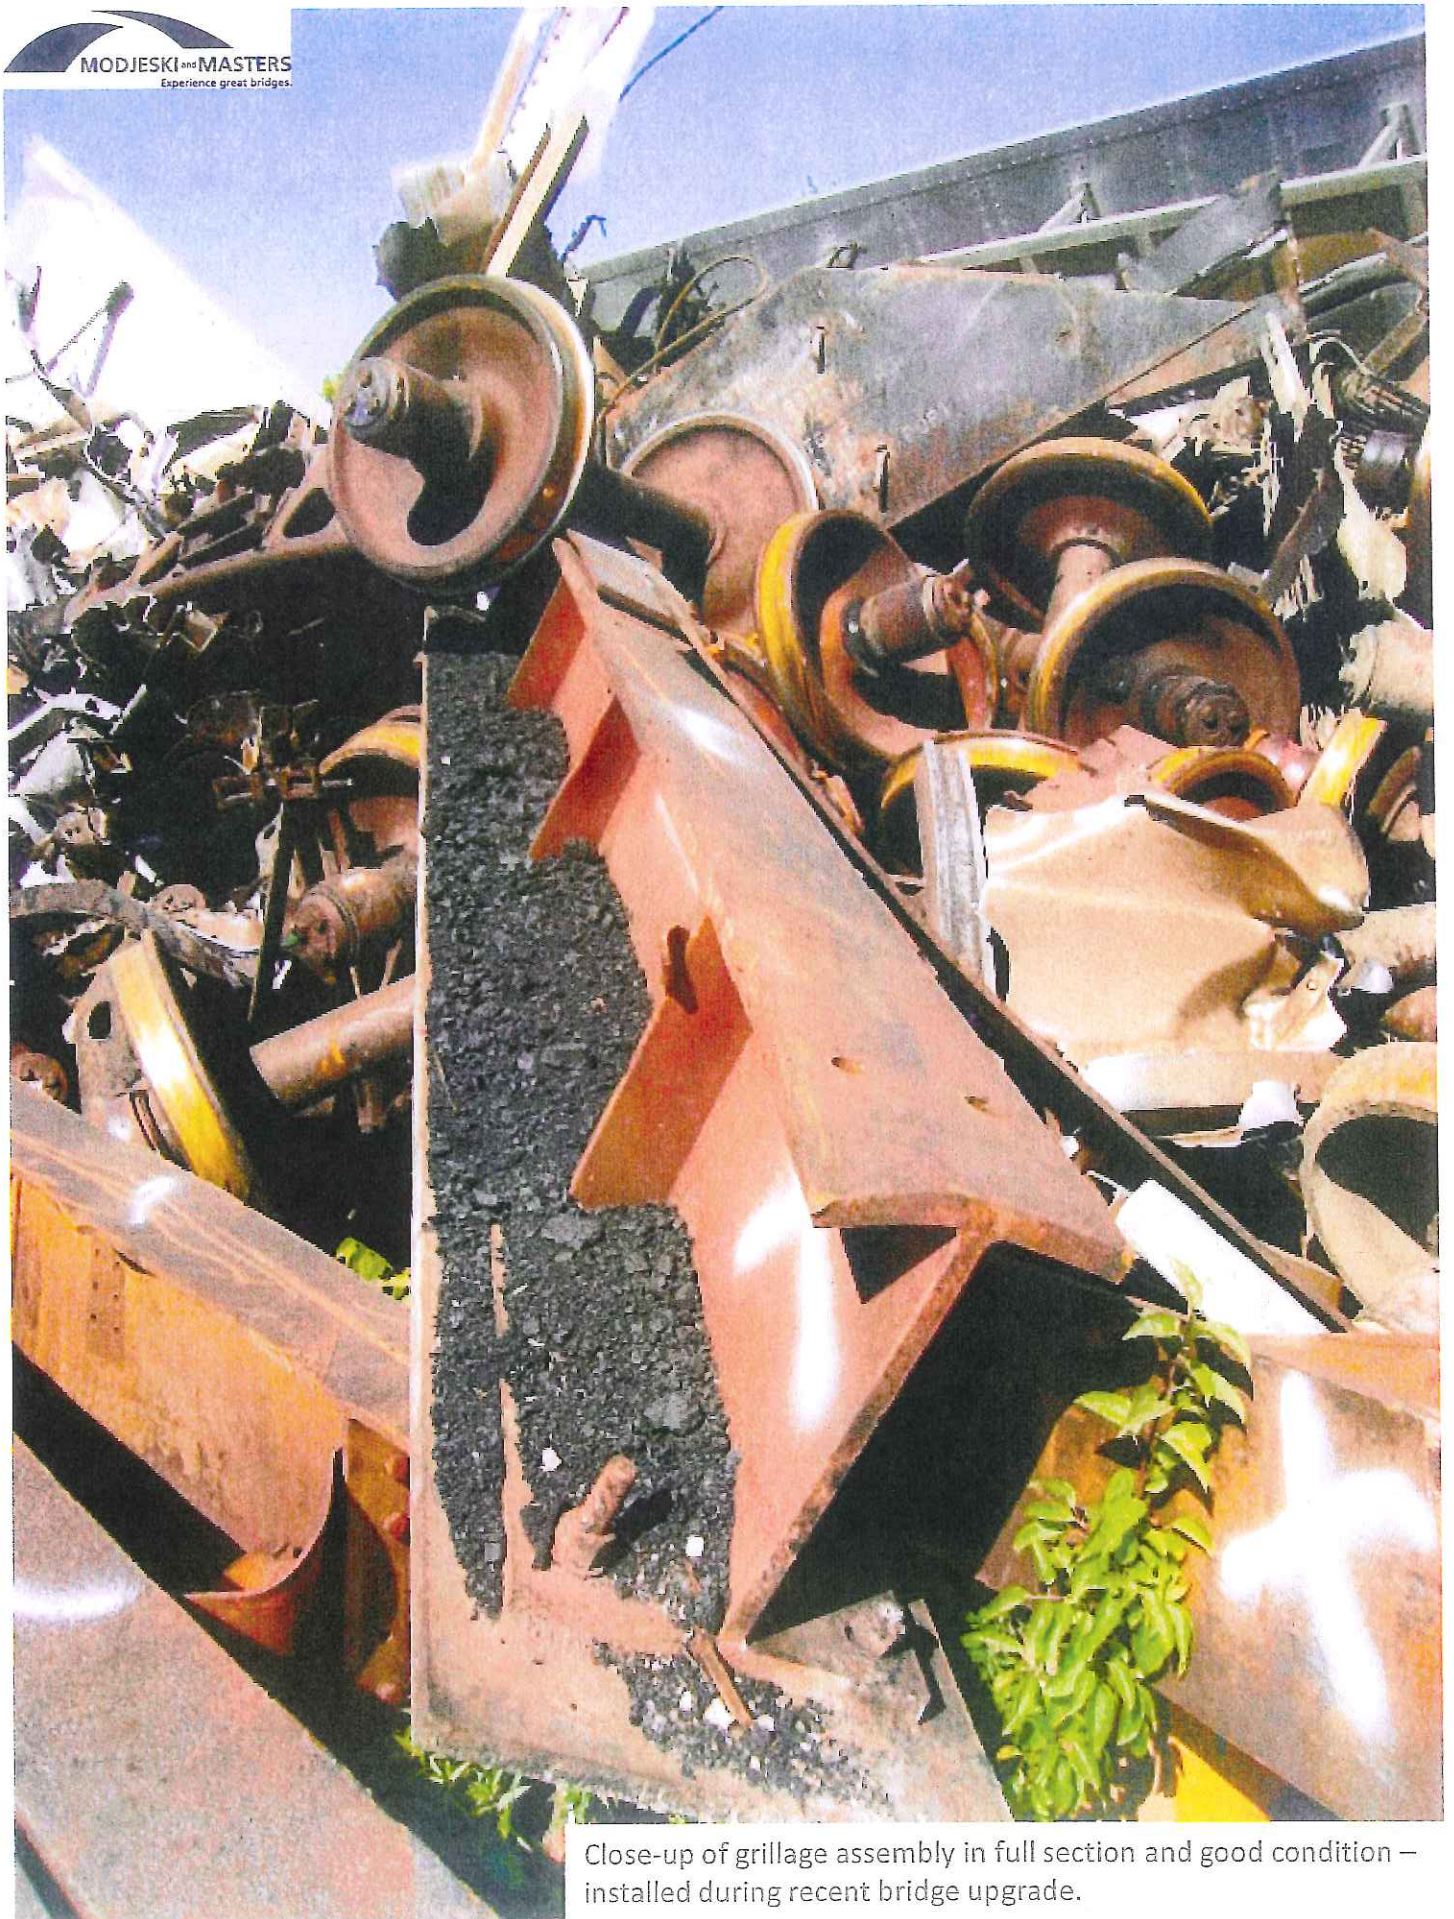
- Grillages were welded beams having a 12 x 1.25 top flanges, 1" thick web and an 18 x 1.5 bottom flange sitting on a base plate
- Multiple grillages were present without bridge location identity
- Grillages were installed in recent past and in good condition having full section
- No indications of failure

Close-up of grillage assembly in full section and good condition – installed during recent bridge upgrade.
