BRIDGE NO. 17.44 MILWAUKEE SUB
ACCIDENT OF JULY 4, 2012
INSPECTION OF BRIDGE SPANS
ACCIDENT OPINION

Bridge No. 17.44 Milwaukee Sub
Accident of July 4, 2012
Inspection of Bridge Spans
Appended Report

Bridge No. 17.44 Milwaukee Sub Accident of July 4, 2012 Inspection of Bridge Spans

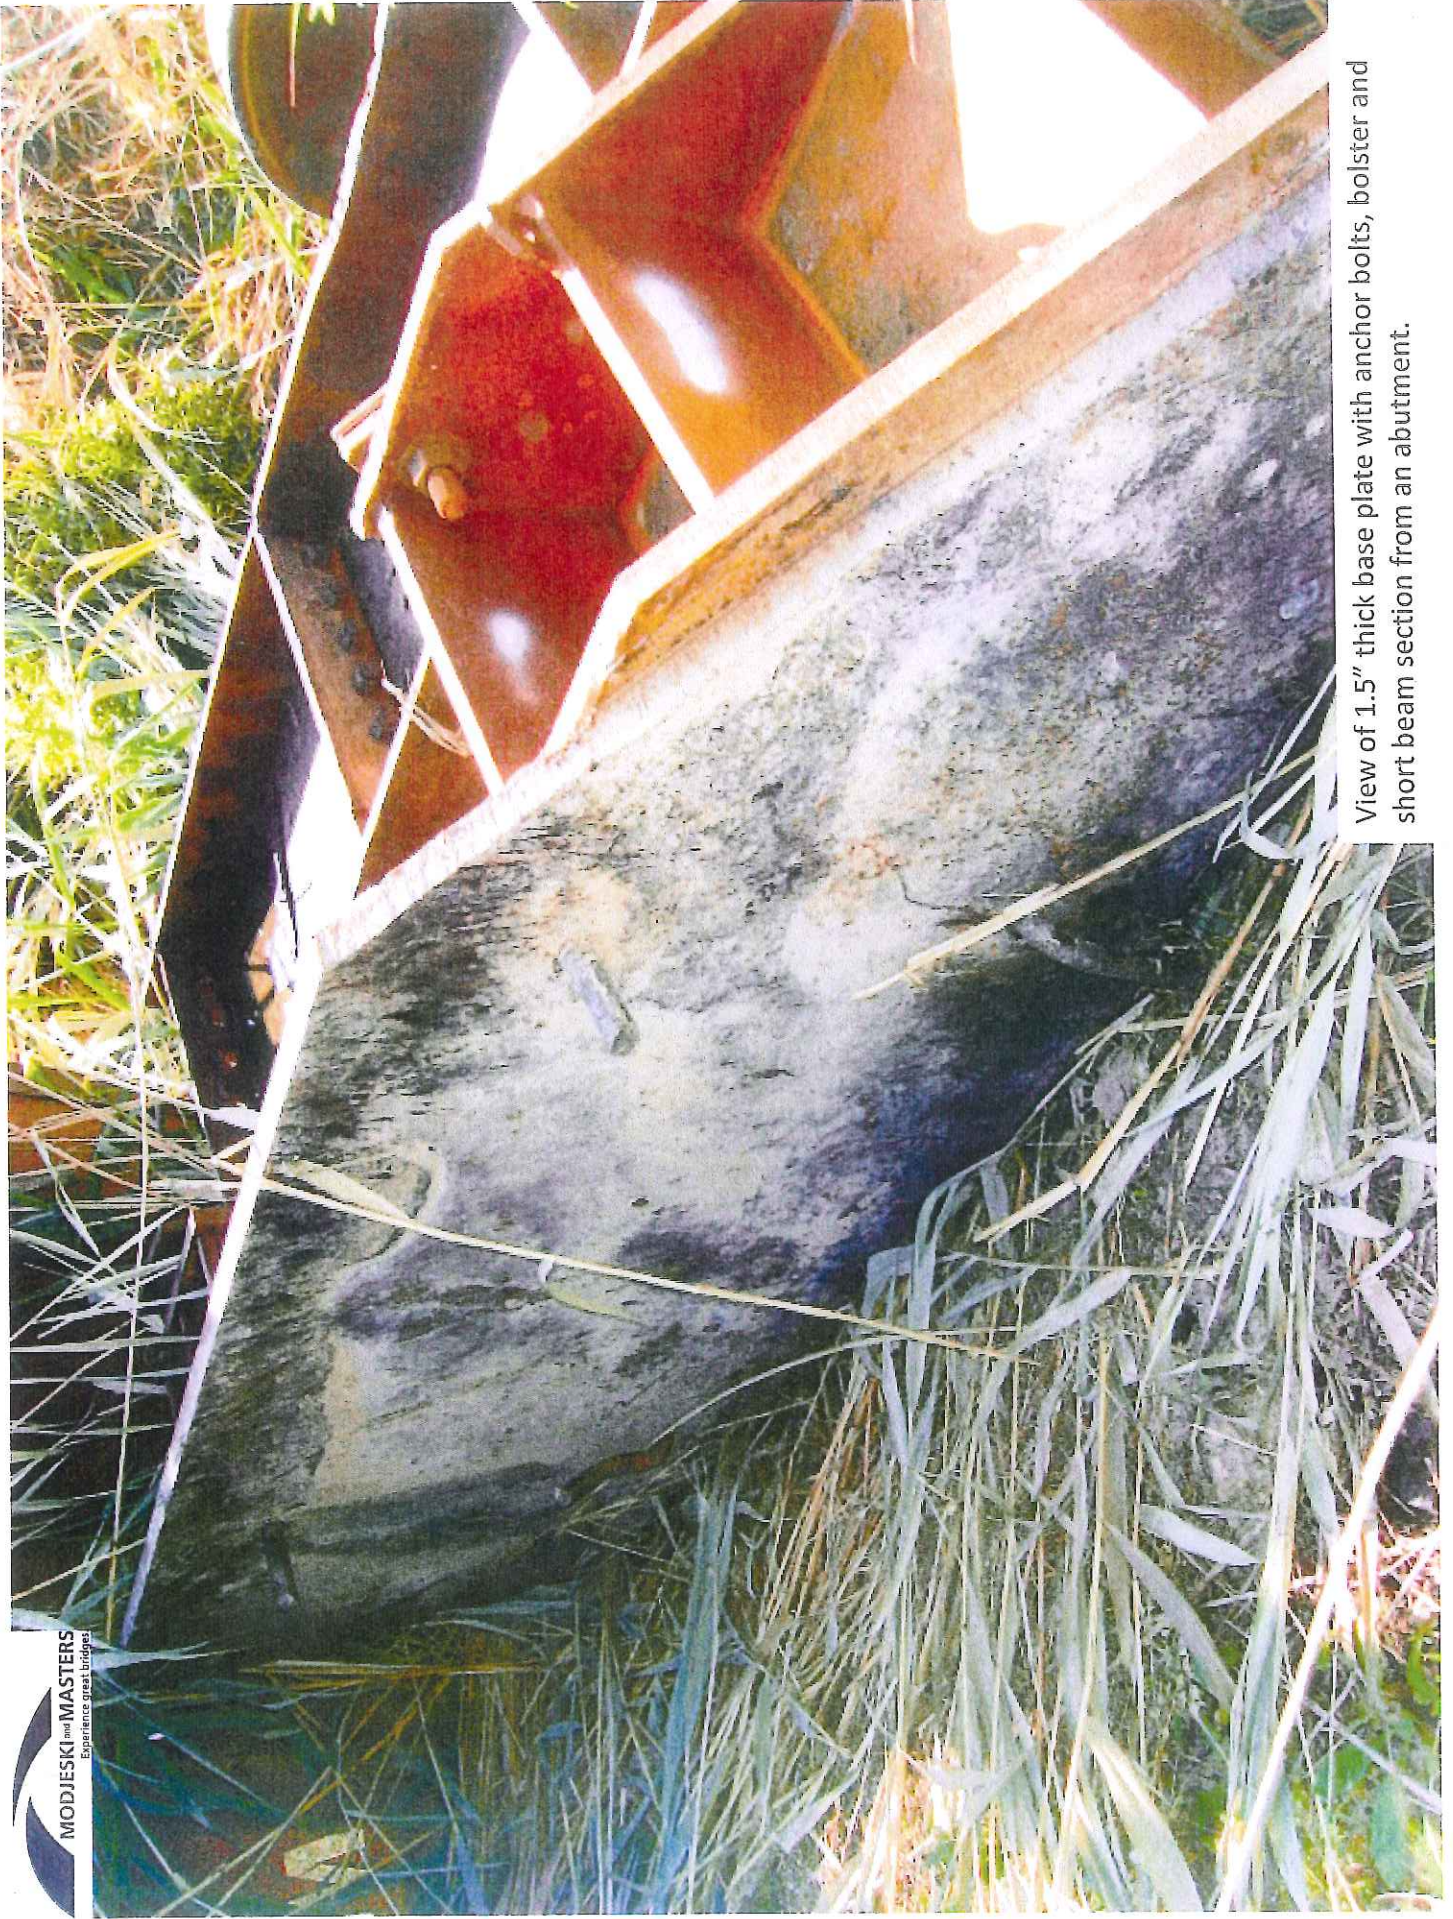
View of 1.5" thick base plate with anchor bolts, bolster and short beam section from an abutment.

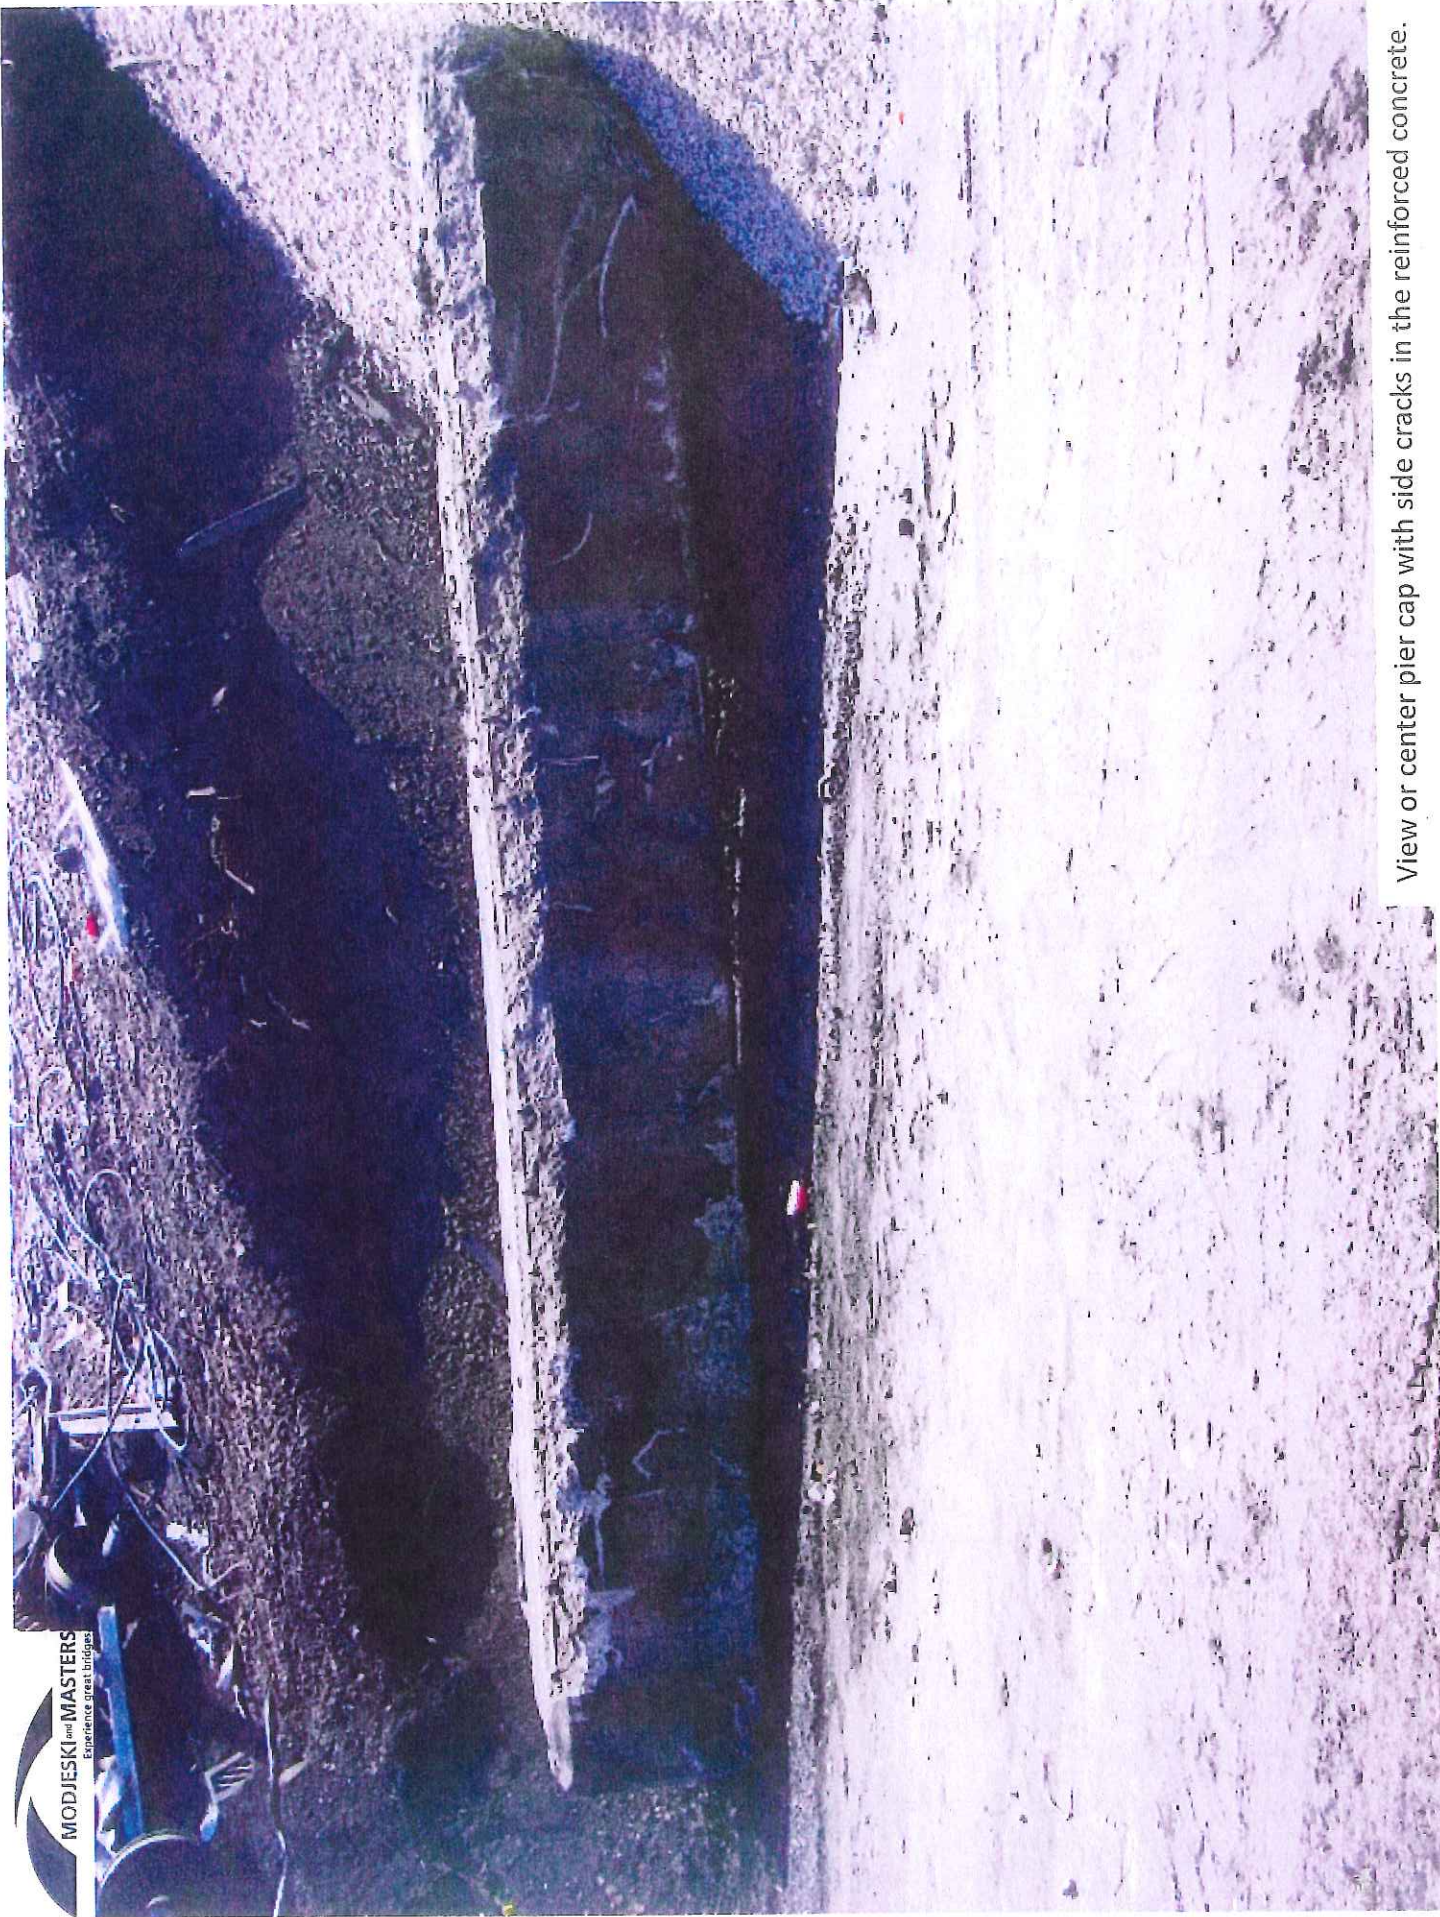
At that time of the inspection, rail traffic had been re-established for multiple days as the Railroad completely “filled” the underpass with stone for temporary support of the two tracks. The fill negated inspection of the abutments and center pier. Photographs furnished by the Union Pacific of both abutments prior to placement of fill showed that the massive concrete abutments remained in good condition with only minor damage. Located to the west of the bridge, at the toe of the fill on Shermer Road was the center pier cap which was of reinforced concrete. The pier cap was cracked, but remained intact. H-pile supports for the cap were not observed.

View of center pier cap with side cracks in the reinforced concrete.
