Bridge 17.44 Crossing Shermer Road, Glenview, IL at a skew

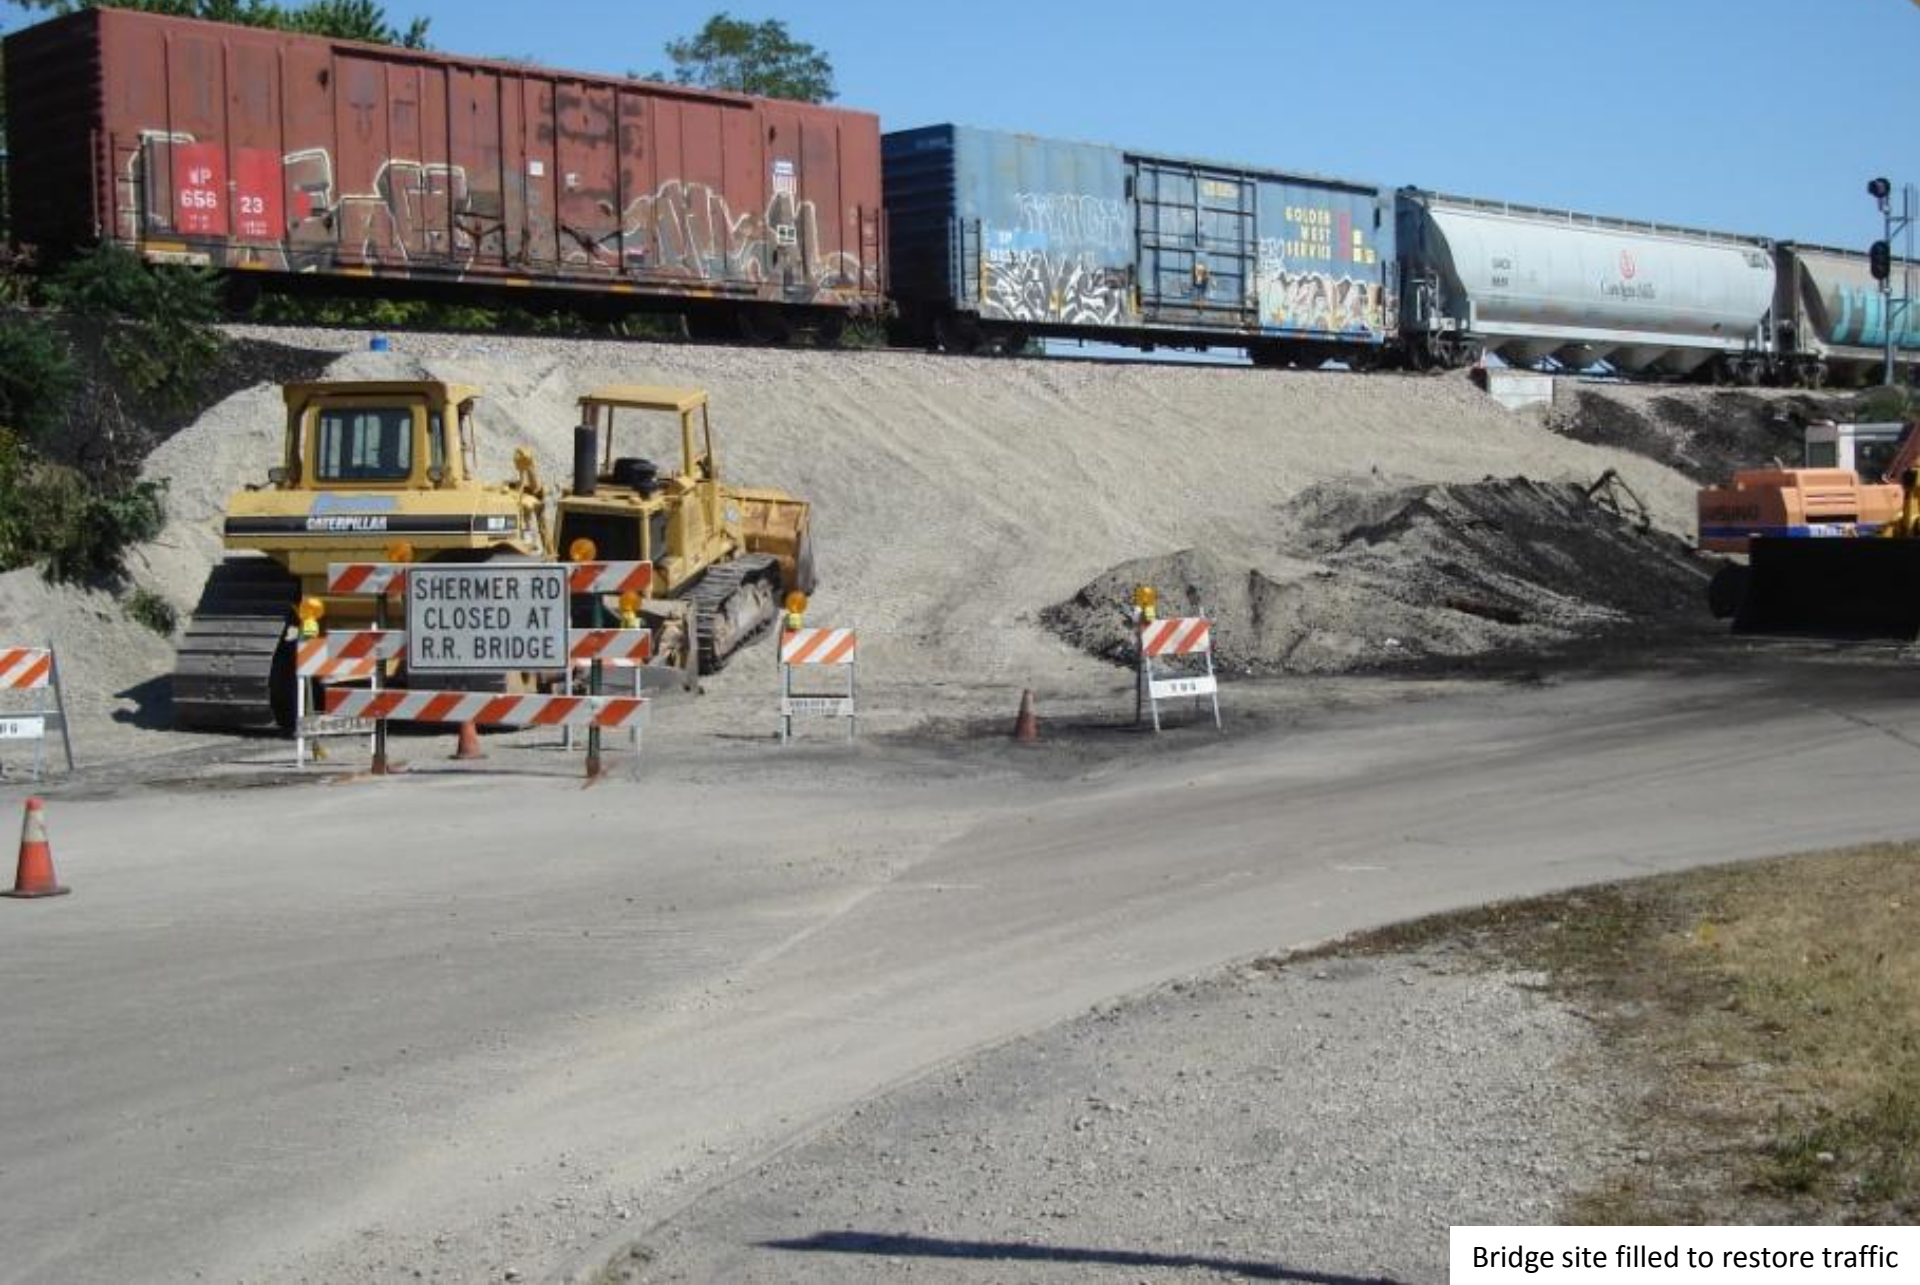
Bridge site filled to restore traffic

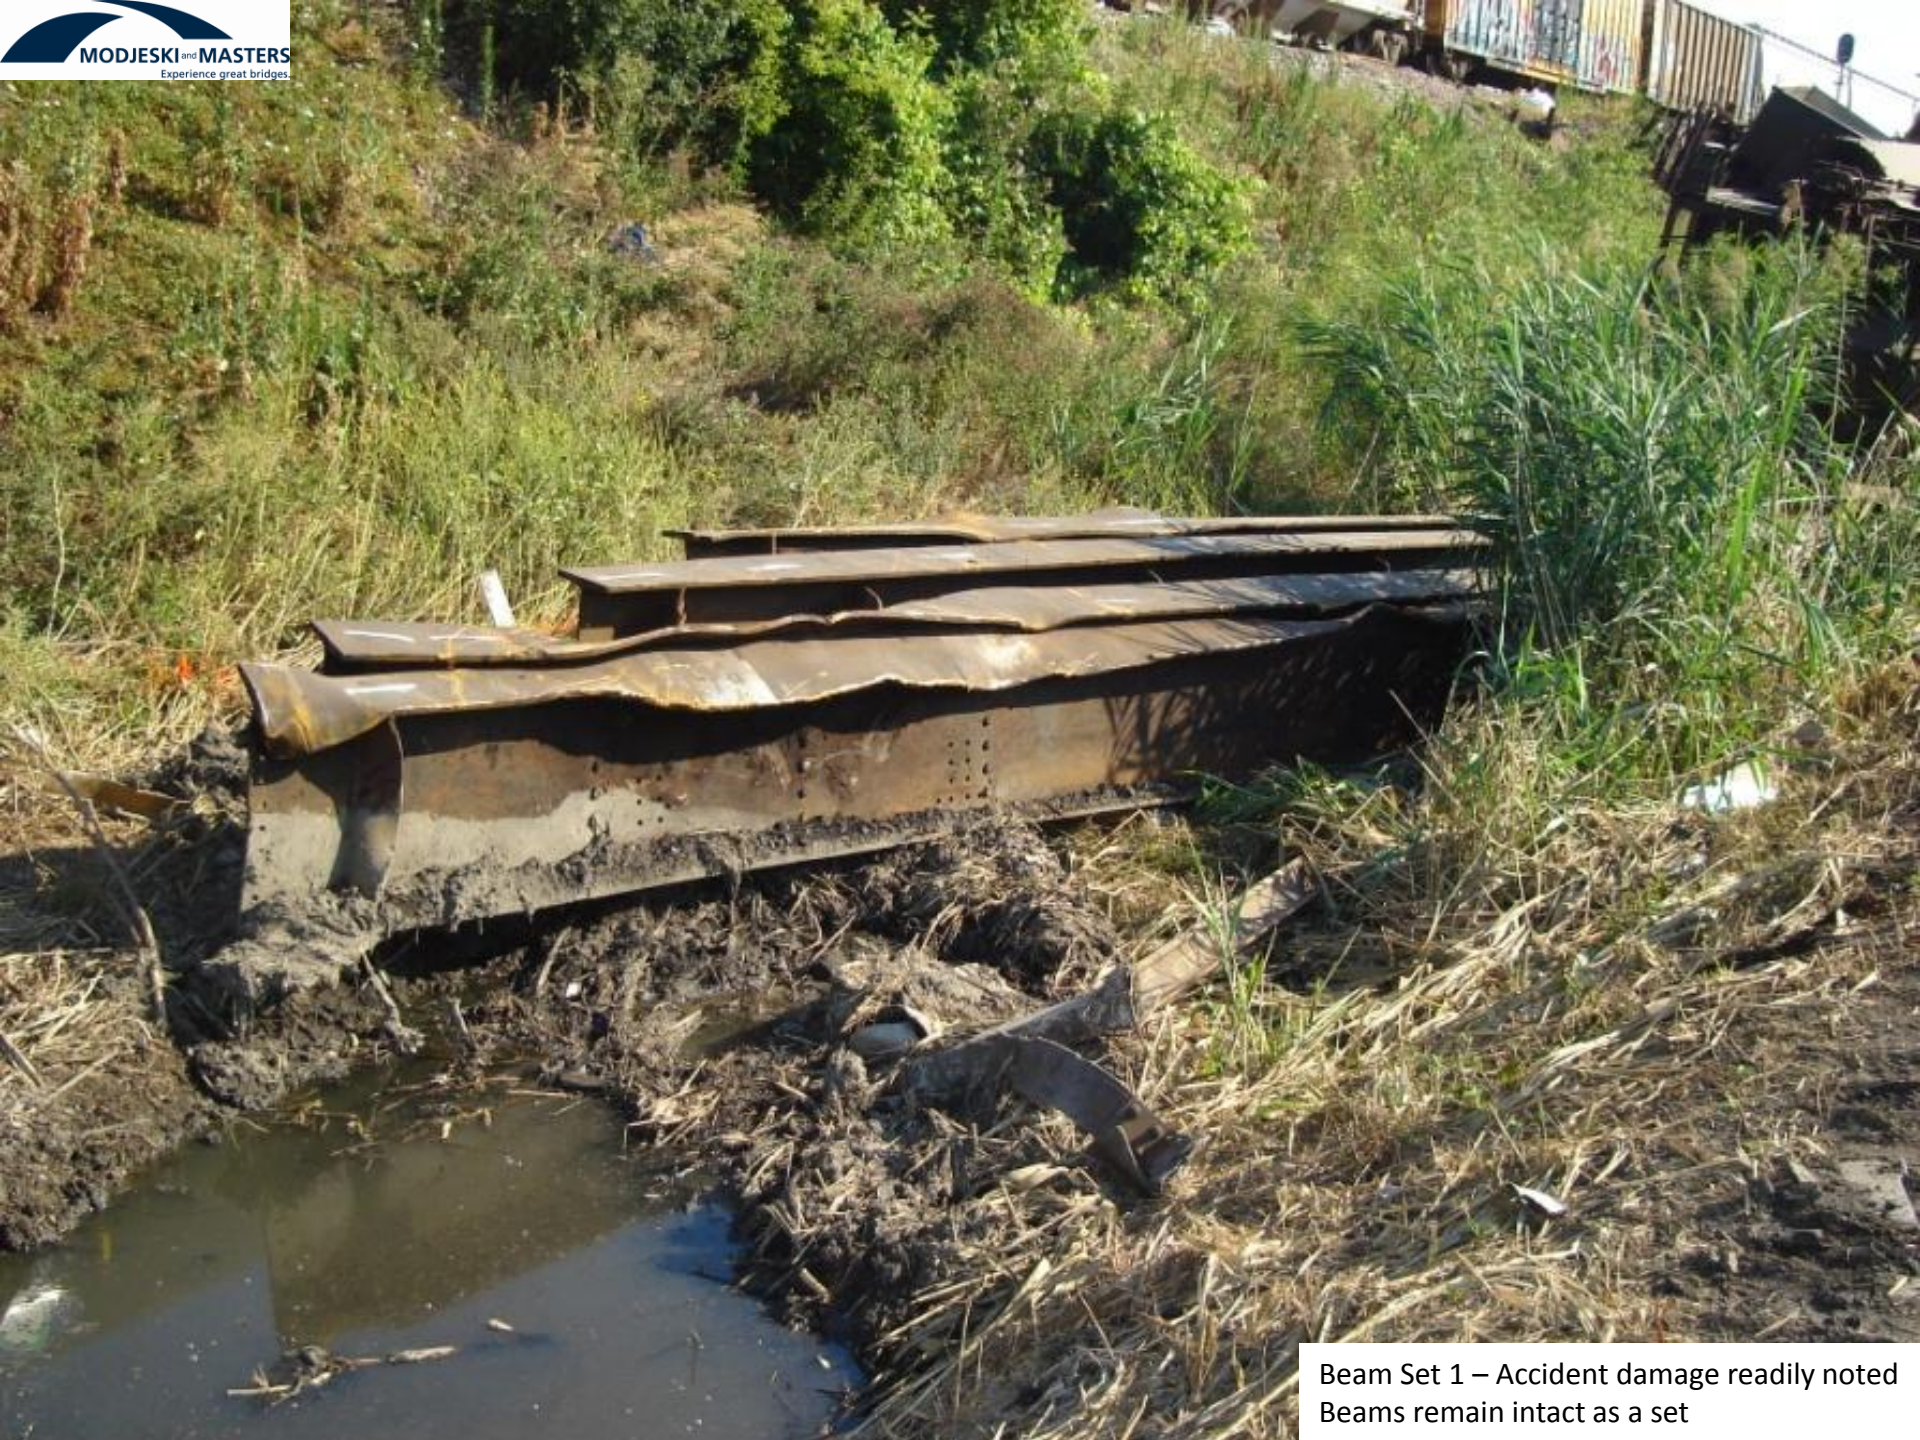
Beam Set 1 – Accident damage readily noted
Beams remain intact as a set

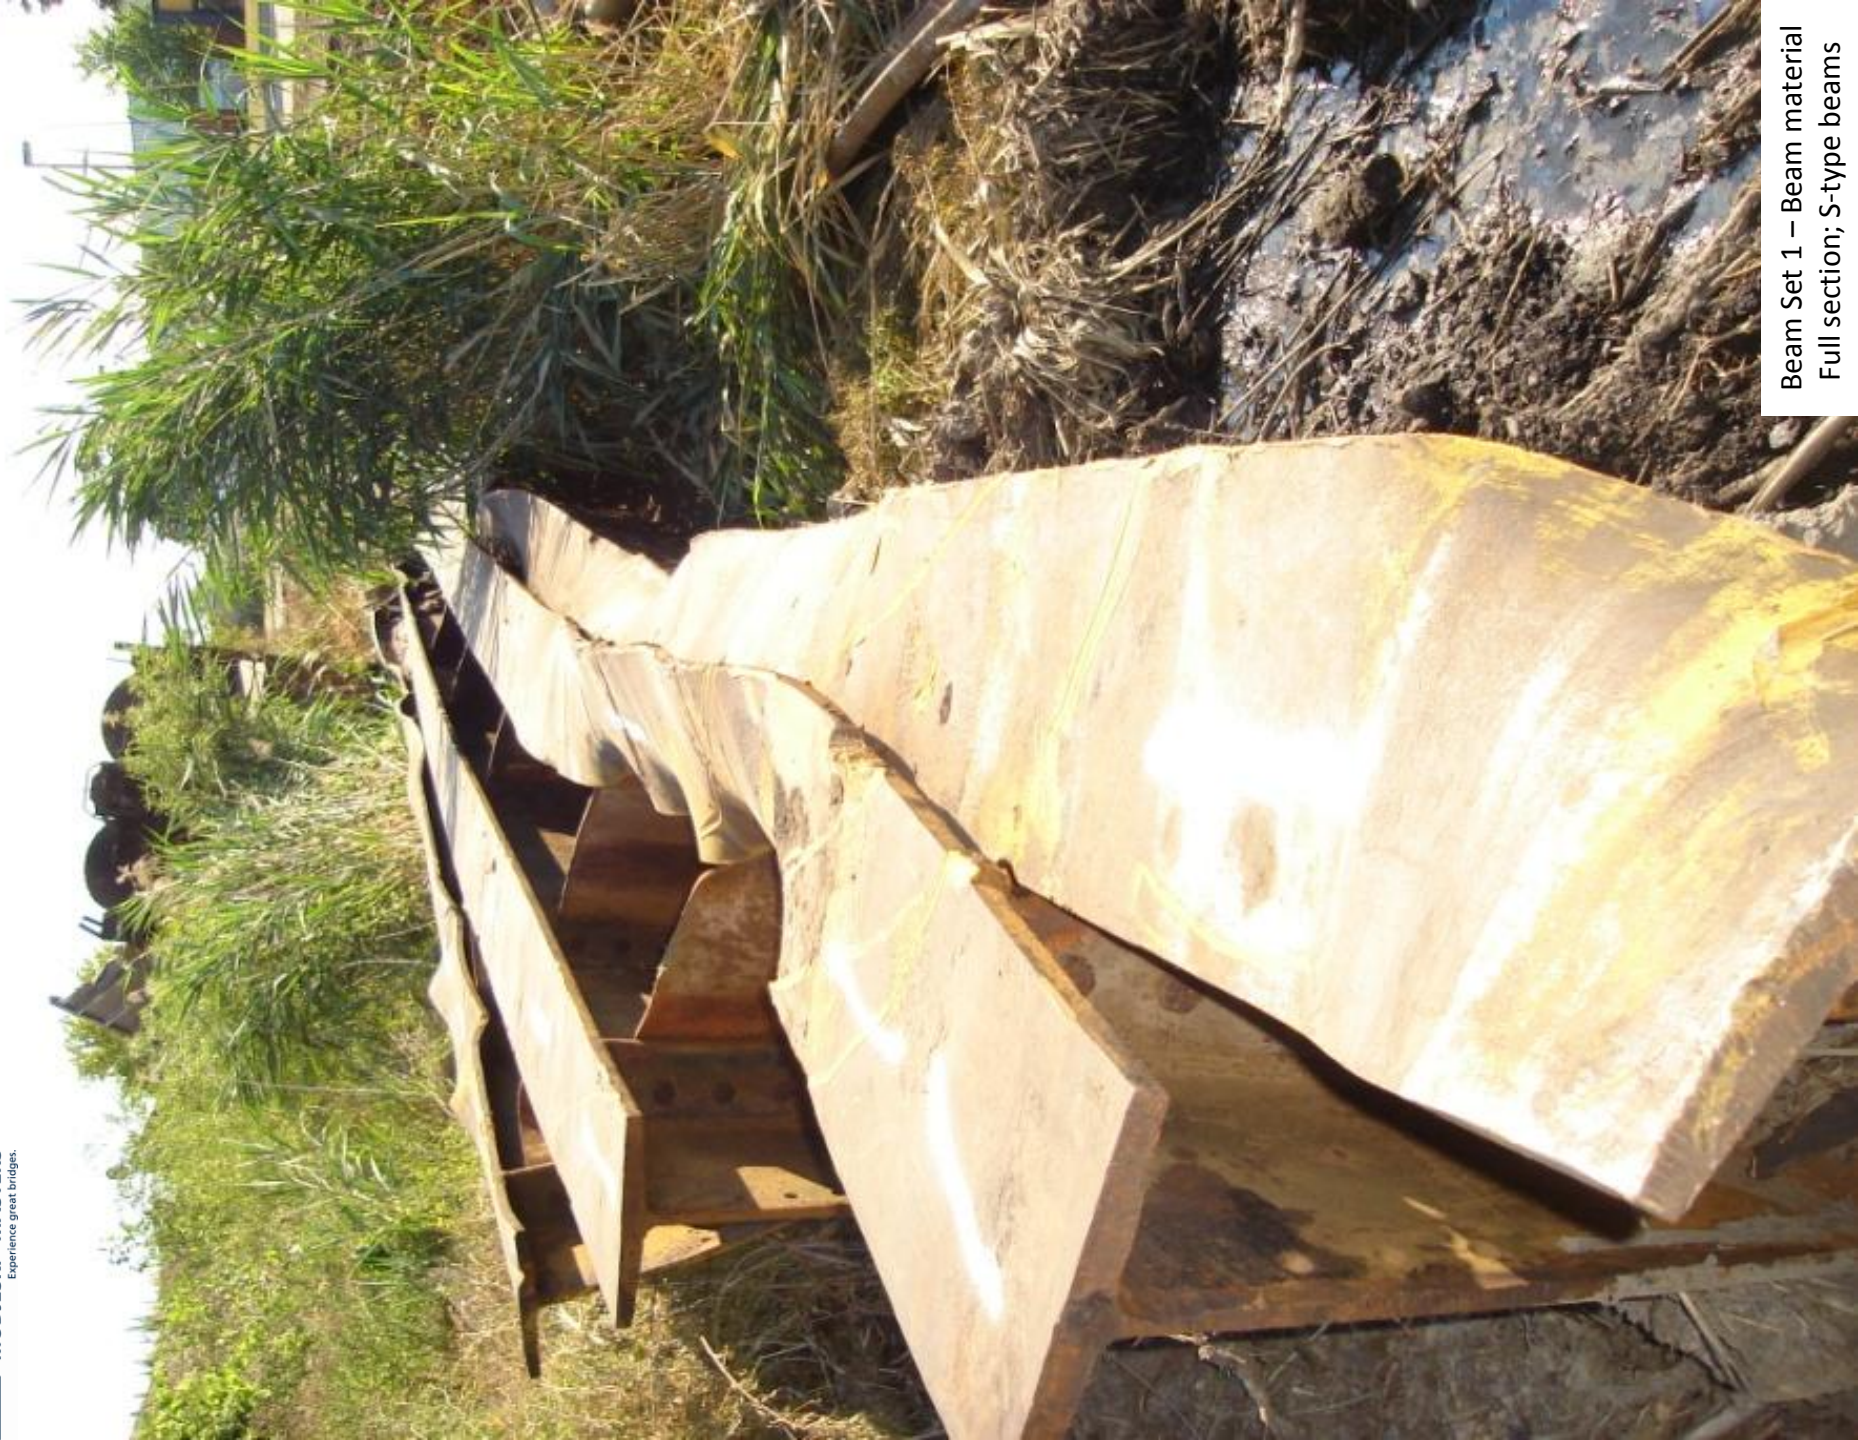
Beam Set 1 – Beam material
Full section; S-type beams

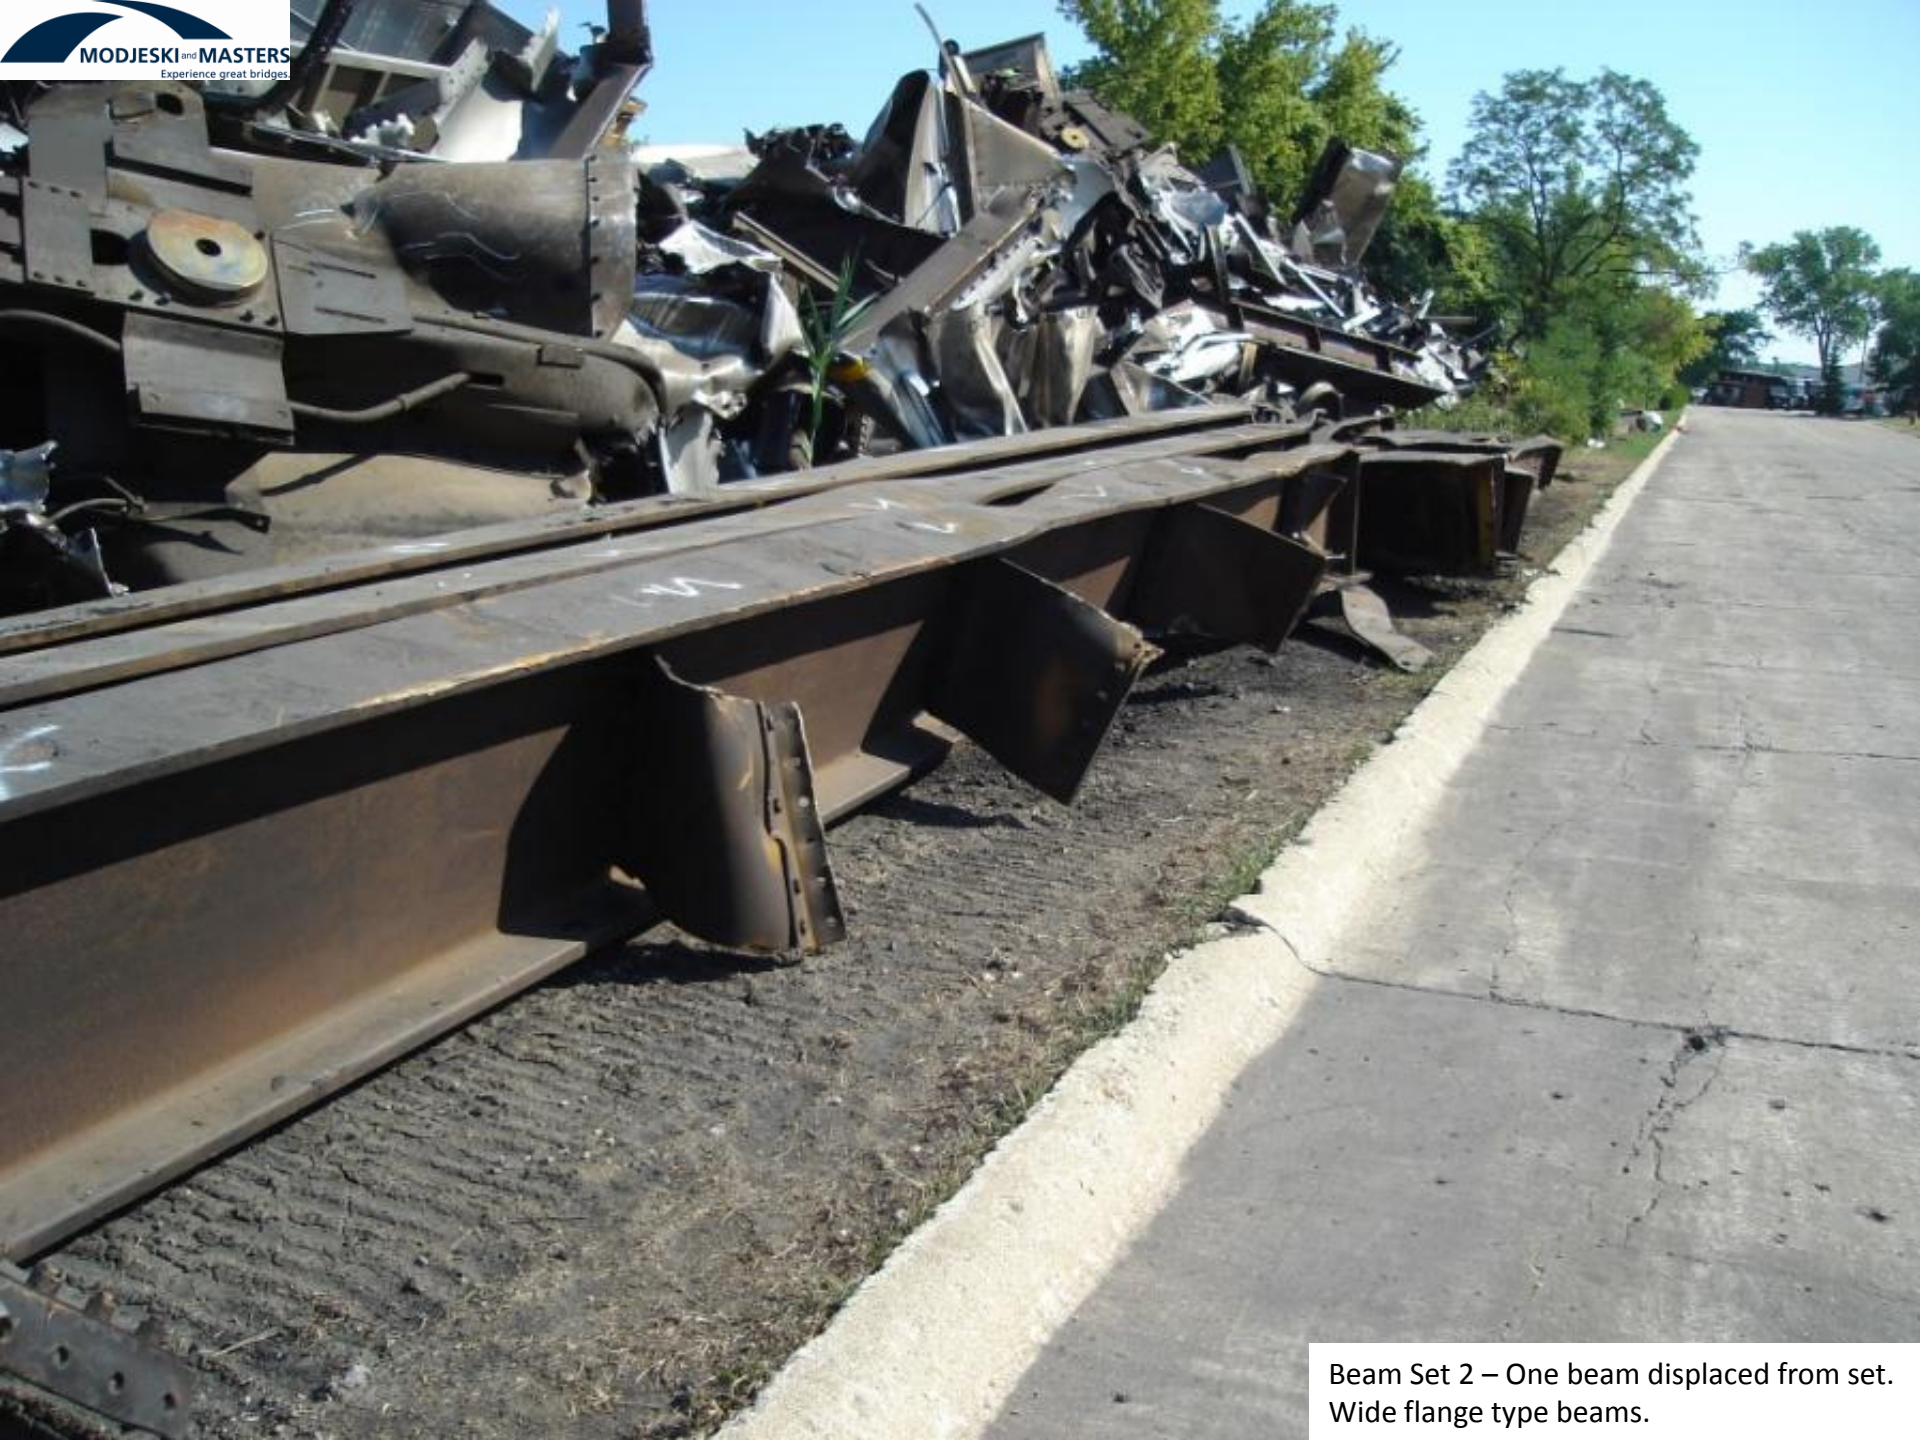
Beam Set 2 – One beam displaced from set.
Wide flange type beams.

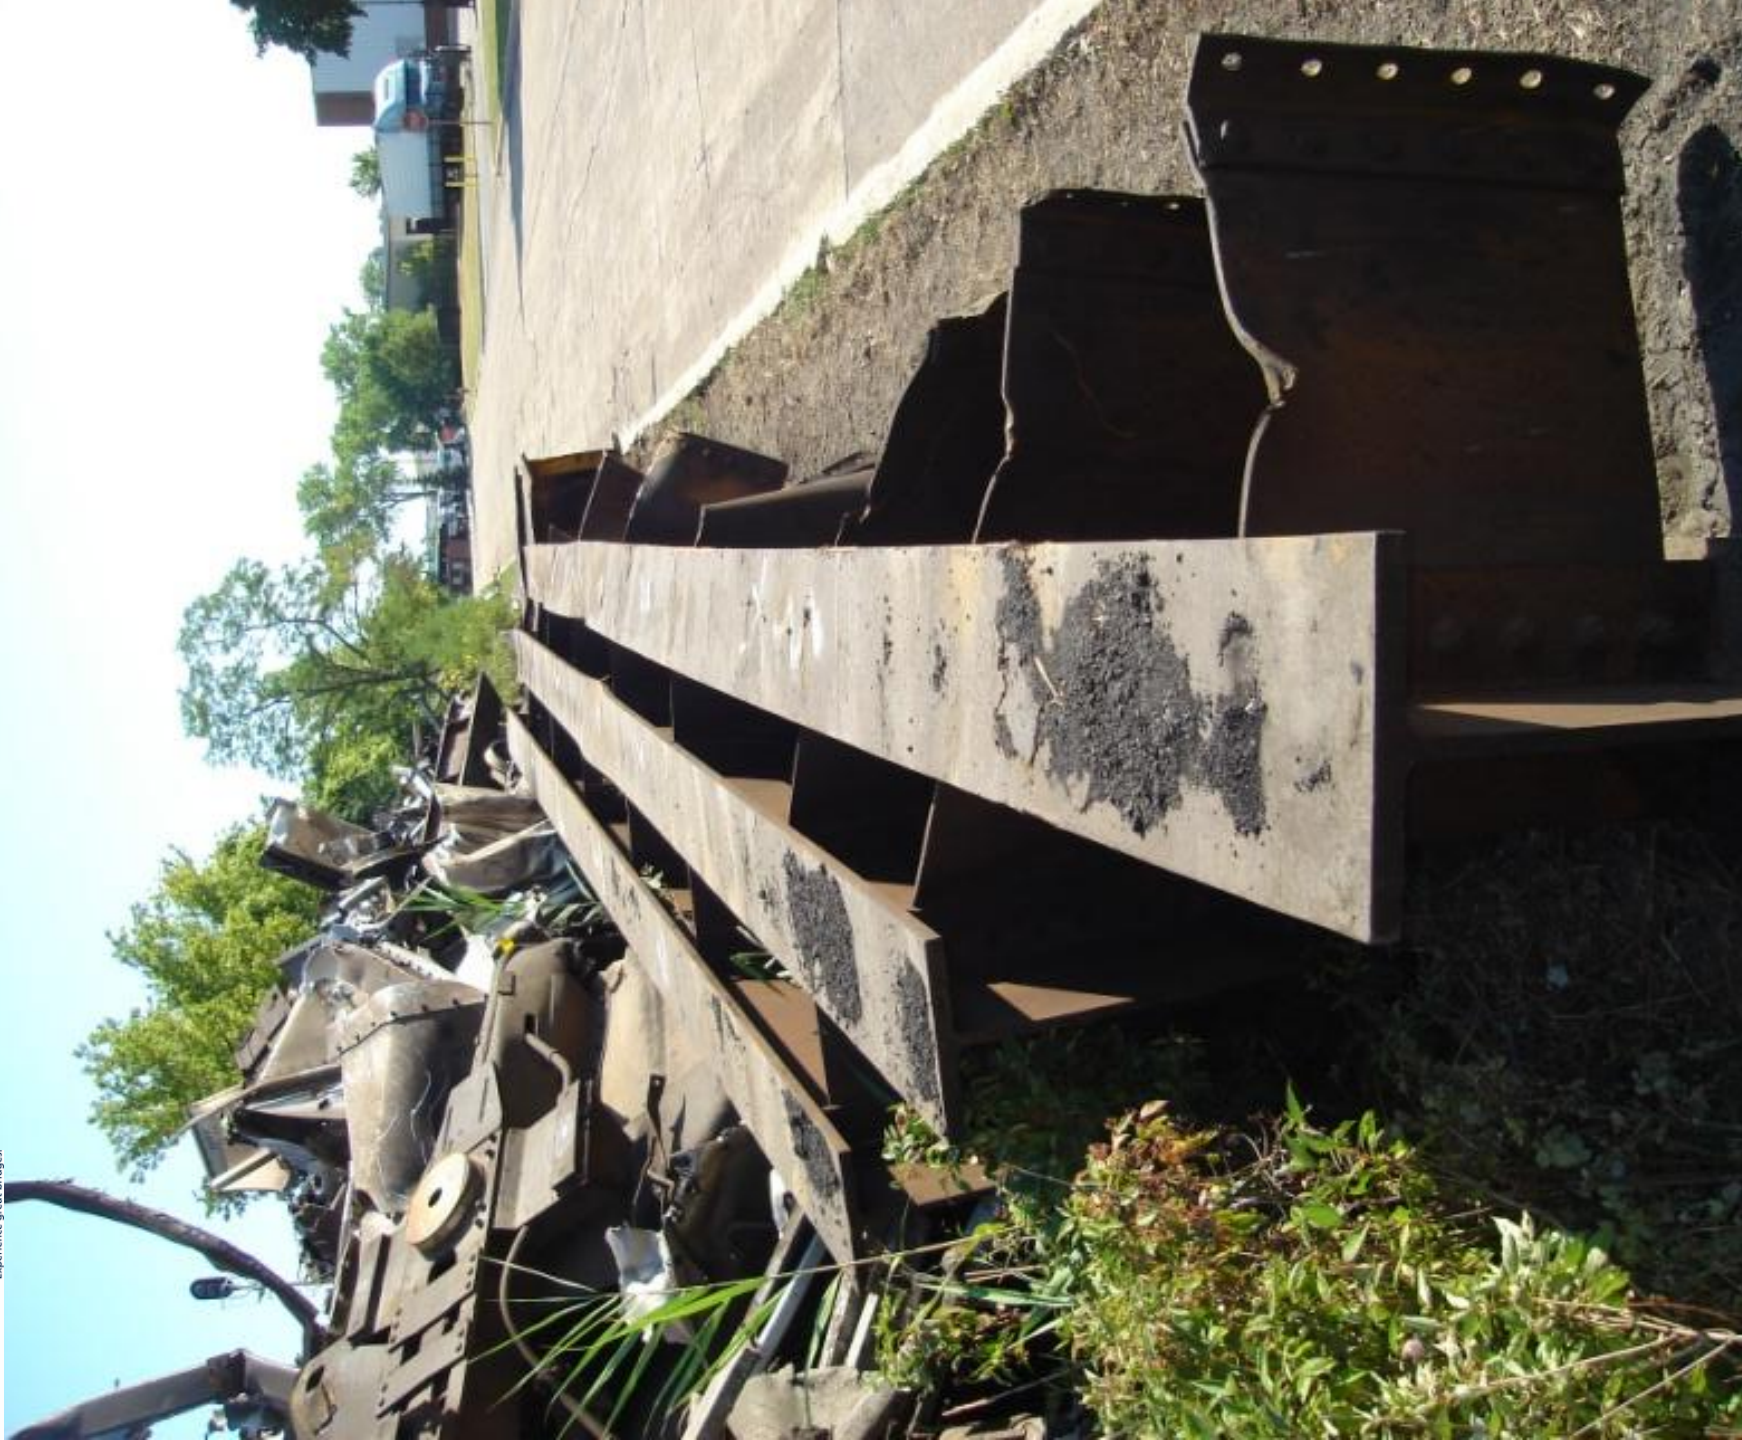
Beam Set 2 – Beam material found in full section.
All “dings” are new.

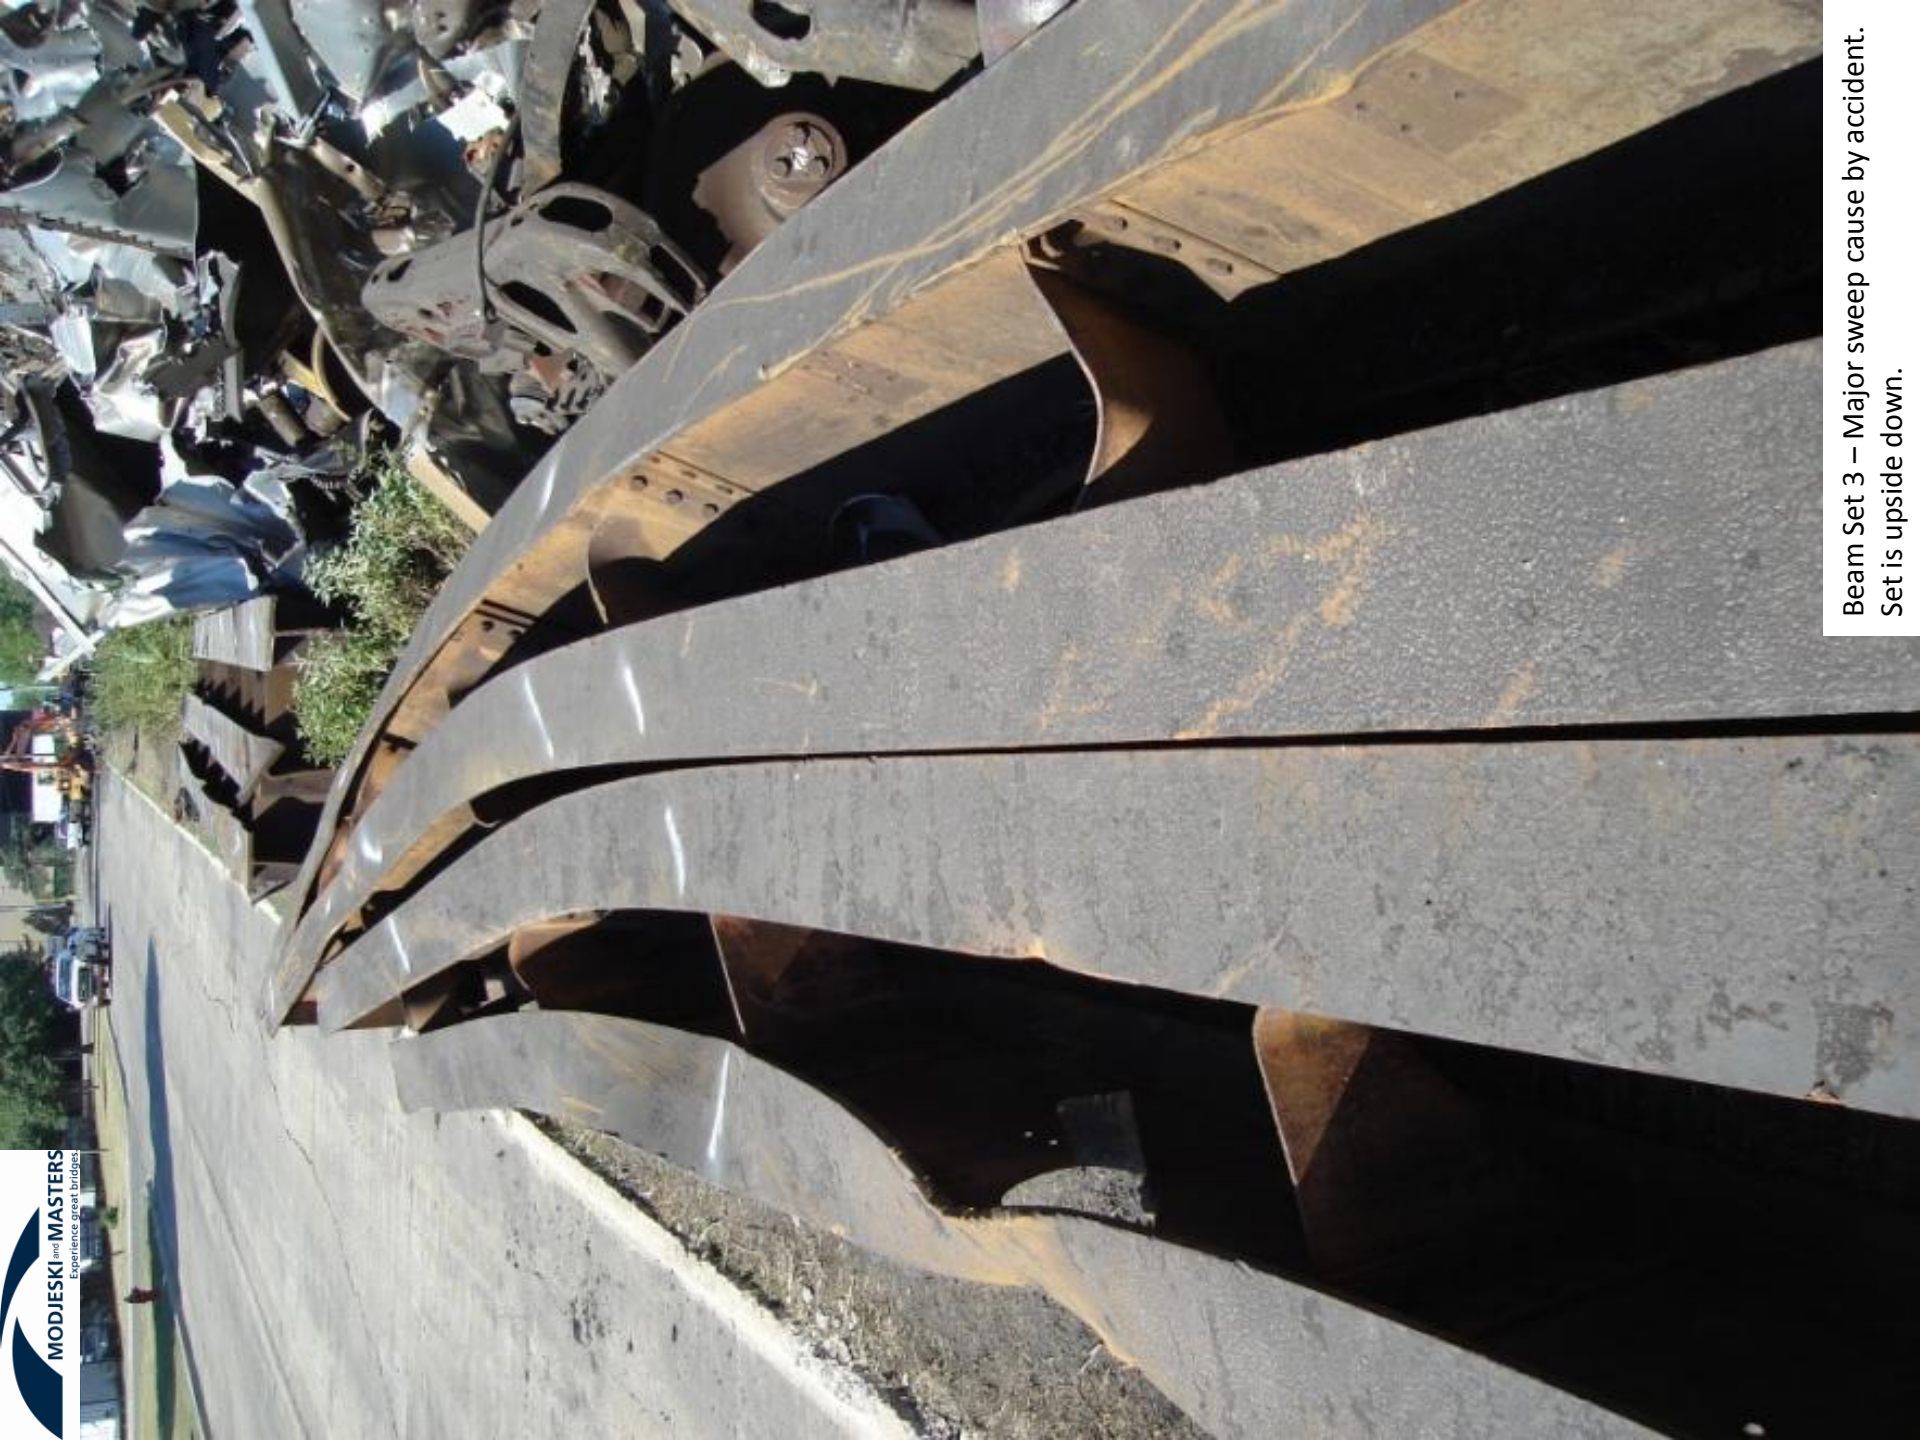
Beam Set 3 – Major sweep cause by accident.
Set is upside down.

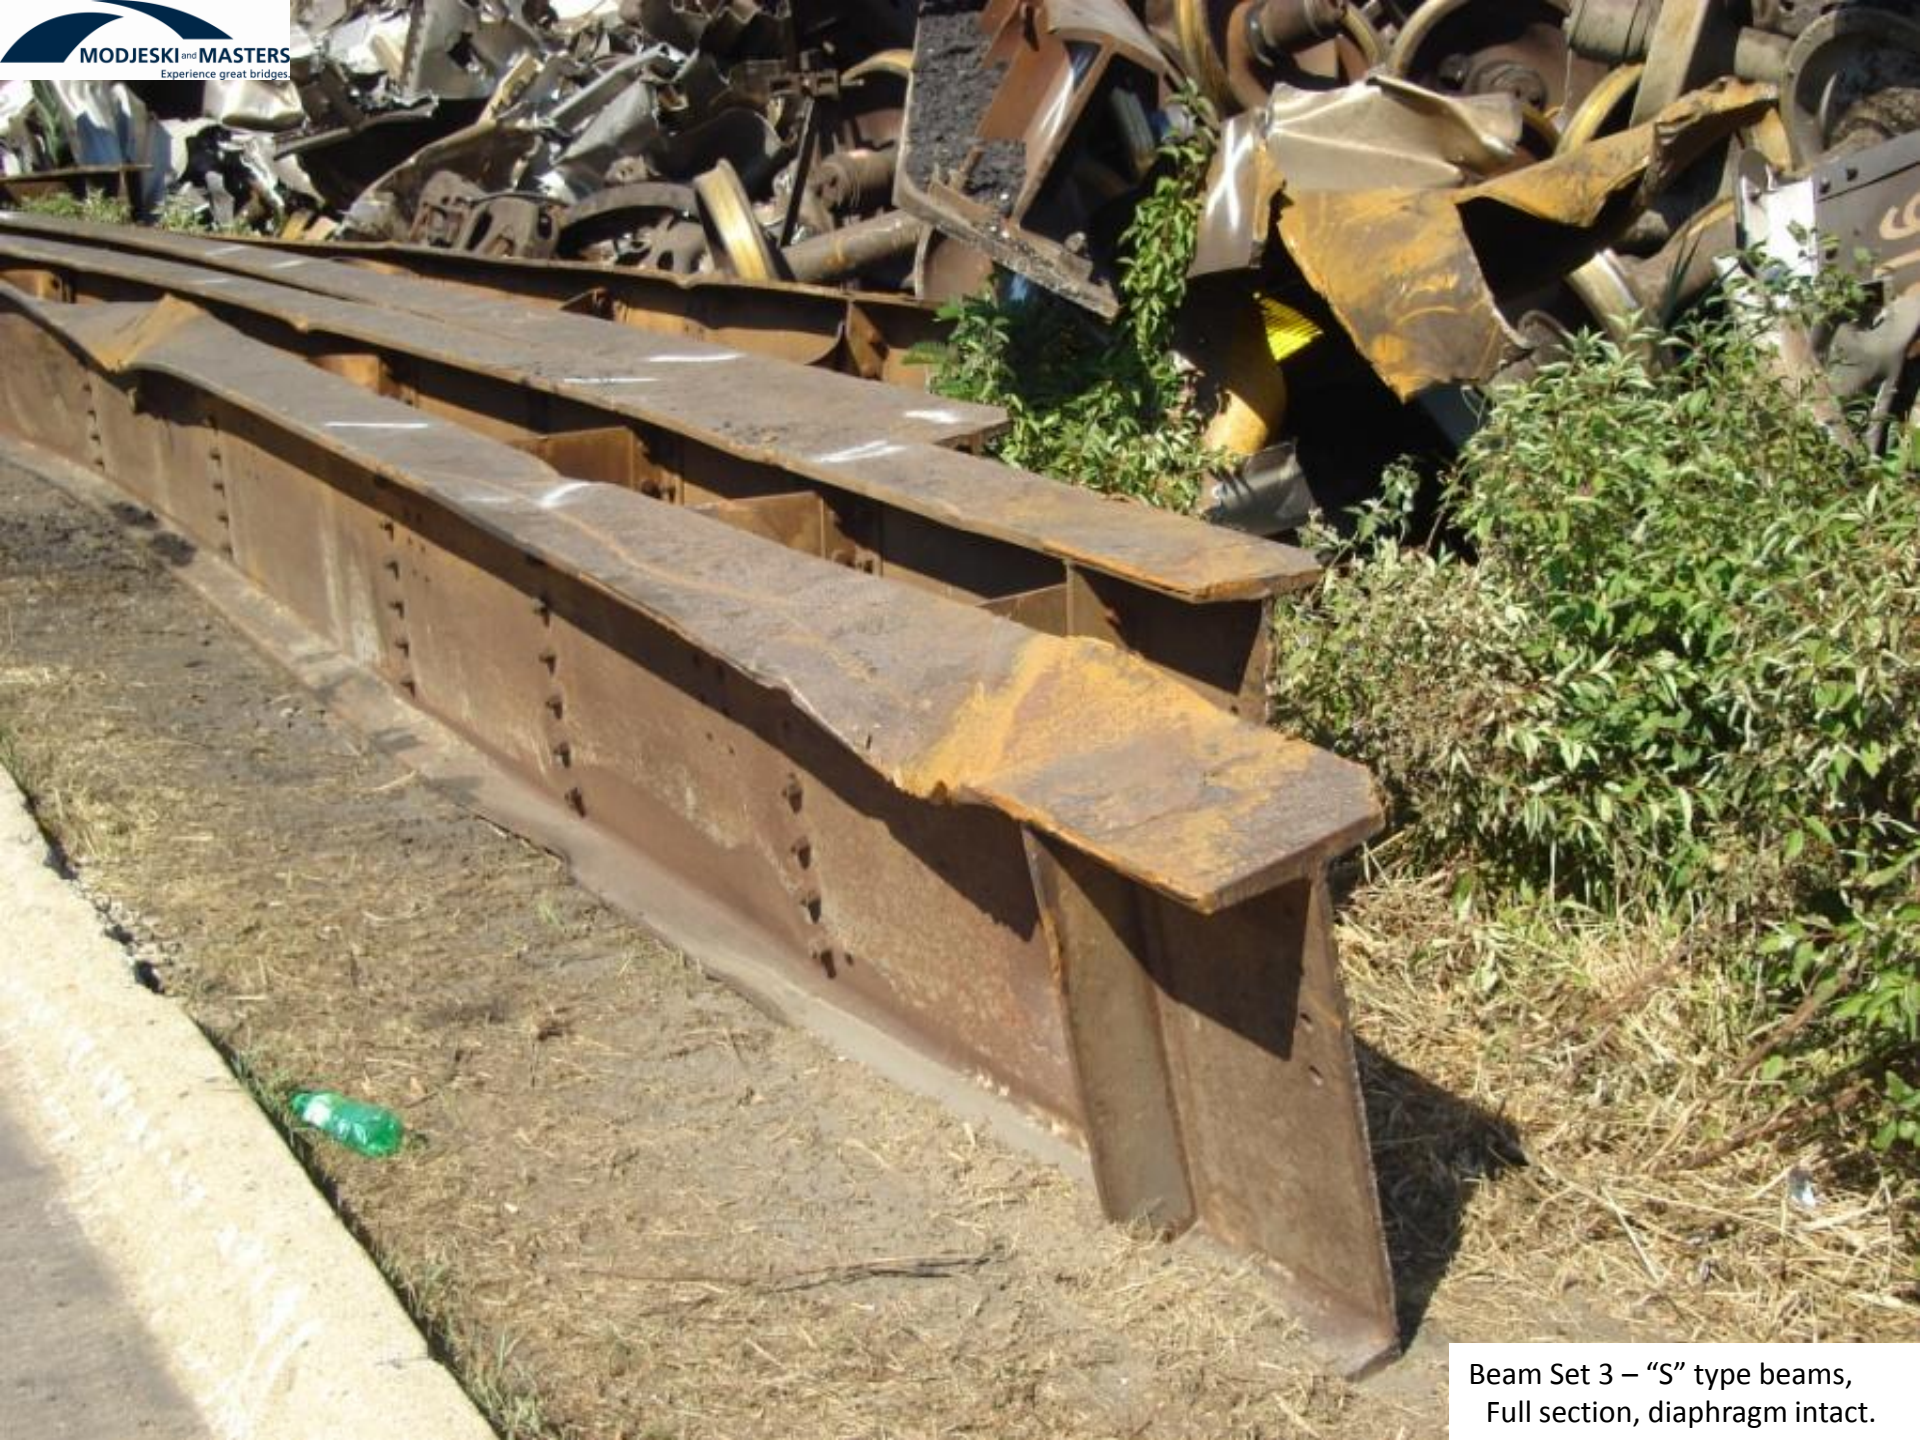
Beam Set 3 – “S” type beams,
Full section, diaphragm intact.

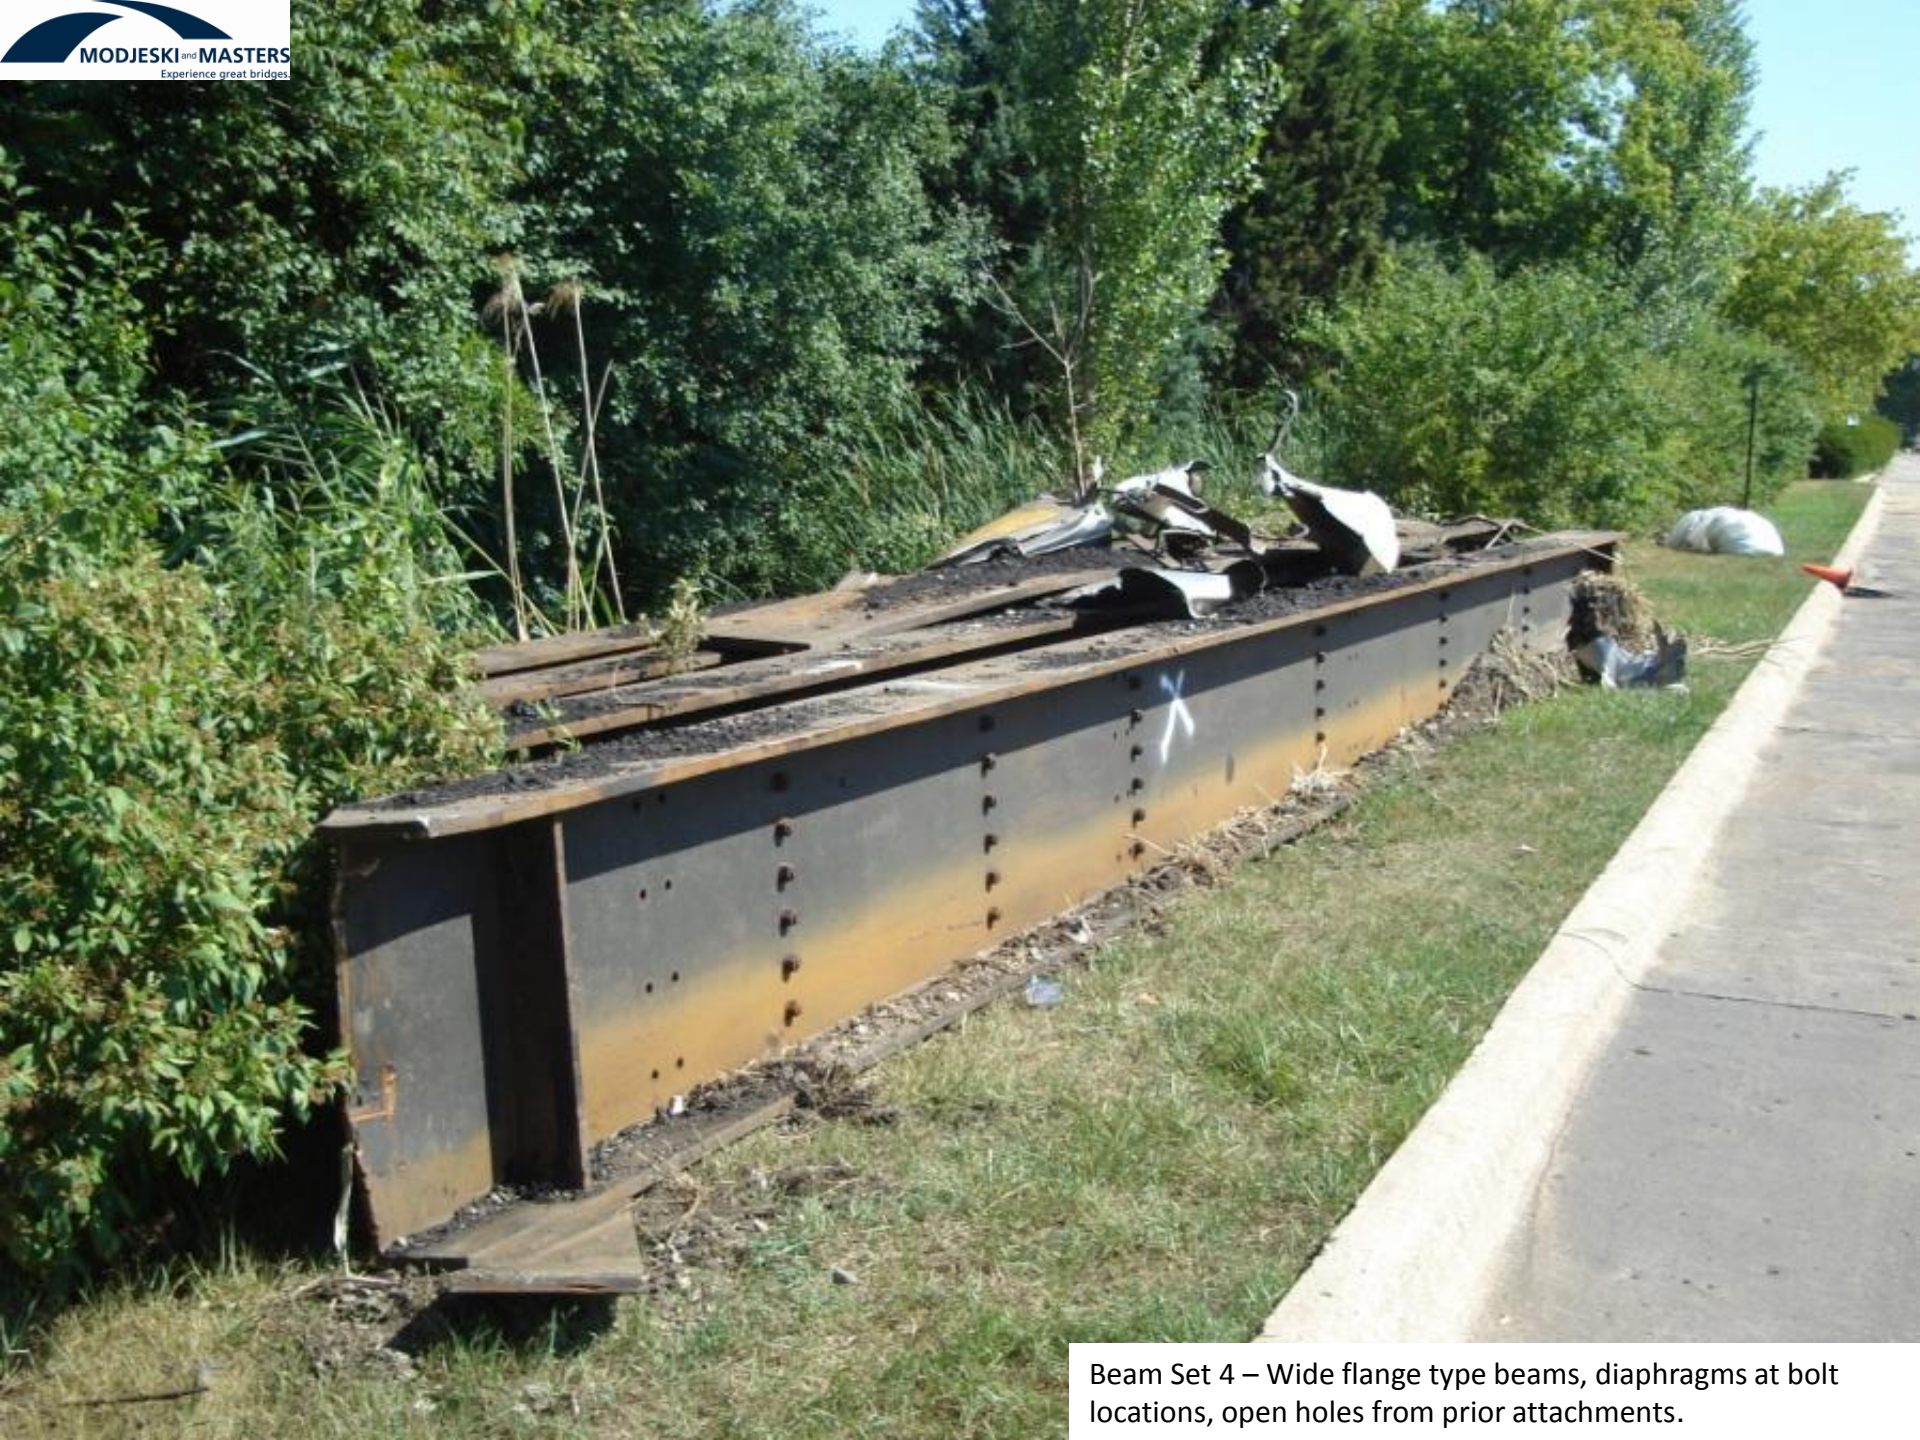
Beam Set 4 – Wide flange type beams, diaphragms at bolt locations, open holes from prior attachments.
