Bridge 17.44 Crossing Shermer Road, Glenview, IL at a skew

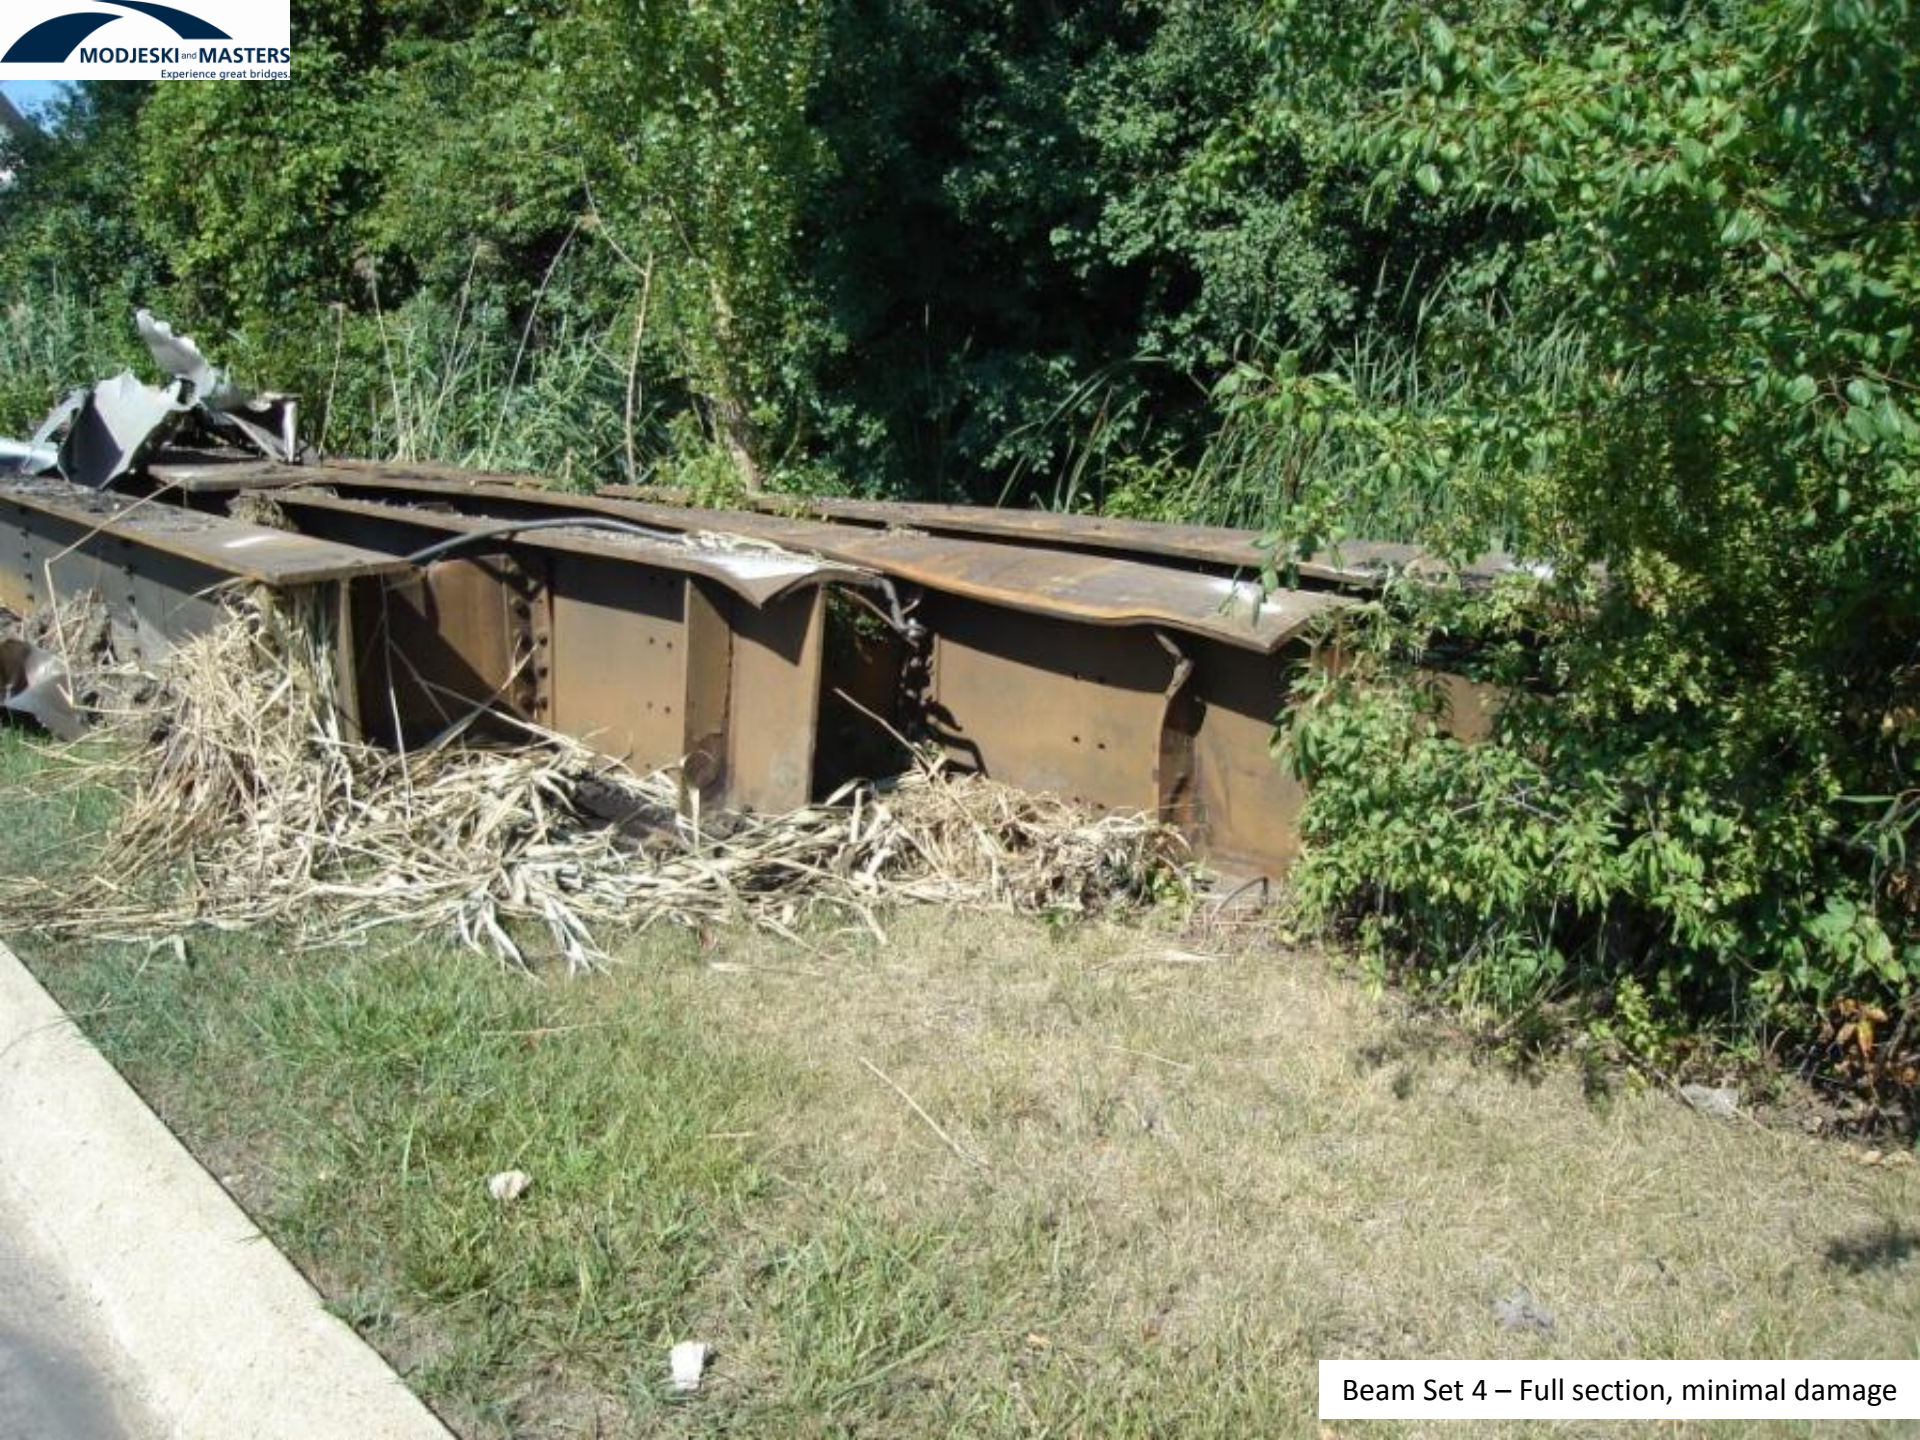
Beam Set 4 – Full section, minimal damage

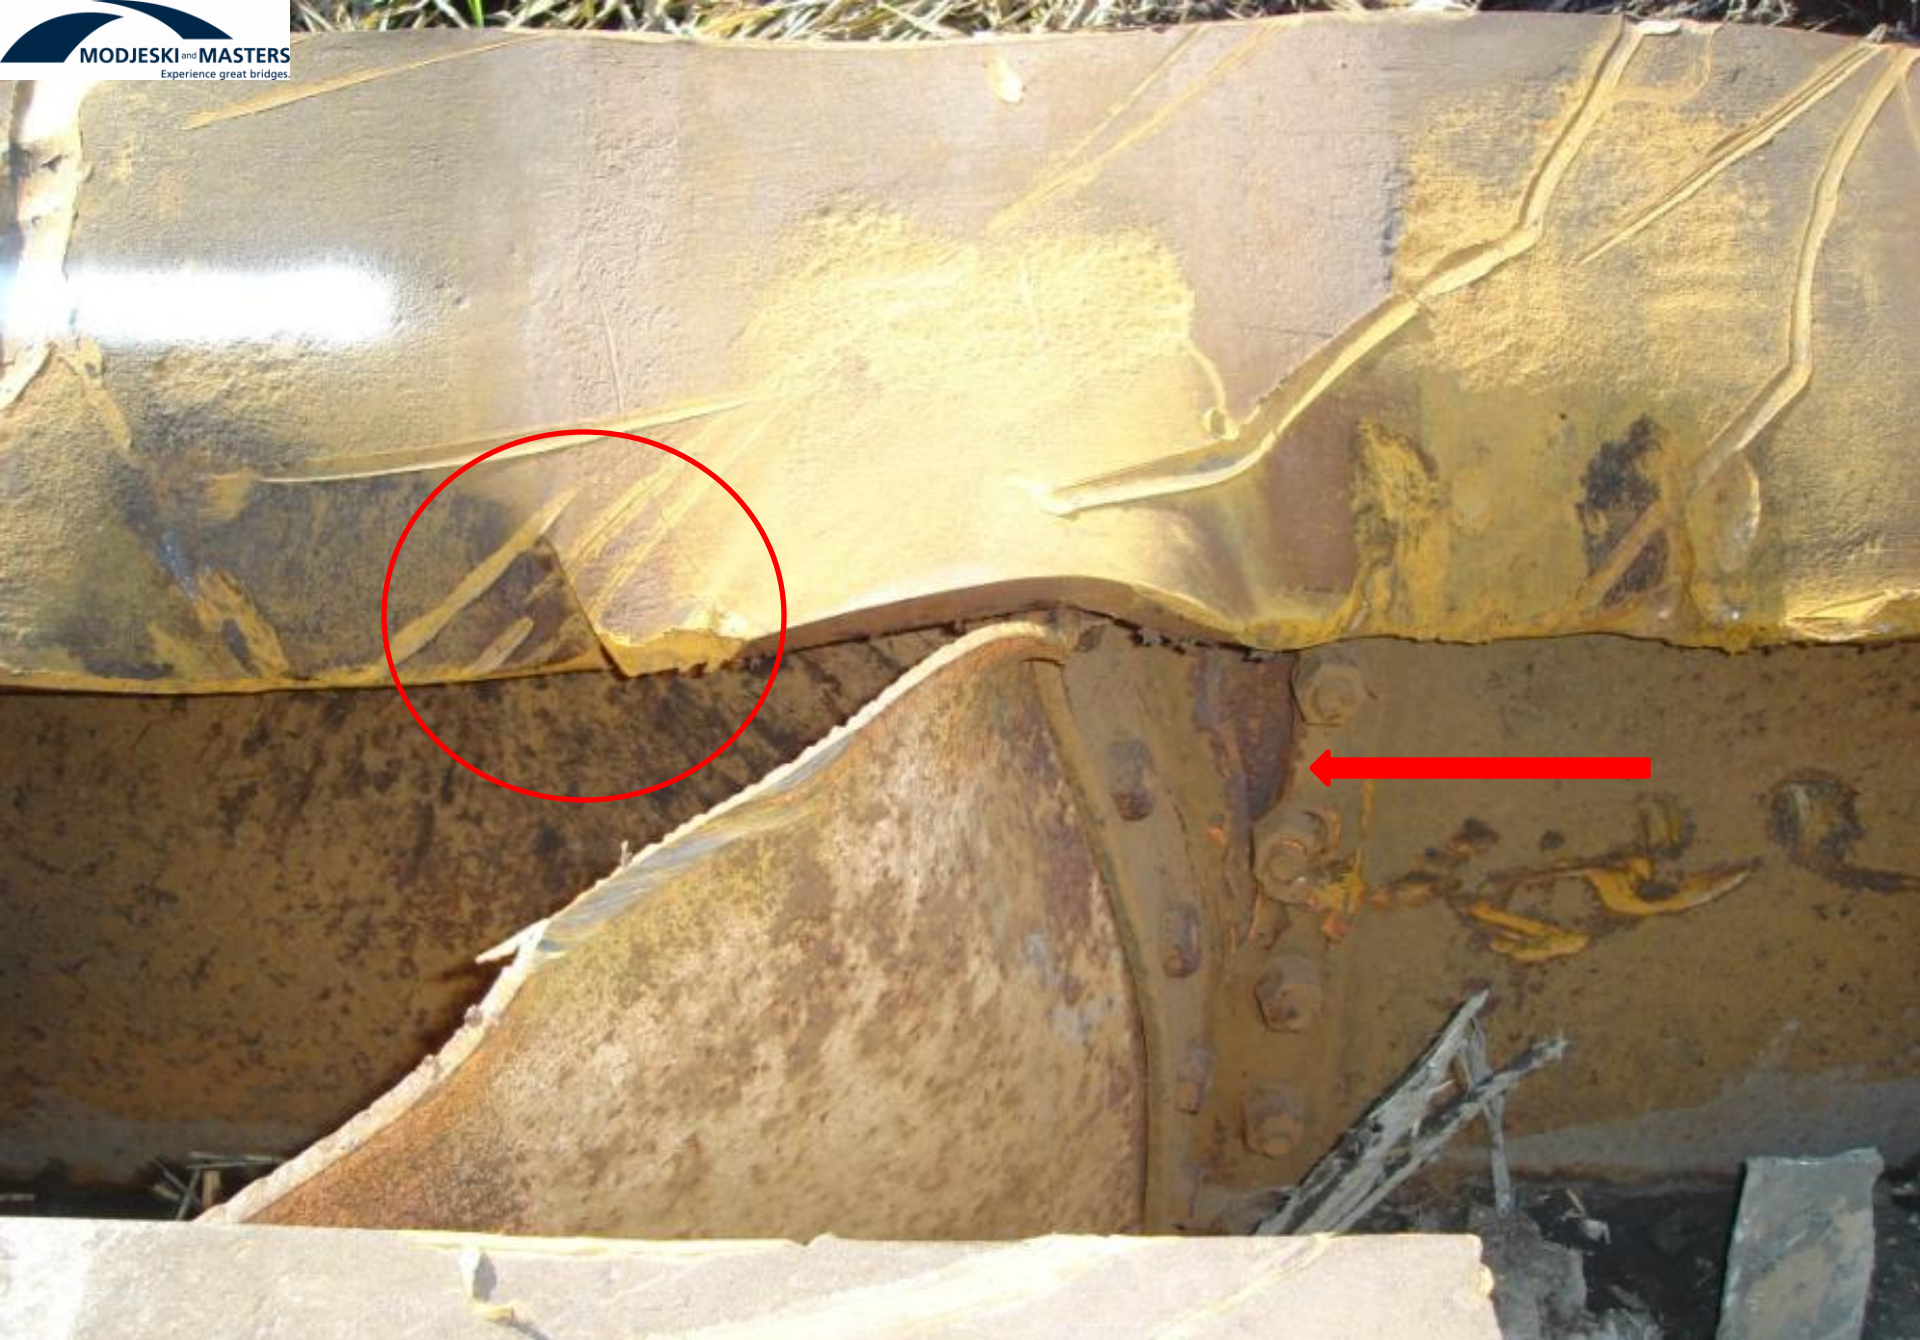
Beam Set 1 – Tear in flange with fresh rust indicating accident damage (circle);
Diaphragm connection angle torn in accident (arrow)

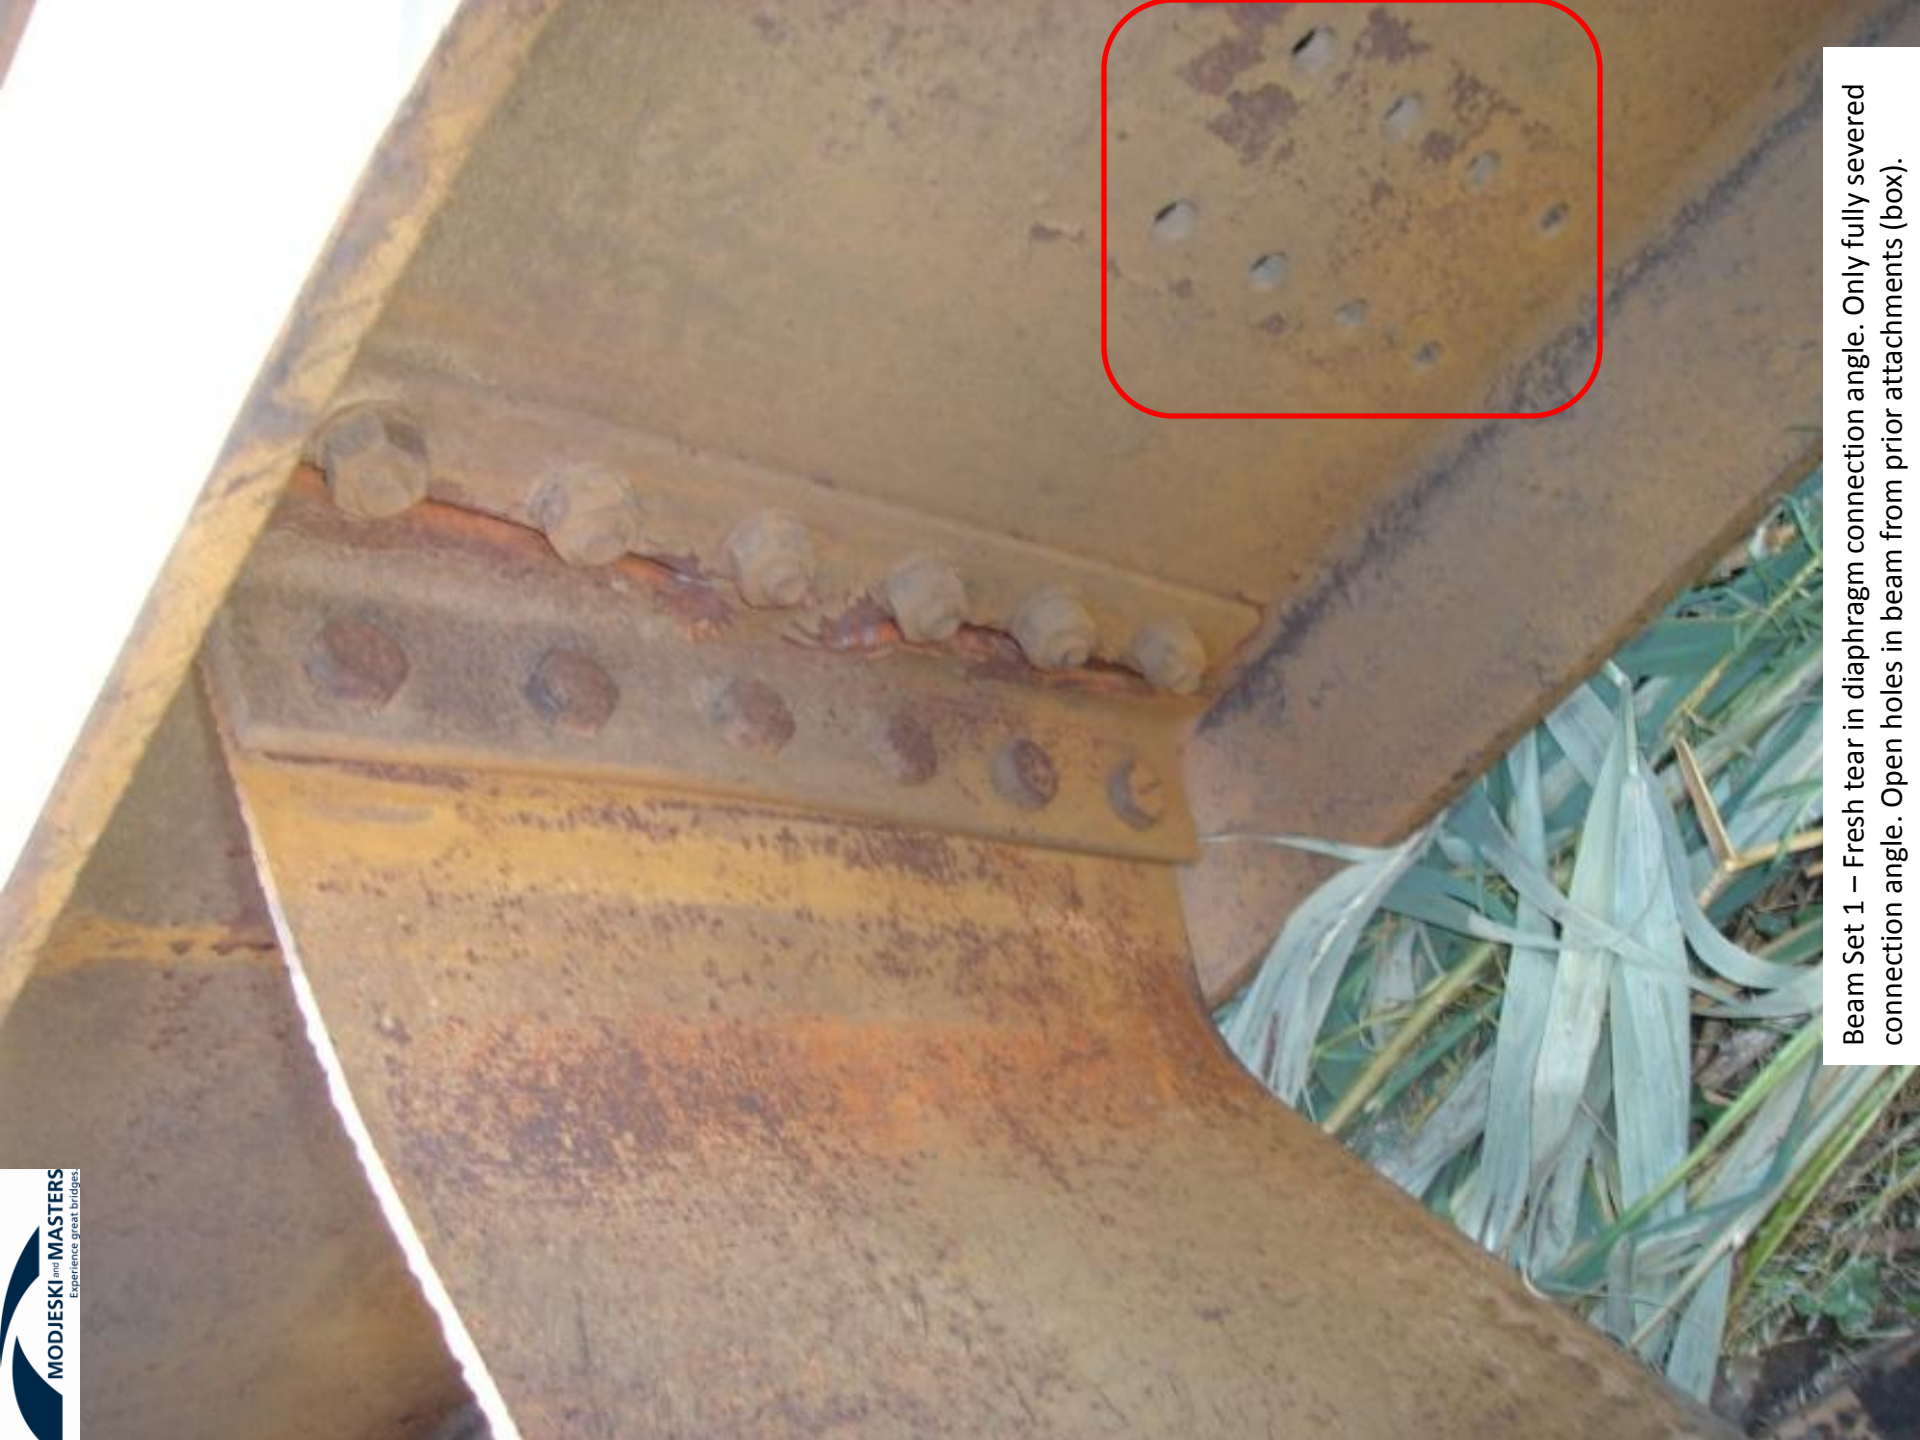
Beam Set 1 – Fresh tear in diaphragm connection angle. Only fully severed connection angle. Open holes in beam from prior attachments (box).

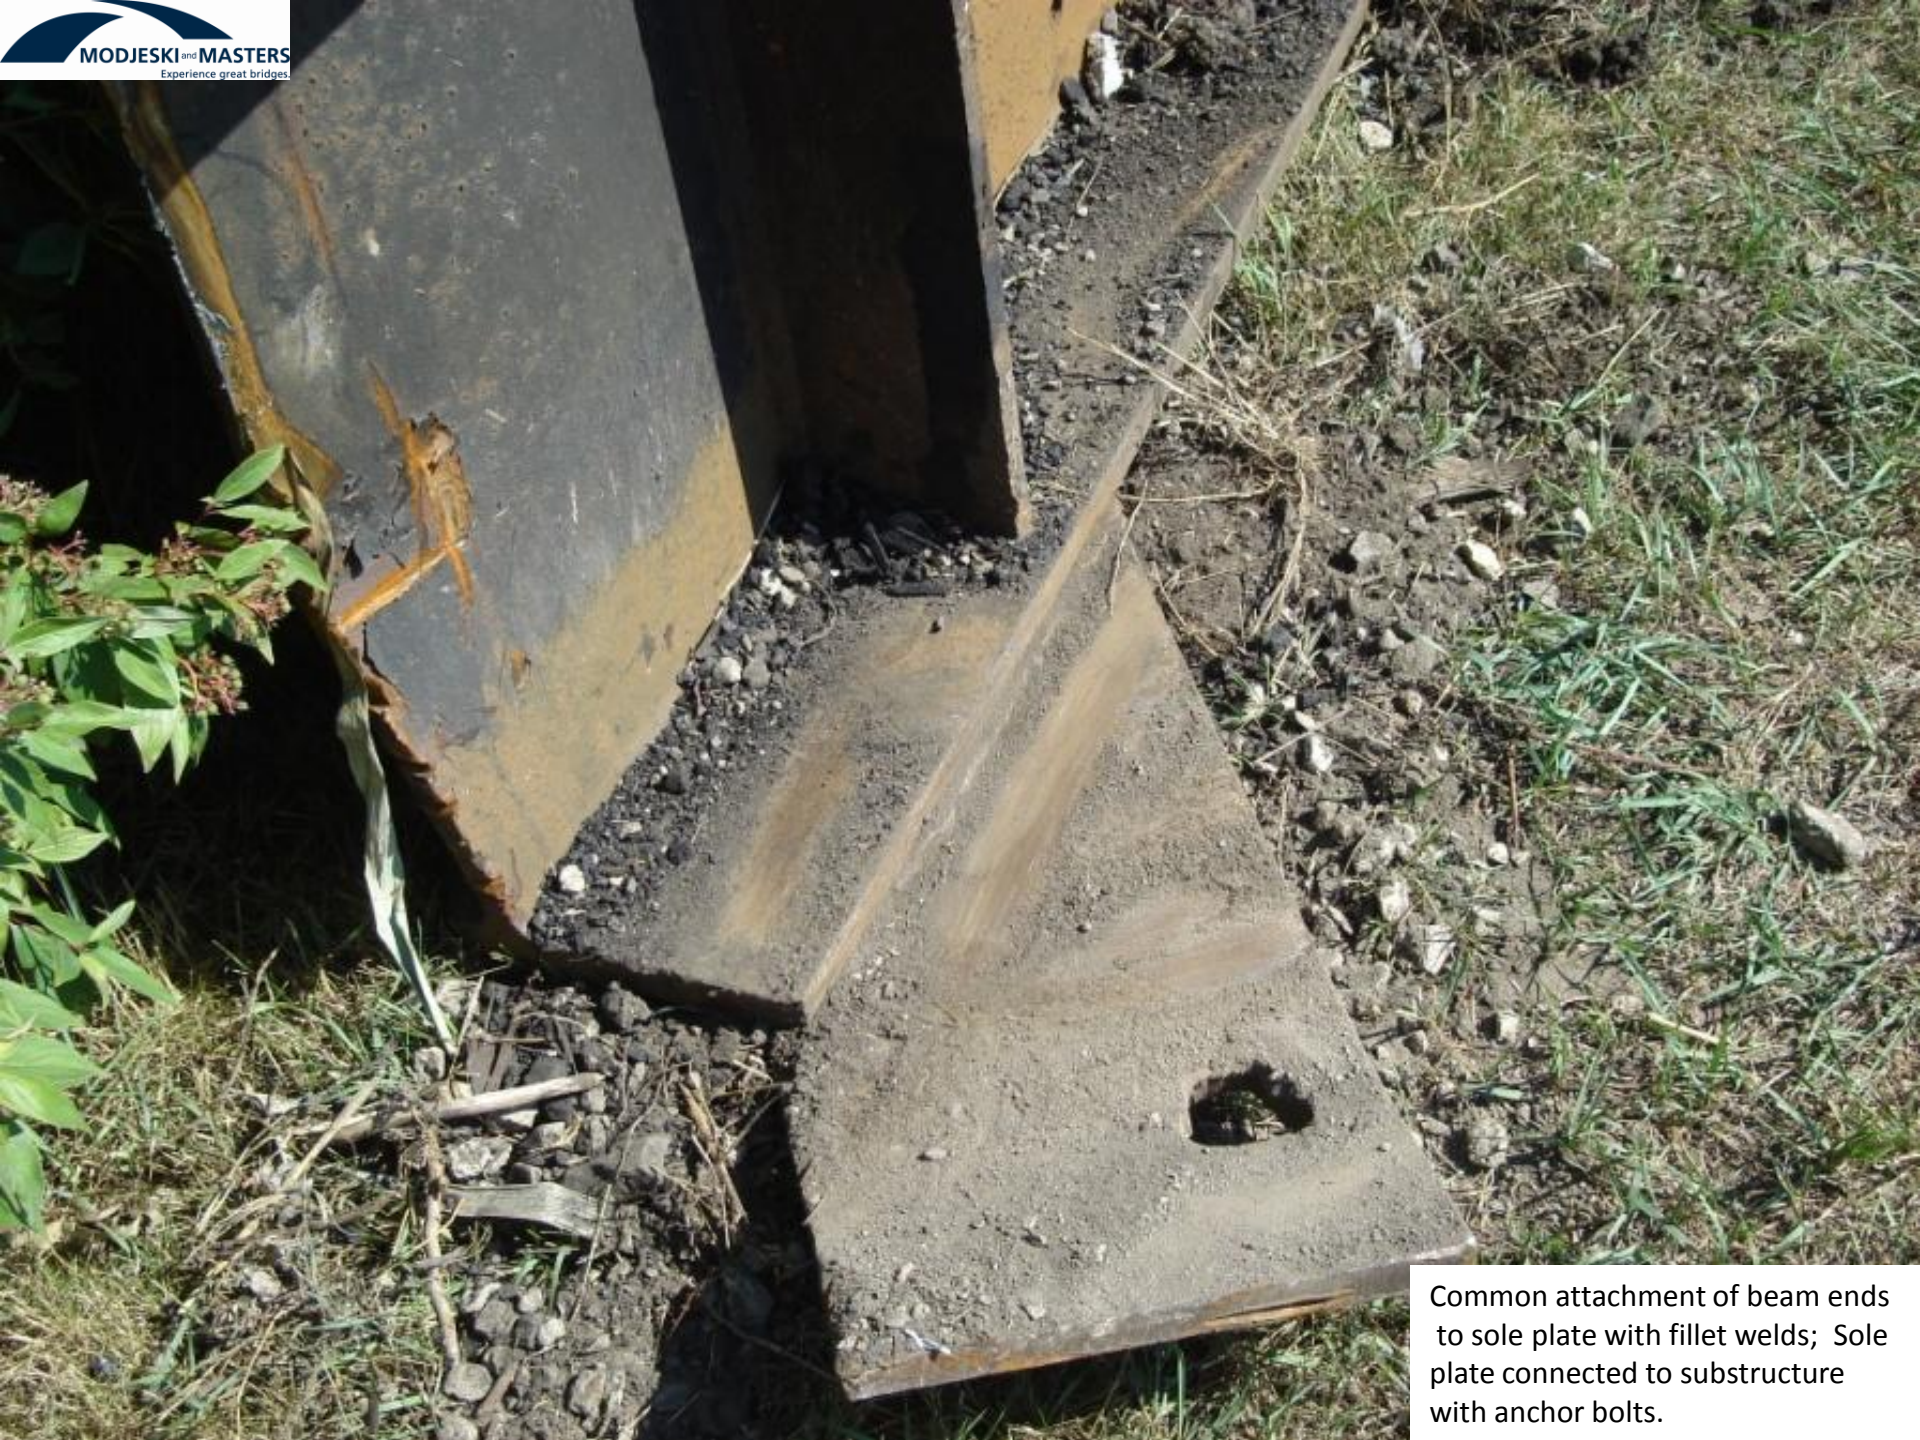
Common attachment of beam ends to sole plate with fillet welds; Sole plate connected to substructure with anchor bolts.

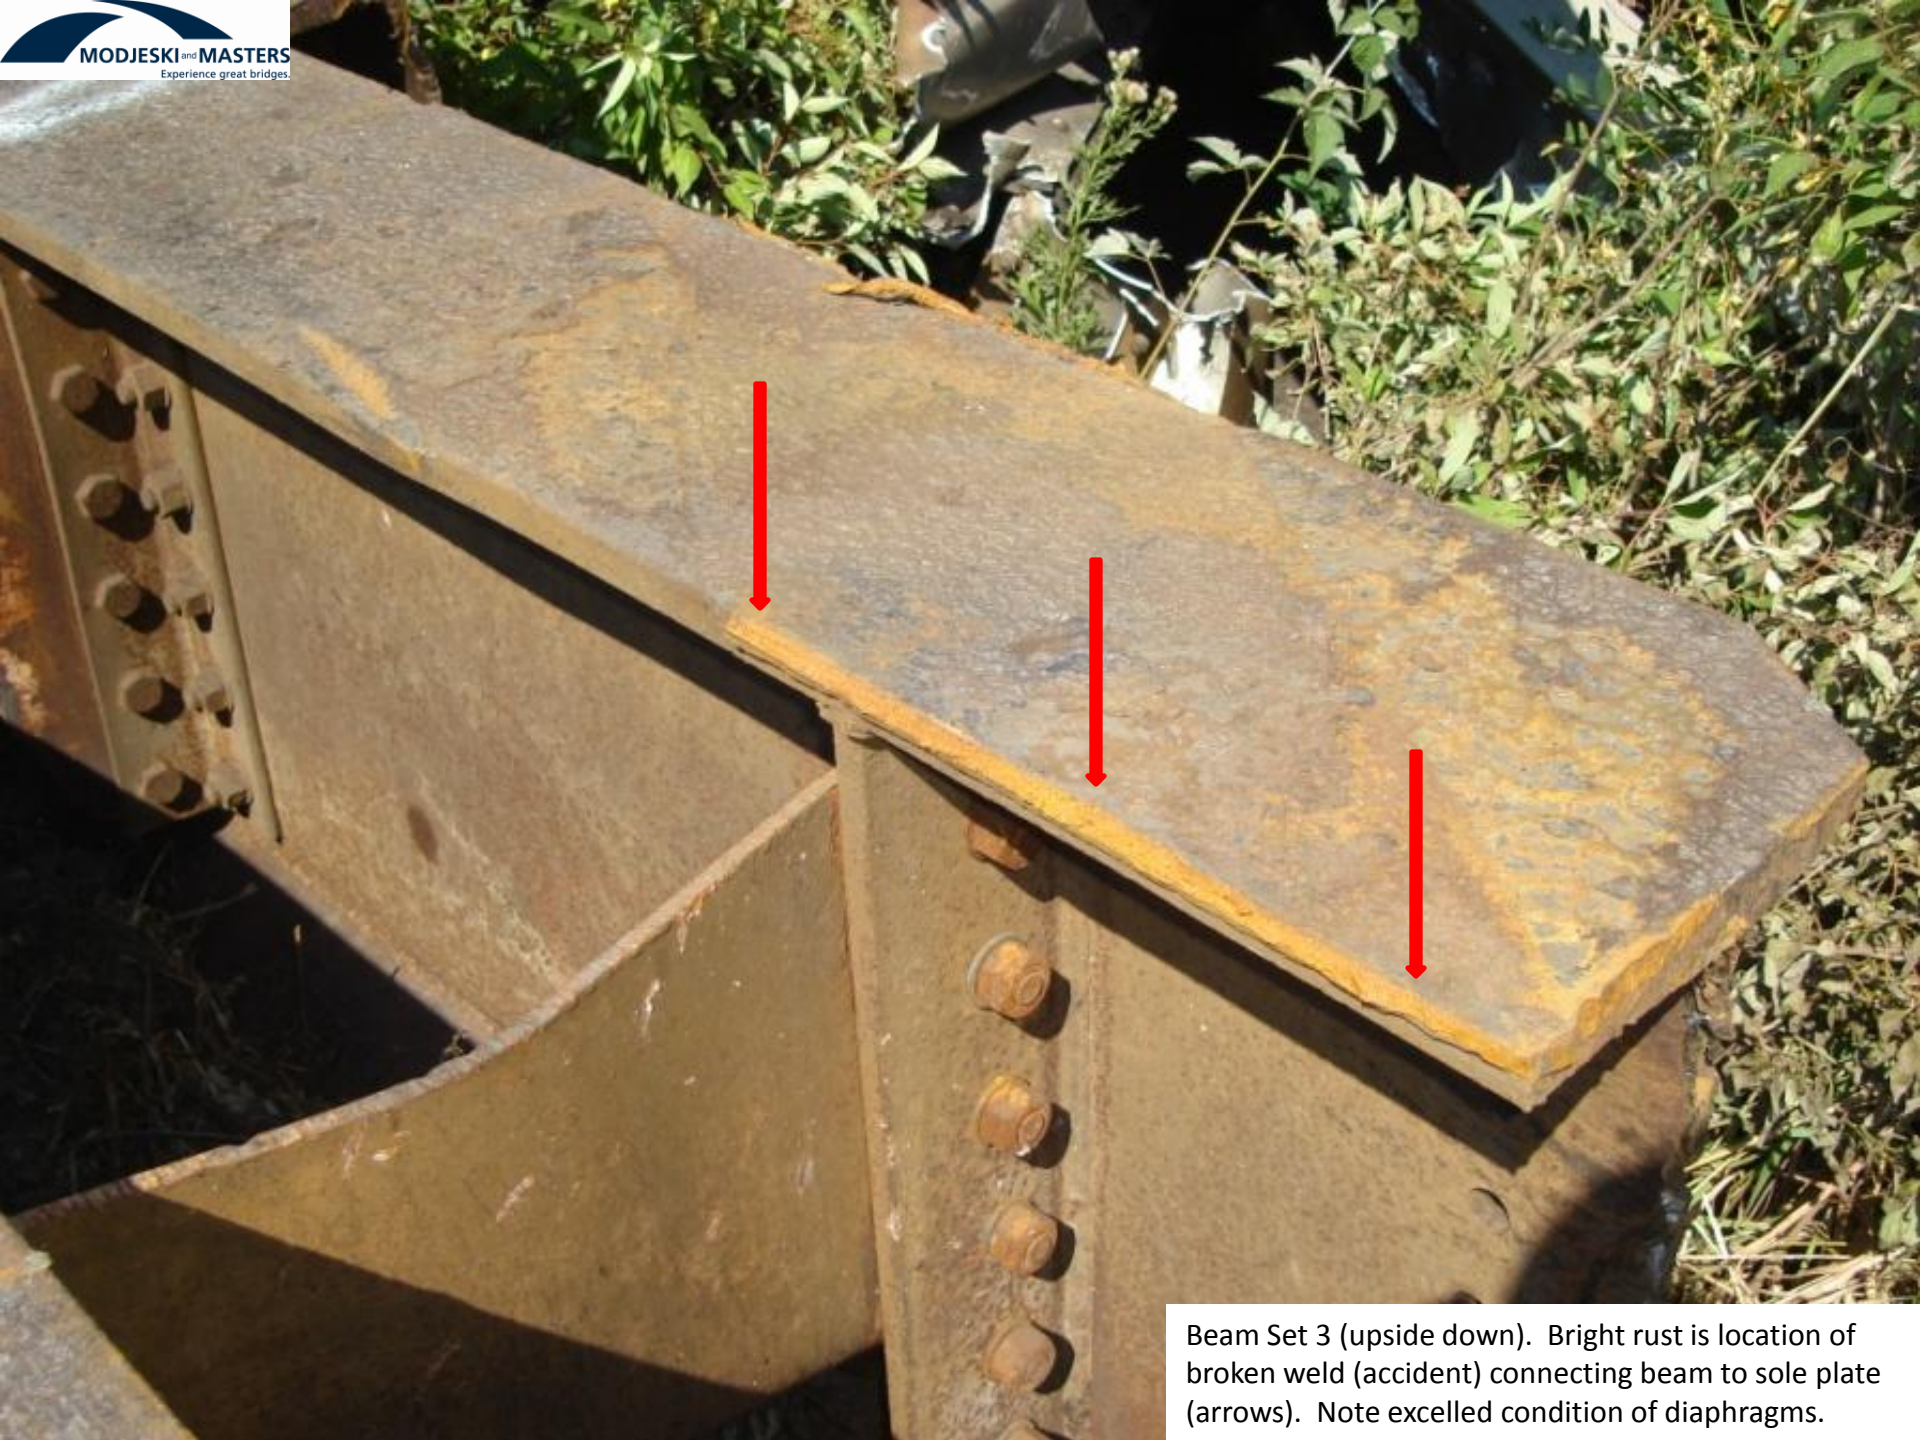
Beam Set 3 (upside down). Bright rust is location of broken weld (accident) connecting beam to sole plate (arrows). Note excellent condition of diaphragms.

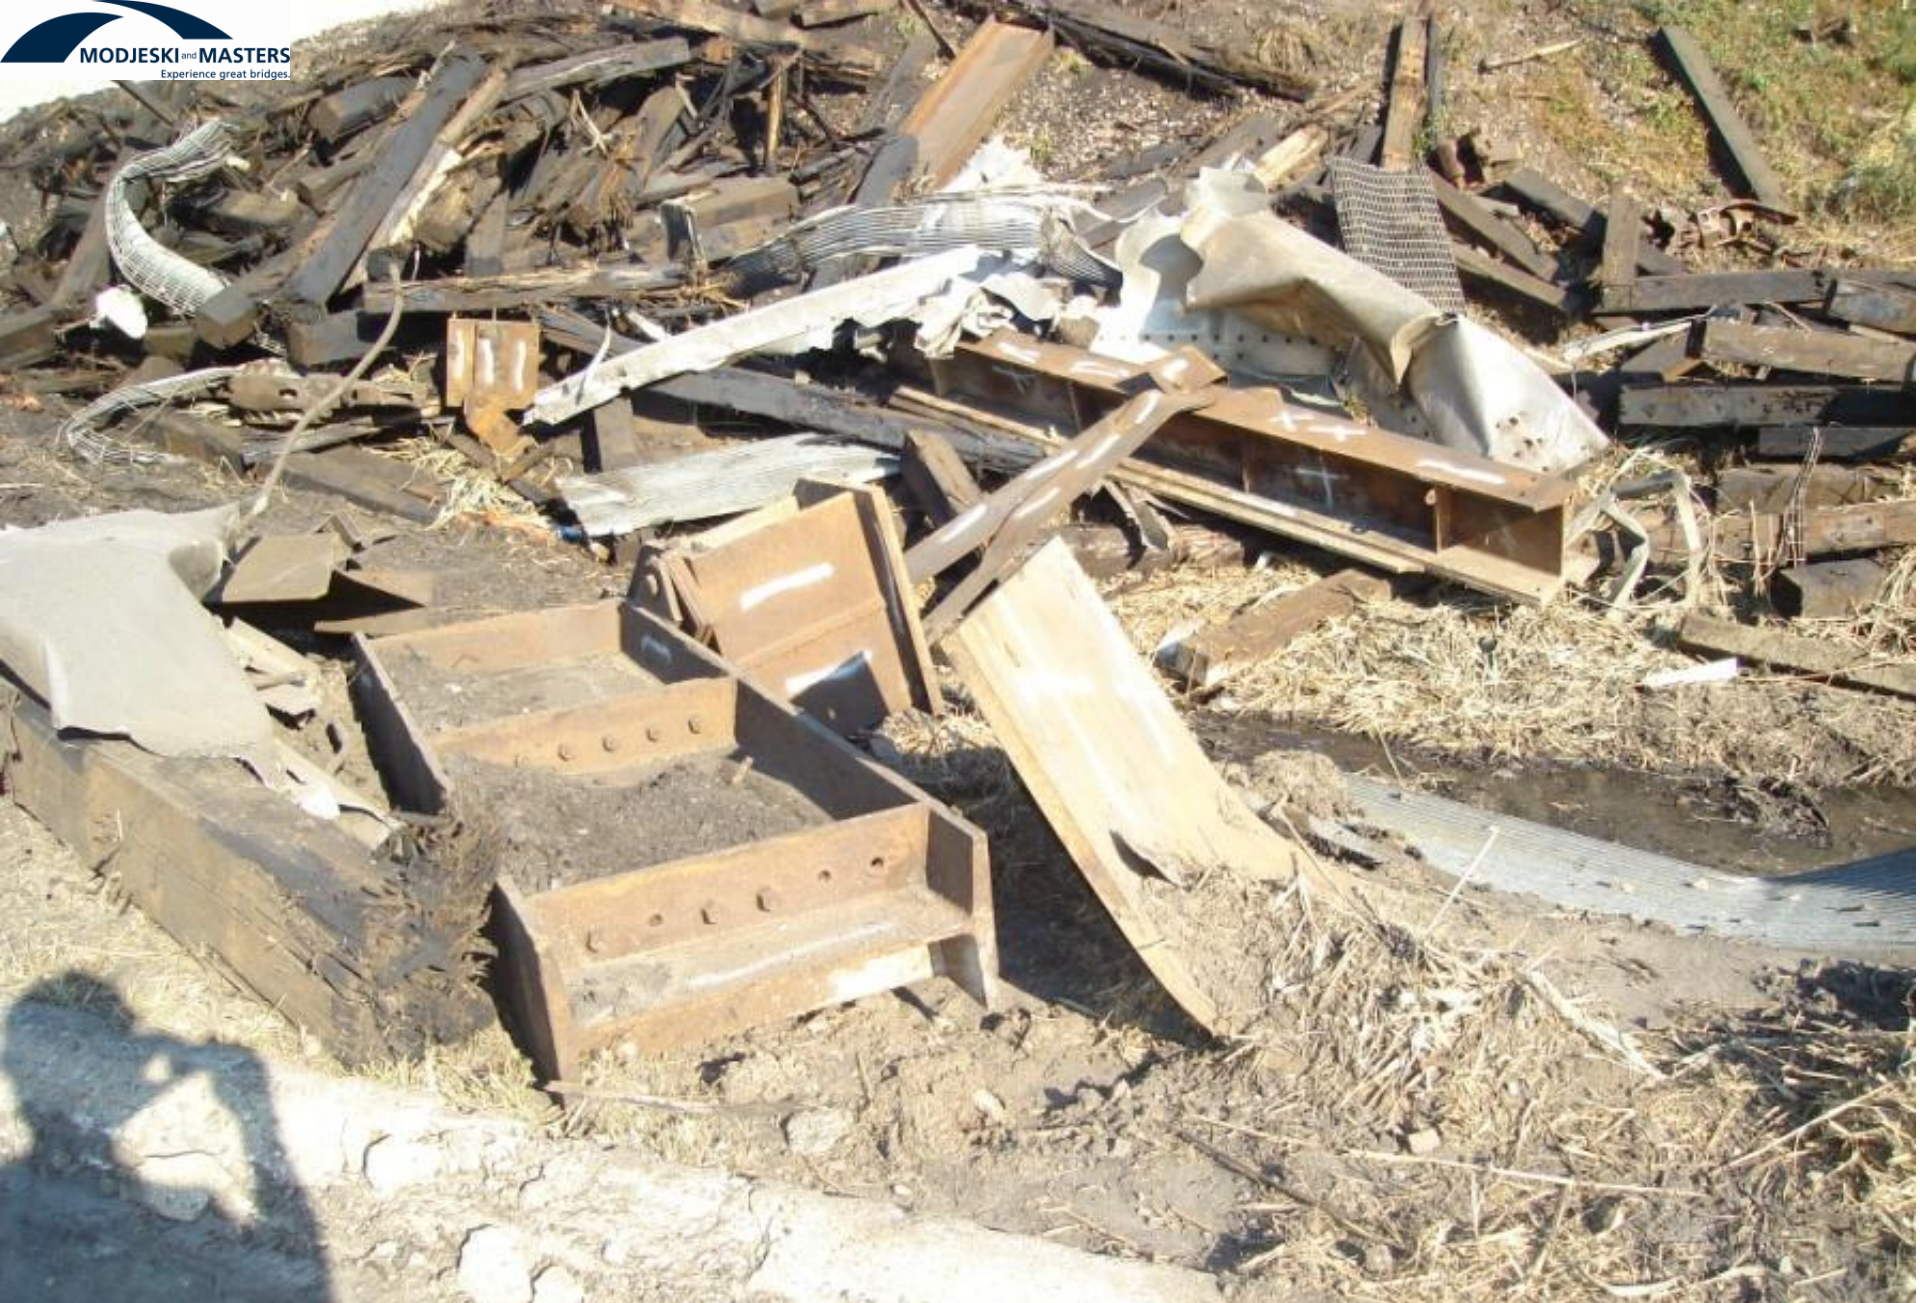
View of multiple bridge components all in full section and good condition.
Left center – 9 ' long beam (jump span)
Far center - grillage assembly

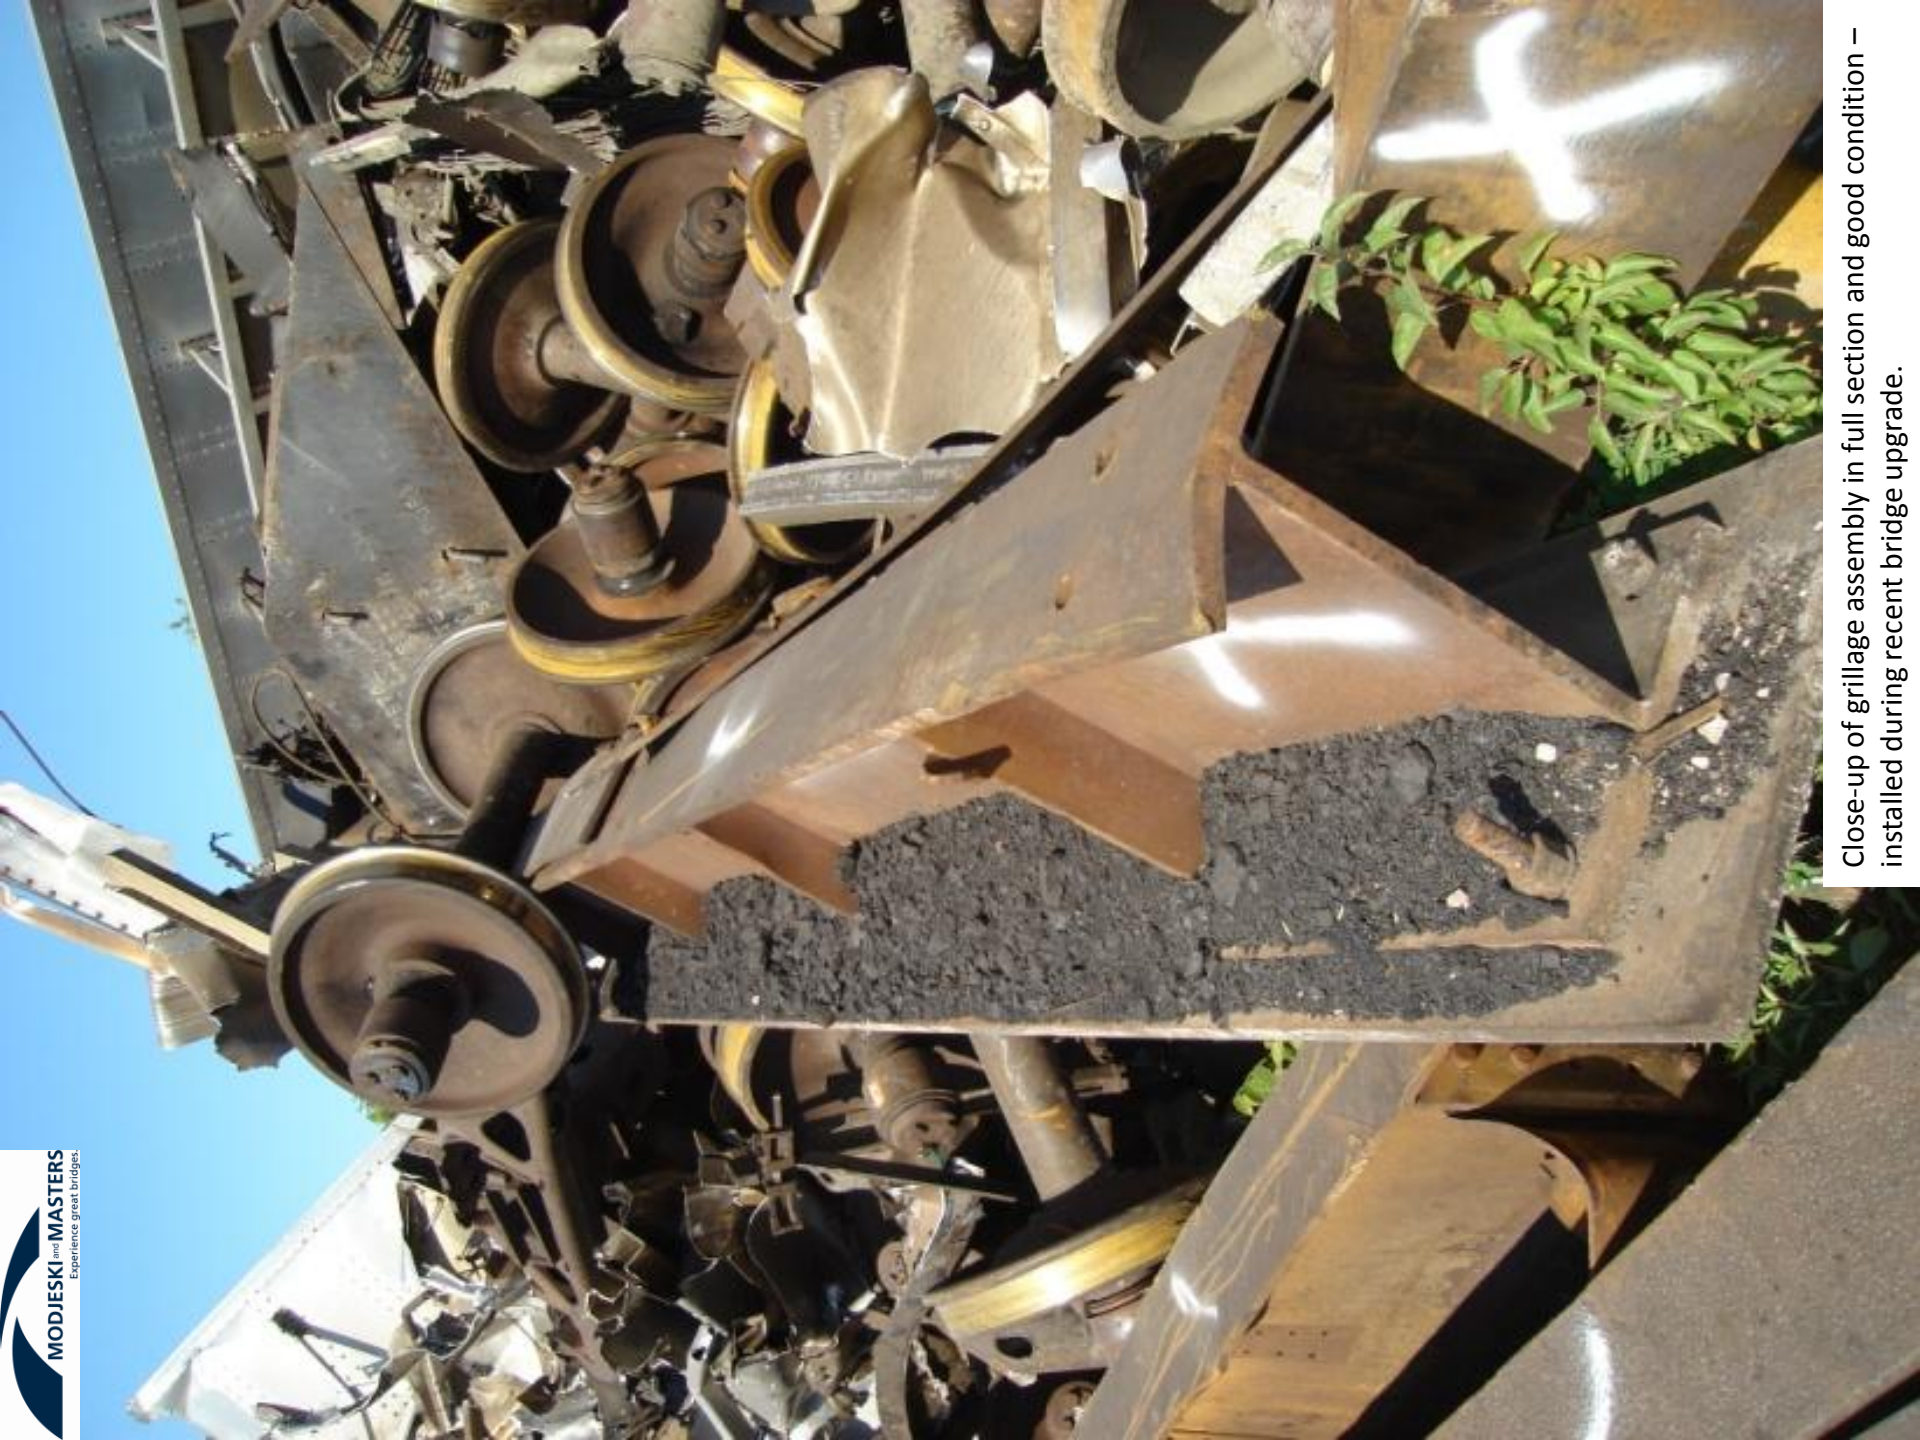
Close-up of grillage assembly in full section and good condition – installed during recent bridge upgrade.

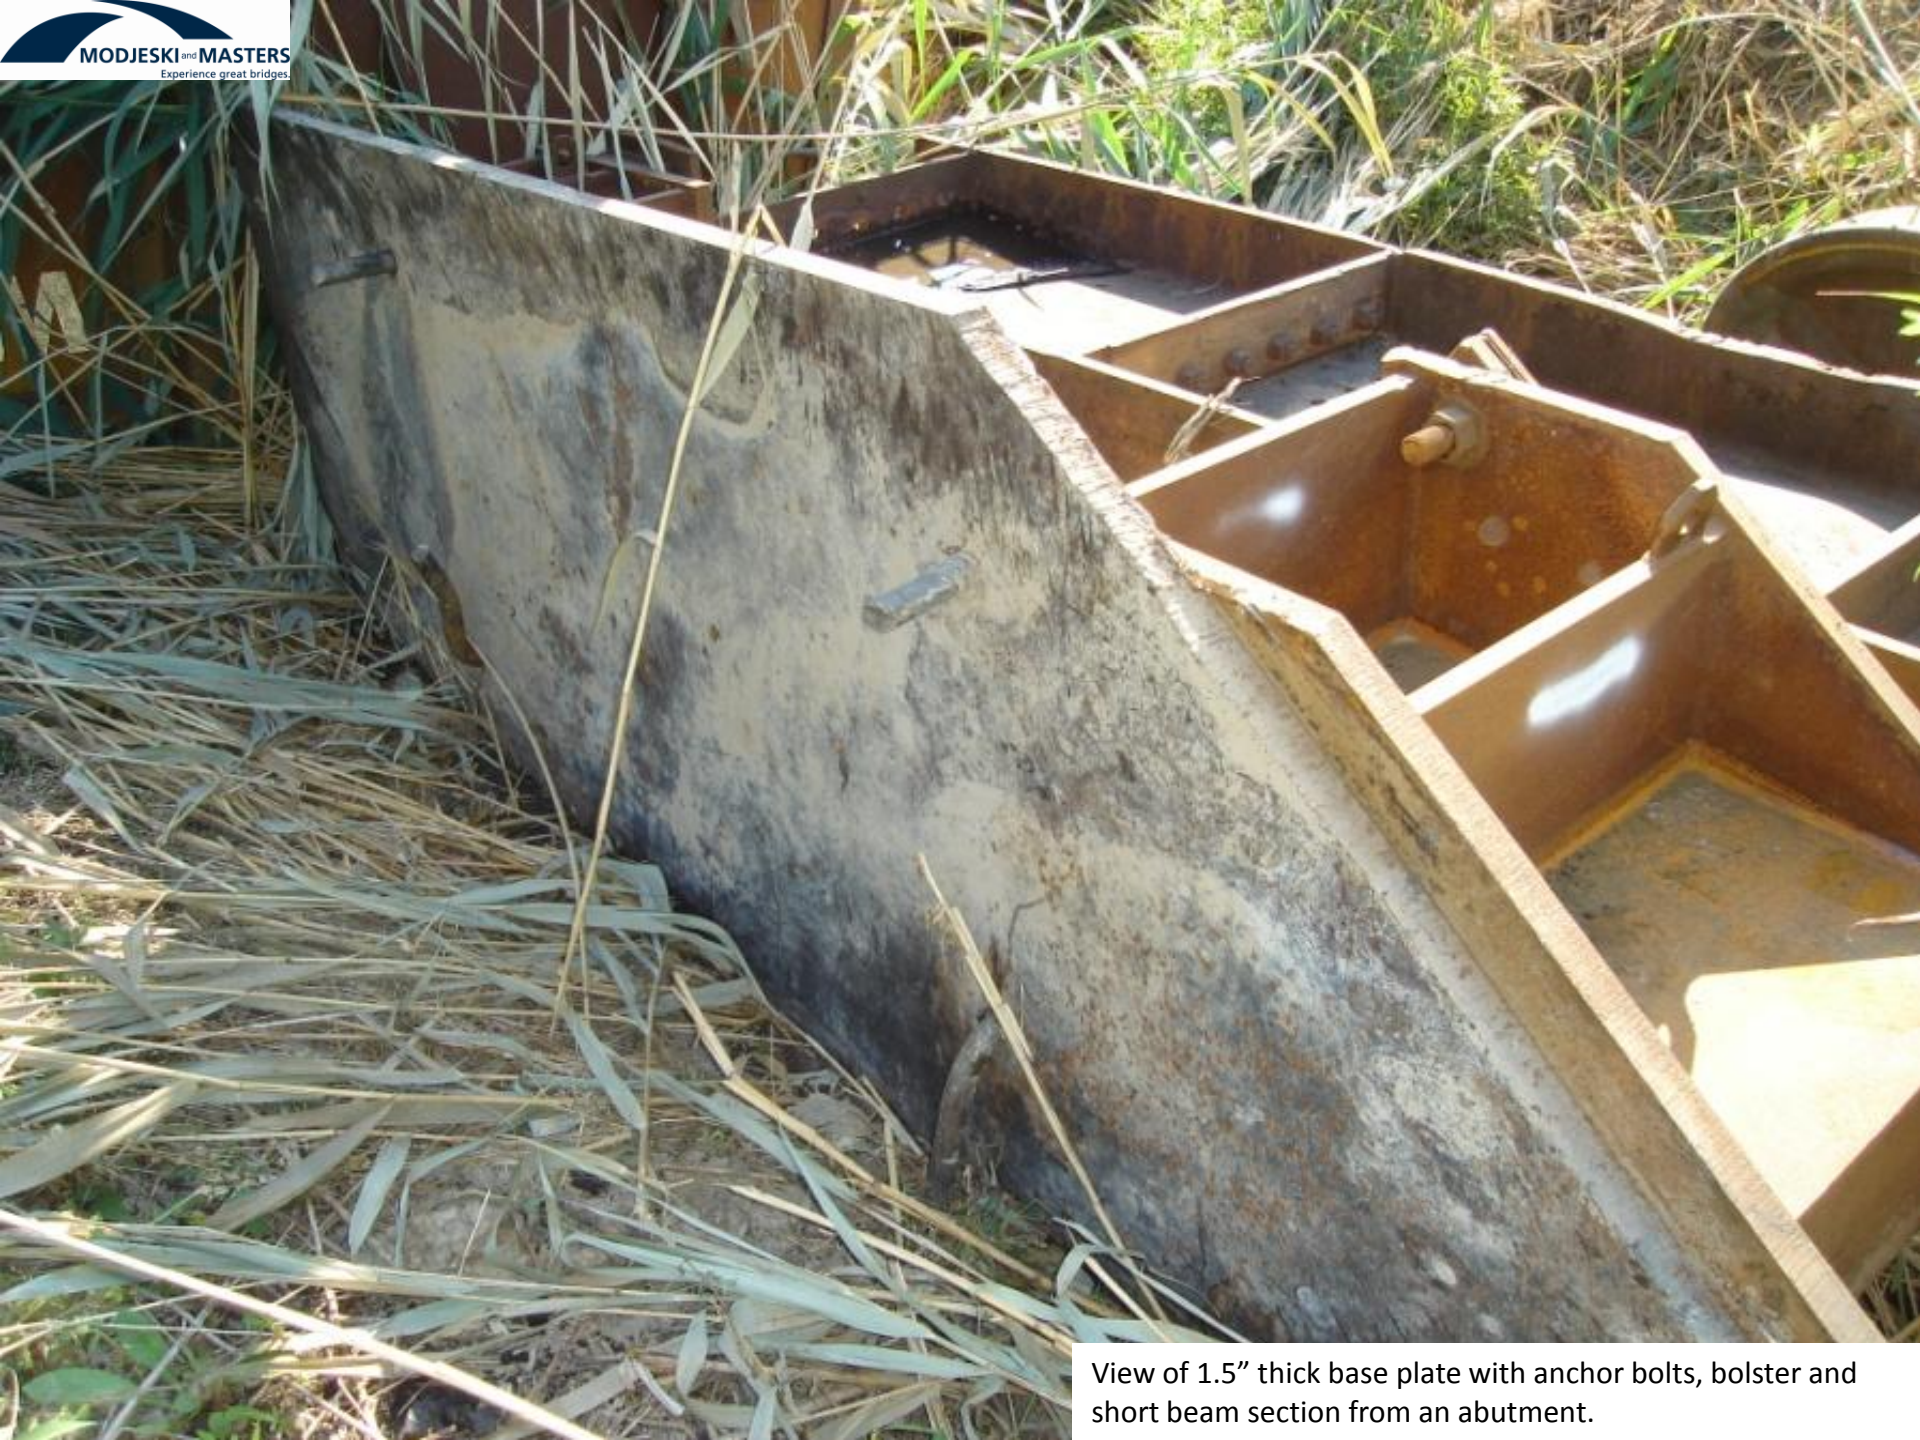
View of 1.5" thick base plate with anchor bolts, bolster and short beam section from an abutment.
