Bridge 17.44 Crossing Shermer Road, Glenview, IL at a skew

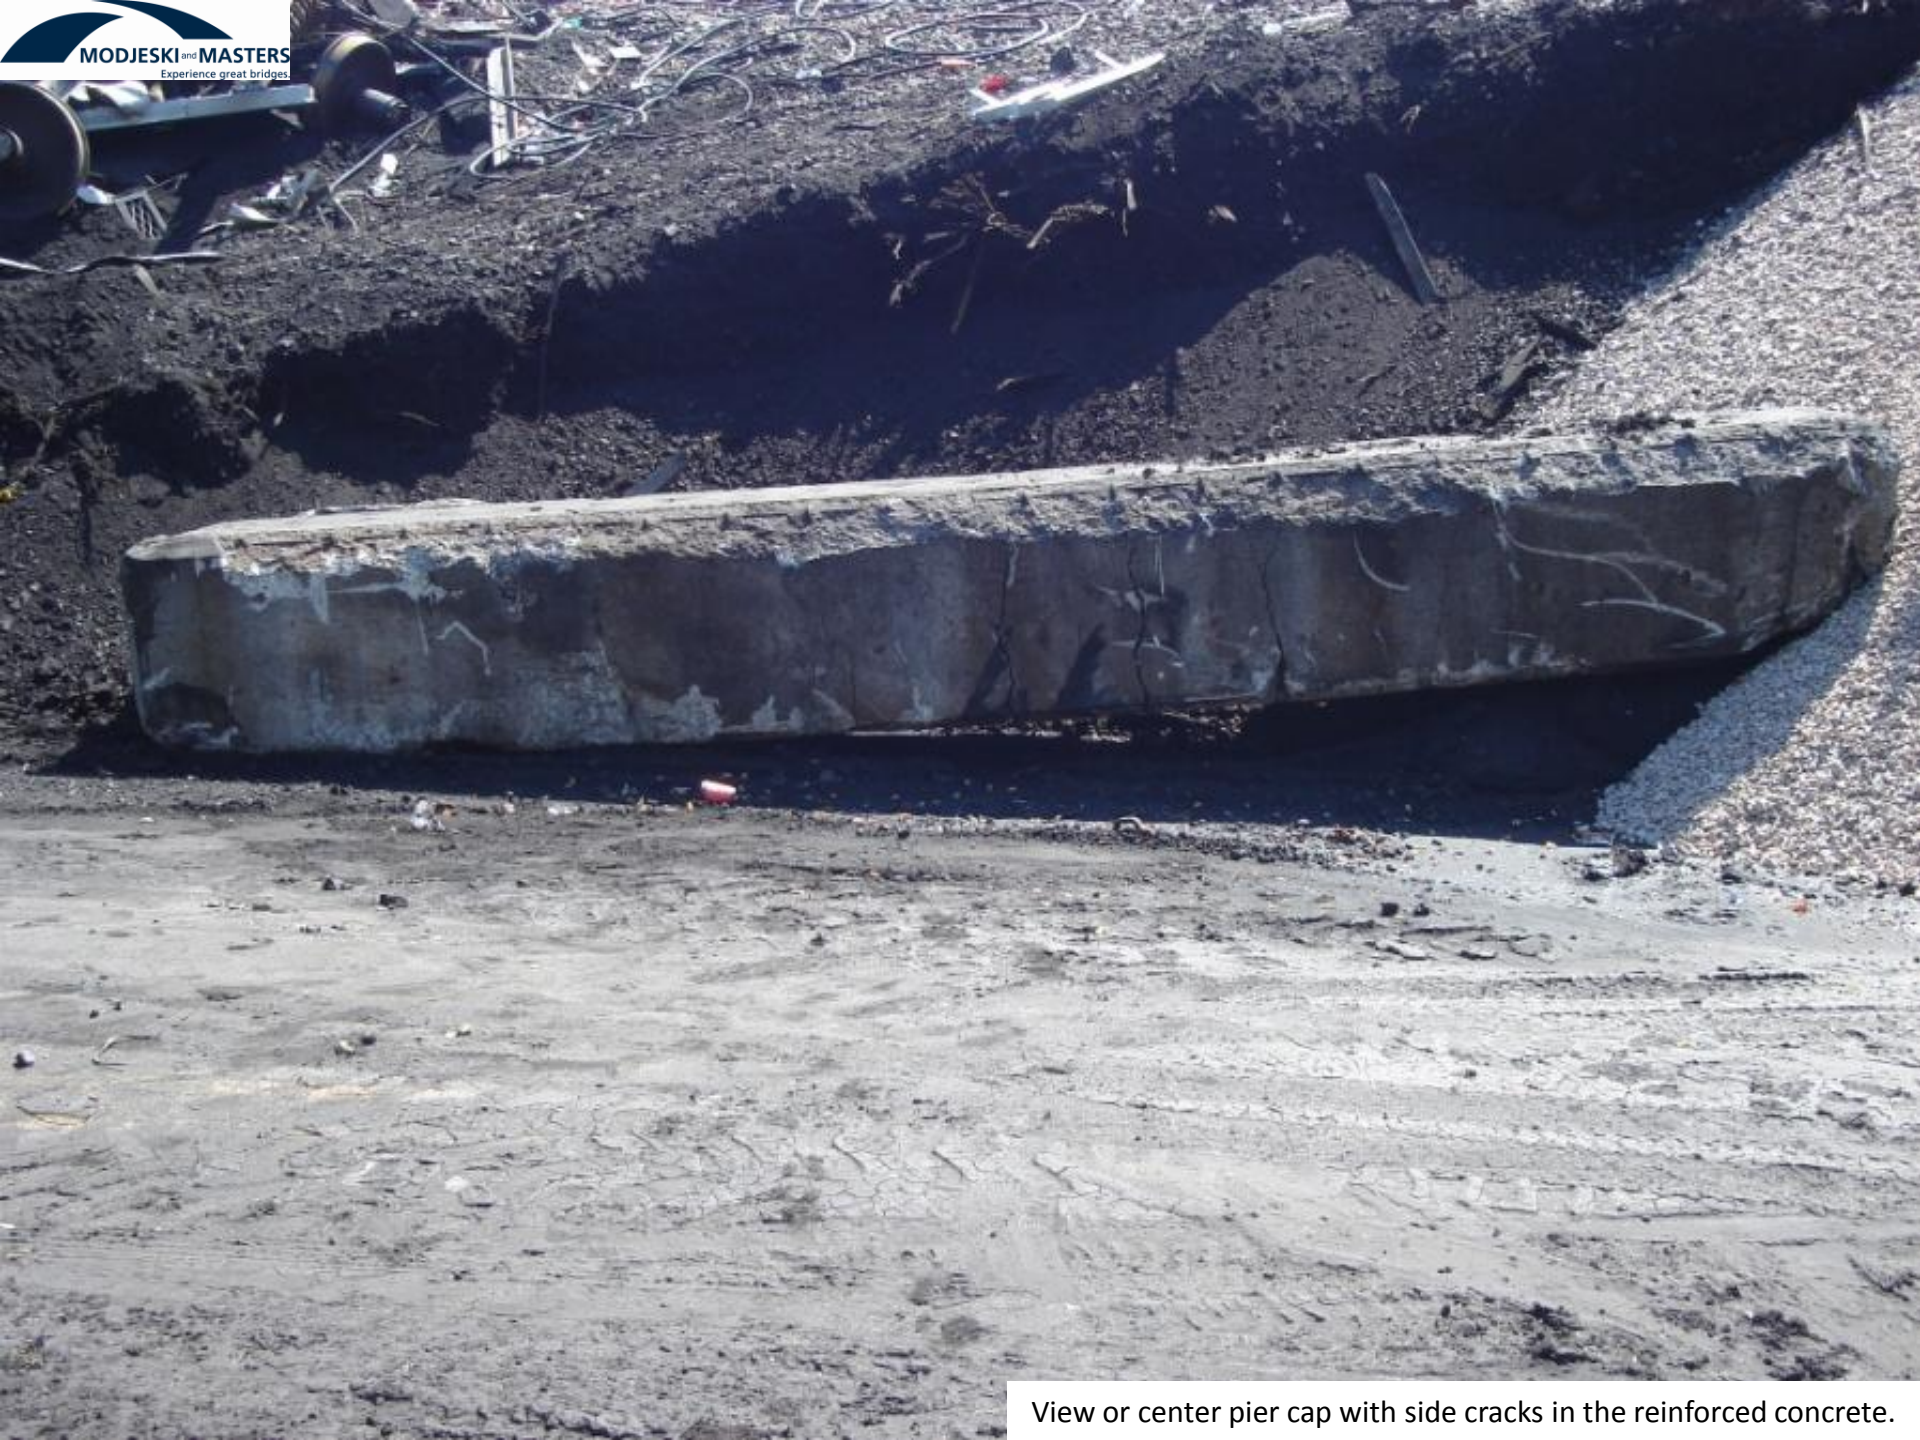
View of center pier cap with side cracks in the reinforced concrete.
