26. Village of Glenview-Owned Detention Basins (Maps C, D, N, O, and P)

Site #'s: C-5, D-2 & 3, N-3, 4, & 6, O-2 & 4, and P-1

Ownership: Village of Glenview

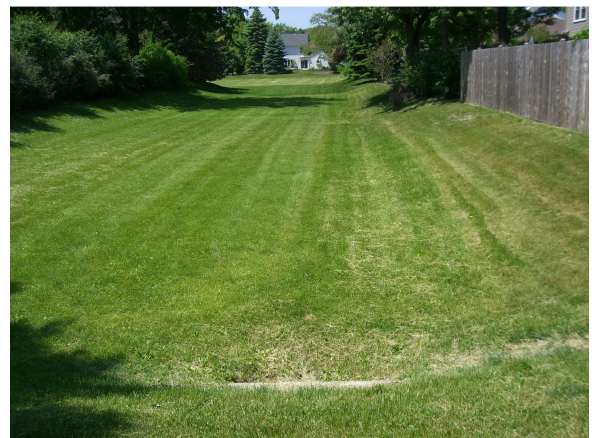
Site C-5 (Pfungsten Road Basins; 1.47 acres)

Two dry-bottom basins are located at site C-5 (Map C). Both basins are found within the West Fork subwatershed. The northern basin is located just west of Pfungsten Road between Harvest Lane and Kiess Drive. The second smaller basin is also located off Pfungsten Road between Lizette Lane and Brett Lane. Both basins are entirely mowed turf grass and present good opportunities to remove turf and naturalize with native plant species to help infiltrate and clean stormwater. In addition, the outlet at the larger northern site is exhibiting mild erosion that will likely get worse with time if not repaired.

Dry-bottom detention basin (site C-5).

- Replace turf grass, with native vegetation for improved buffer filtration, wildlife habitat, and bank stabilization. Turf grass on side-slopes should be replaced with a mesic to dry-mesic prairie mix; the bottom of the basin should be planted to wet-mesic prairie or wet prairie mix depending on the moisture content. Basins that are retrofitted to hold water can be planted along the edges with native emergent plants.
- Convert dry-bottom basins to wet or wetland-bottom basins by raising the elevation and reducing size of the outlet structure. Restrictors can be installed on existing outlets to increase detention time and help infiltrate water.
- Remove concrete and other low flow channels to allow water to spread out and be filtered by native vegetation.
- Repair erosion or other problems associated with inlets and outlets.

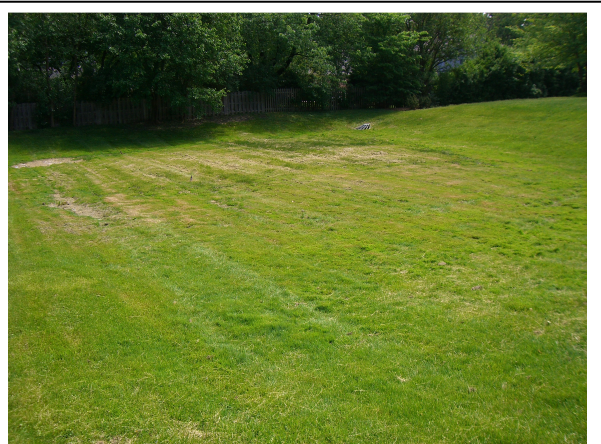
Site D-2 (Keenan Lane Basin; 0.27 acre)

This small dry-bottom detention basin at the end of Keenan Lane and west of Maple Leaf Drive (Map D) is located within the West Fork subwatershed. It is constructed similar to other Village-owned dry-bottom basins observed during the survey. The basin is lined with mowed turf grass. Recommendations include naturalizing with native vegetation to improve infiltration and water quality. Naturalizing is also recommended to improve aesthetics due to the basin's location within a residential subdivision.

Dry-bottom detention basin (site D-2).

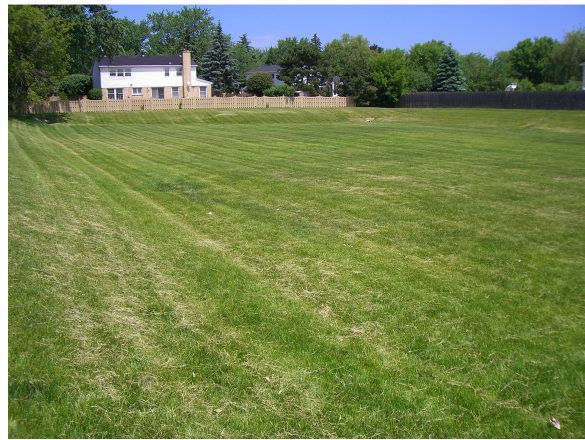
Site D-3 (Vantage Lane Basin; 0.95 acre)

The Vantage Lane dry-bottom detention basin is relatively large and located within a residential development in the West Fork subwatershed (Map D). Two stormwater inlets drain to the basin, presumably from surrounding residential streets. Excess water leaves the basin through a single outlet. The side-slopes and bottom of the basin are entirely turf grass mowed by the Village of Glenview. This basin presents an excellent larger scale naturalization opportunity within a residential neighborhood that would not only improve water quality but would also improve aesthetics.

Dry-bottom detention basin (site D-3).

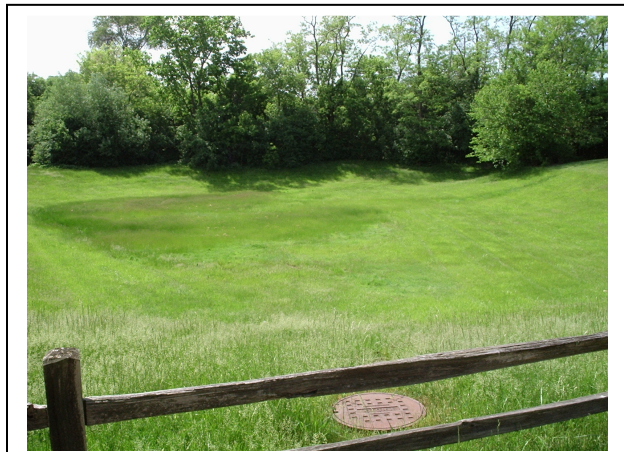
Dry-bottom detention basin (site N-3).

Two small, dry-bottom detention basins are located off Bette Road in a residential subdivision in the Des Plaines River subwatershed (Map N). The first site (N-3) (0.73 acre) is a typical dry-bottom detention basin with turf-lined slopes, but it does retain some water on the bottom. These conditions provide an excellent opportunity to retrofit the side-slopes and basin bottom to native plants. Naturalizing also will improve aesthetics along this highly visible site.

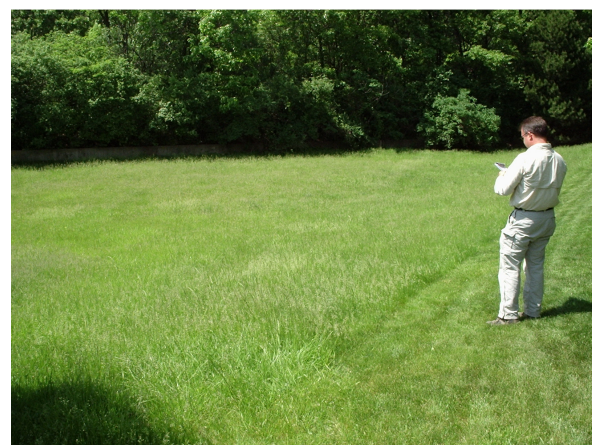
The second basin (N-4) (0.52 acre) is behind several residential houses and not highly visible. It too is planted to turf grass and does not appear to hold significant amounts of stormwater during rain events. Although naturalizing with native plants is recommended, it is not high priority.

Dry-bottom detention basin (site N-4).

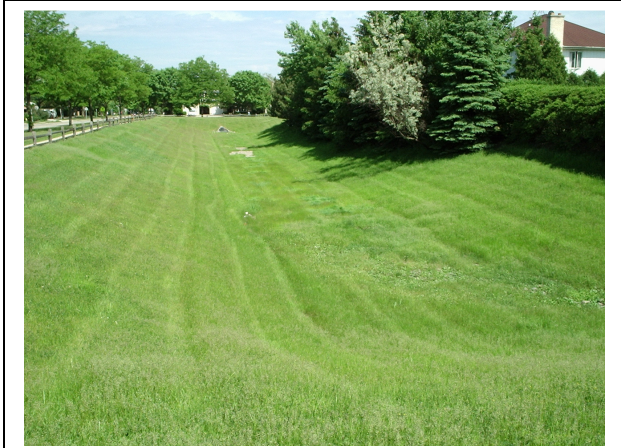
Dry-bottom detention basin (site N-6).

Site N-6 (Neil Basin; 0.73 acre): This highly visible dry-bottom detention basin is located just south of Glen Grove School off Glenview Road in the Des Plaines River subwatershed. (Map N). The basin is covered with mowed turf grass along the slopes and a mix of turf and spike rush on the bottom. One inlet is present on the west end. Water leaves the basin through an outlet on the west end of the basin. Based on the dominance of turf and rush at the bottom of the basin, it does not appear to retain much water during rain events, rather it short circuits from the inlet directly to the outlet. Retrofitting the basin with native plants and potentially restricting the outlet size to detain water are potential opportunities.

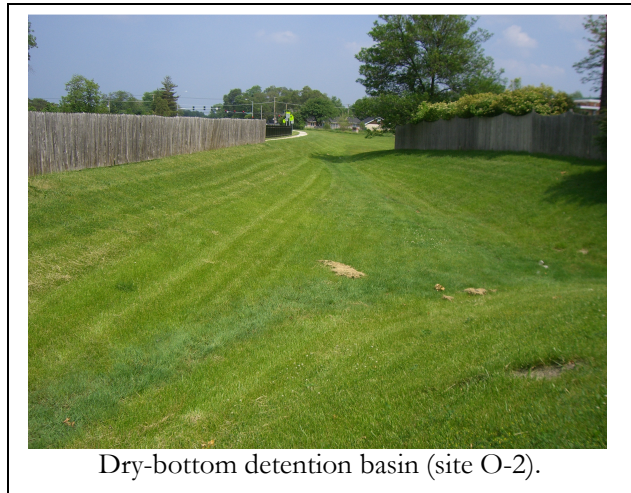
Site O-2 (Highland Basin; 0.64 acre)

The Highland dry-bottom detention basin is adjacent to a cul-de-sac at the north end of Highland Lane and located within the West Fork subwatershed (Map O). A wood fence separates the site from East Lake Avenue to the north. This low visibility basin is lined with turf grass on the side-slopes and bottom. This is a lower priority site for naturalization because of its low visibility, although benefits of naturalizing the basin with native plants would be improved water quality and infiltration capabilities.

Dry-bottom detention basin (site O-2).

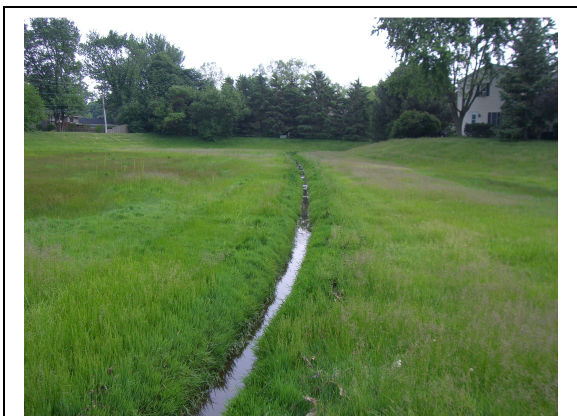
Site O-4 (Lindenwood Lane Basin; 1.40 acres)

The Lindenwood dry-bottom detention basin is located within the West Fork subwatershed (Map O). This basin presents the best opportunity to retrofit an existing dry-bottom detention basin. Like

Dry-bottom detention basin (site O-4).

most dry-bottom basins observed in Glenview, this basin is entirely turf grass along the side-slopes, but retains significant wetness on the bottom. This wetness appears to be the result of a continuous flow of water that enters the basin through an inlet on the south side, and runs through a concrete channel directly to the outlet on the north side of the basin. Cracks in the concrete channel are likely creating wet conditions that support a variety of low-quality wetland plants. The recommended retrofit includes naturalizing the slopes and bottom to native vegetation, supplementing the bottom of the basin with native plant plugs or interseeding,

and removing the concrete channel so that water entering the basin is more able to disperse and infiltrate. A second but more complex option is to create a wet-bottom basin by changing the elevation and size of the outlet structure. The resulting shallow pond/wetland would increase retention time, and could be planted with native emergent plants to improve water quality.

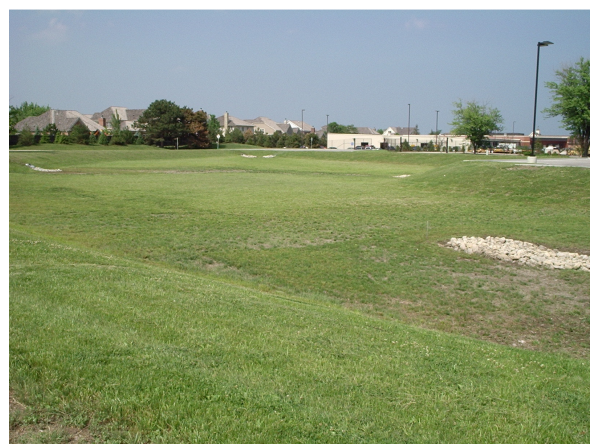
Site P-1 (Shermer Rd Basin: 1.51 acres)

The Shermer Road dry-bottom detention basin is located behind the police station and adjacent to the Village Capital Projects office (Map P). The basin is located within the West Fork subwatershed. It appears to be relatively new construction, built to capture runoff from the police station parking lot and other adjacent areas through six inlet/outlet structures. The basin itself is planted to turf grass on the slopes and bottom. This site presents an excellent opportunity to retrofit an existing dry-bottom detention basin using native plants. It is also a highly visible area, located adjacent to Village buildings/offices. In addition, debris is accumulating in at least one inlet/outlet structure and should be removed to avoid flooding issues.

Dry-bottom detention basin (site P-1).
