14. Tall Trees Park (Map K)

Site number: K-3

Ownership: Glenview Park District

Subwatershed: West Fork of North Branch of Chicago River

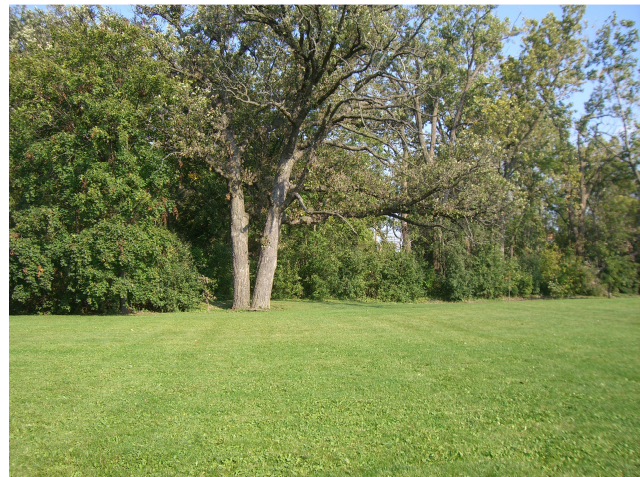
Large remnant bur oak in the wooded buffer along the West Fork.

Multiuse turf grass field in foreground.

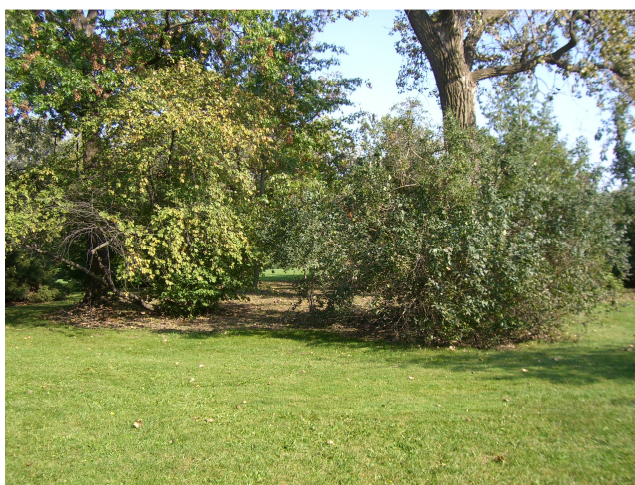
Ornamental planting bed with remnant red oaks in the background.

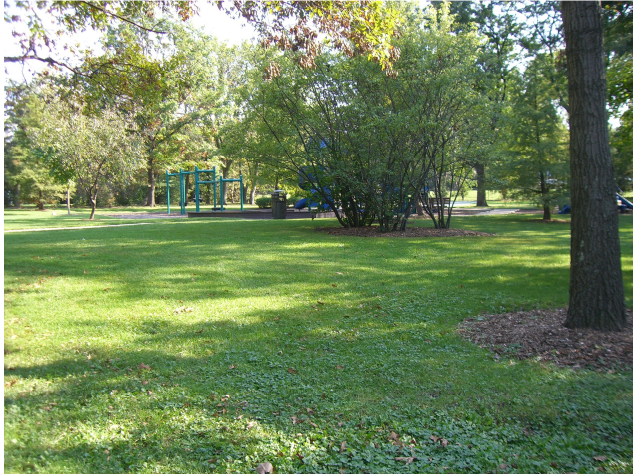
Playground equipment and landscaped planting beds with ornamental trees and shrubs.

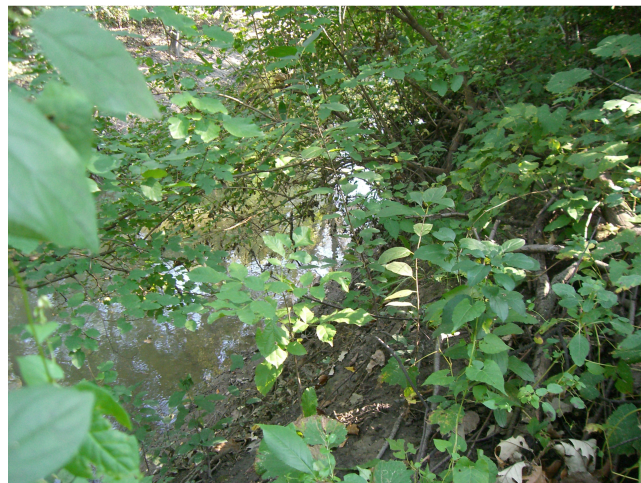
Existing Ecological Conditions: This well maintained park is located near East Lake Avenue and Sequoia Trail along the West Fork. Approximately 1,000 linear feet of the west bank of the West Fork borders the east side of the park. The river bank is severely eroded and steep. Exposed tree roots were observed on the steep slopes.

Steep, eroded west bank of the West Fork.

Restoration and Management Recommendations: Streambank and woodland restoration are the primary restoration recommendations for this site. In the wooded buffer, buckthorn and honeysuckle should be cleared and weedy native species, such as box elder, elm, and green ash should be thinned. This will make the river more visible to the public. Garlic mustard should be pulled and/or herbicided. There is room to pull the streambanks back to decrease the slope grade and stabilize the banks. Some remnant trees may need to be removed as a result. Re-vegetate the banks with shade tolerant, native woodland plants.
