20. Sleepy Hollow Park (Map Q)

Site number: Q-1

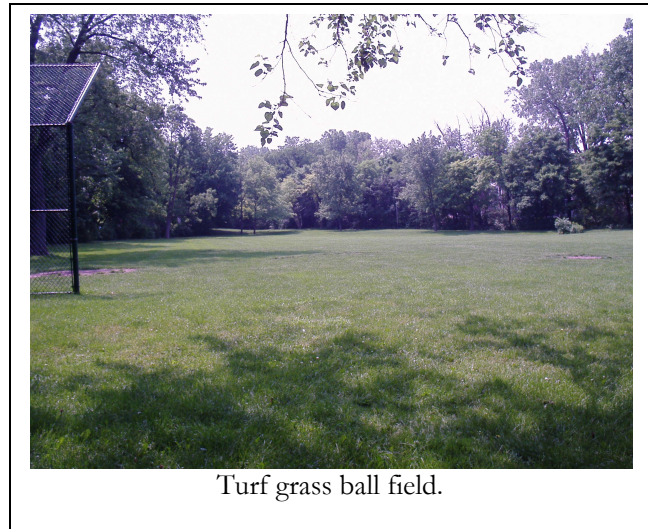
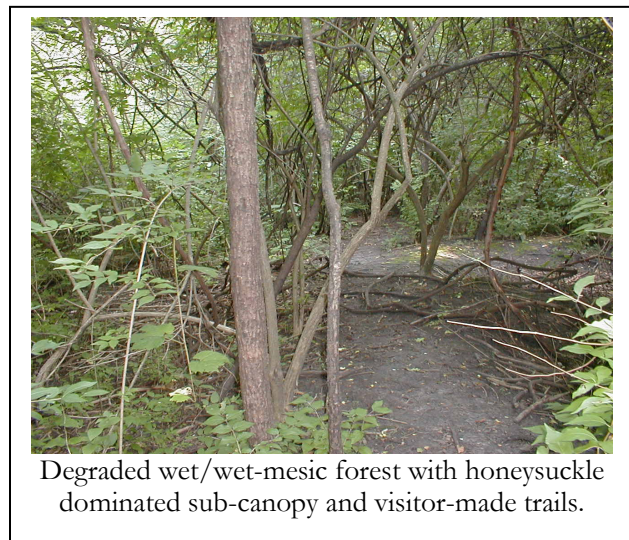
Approximately 2,000 linear feet of the West Fork borders the western edge of the site. Along the river, the wet/wet-mesic forest is highly degraded and contains weedy native trees, such as cottonwood, elm, and ash. Non-native invasive honeysuckle dominated the sub-canopy layer. Buckthorn was also observed. Garlic mustard was common on the ground layer. Numerous walking trails (some mulched,

others bare soil) meander through the forest. Many of the trails seem to have been made by visitors making their own new paths. The vegetation on these “visitor-made” paths is trampled and or absent. A narrow buffer of unassociated woody growth, dominated by buckthorn, lines the west side of the West Fork. Bank erosion along the river is moderate to severe, and evidence of prior erosion control (erosion matting) attempts along the creek was observed.

This site is an ideal candidate for streambank restoration, an in-line sedimentation basin, or off-line stormwater storage to improve water quality. Stream bank restoration would involve pulling back banks, removing trees and shrubs, creating a floodplain shelf, and seeding and planting with native species. Creating in-line or off-line detention would require similar work.

The “visitor-made” trails should be blocked from continued use and re-vegetated with native vegetation. The park designated trails should be clearly marked. Installation of signs instructing visitors to stay on the park trails is recommended.
