# Metra Permeable Pavement Parking

Location: Compass Road and Lehigh Avenue

Construction complete: Fall 2011  
Bioswale area: 13,000 square feet

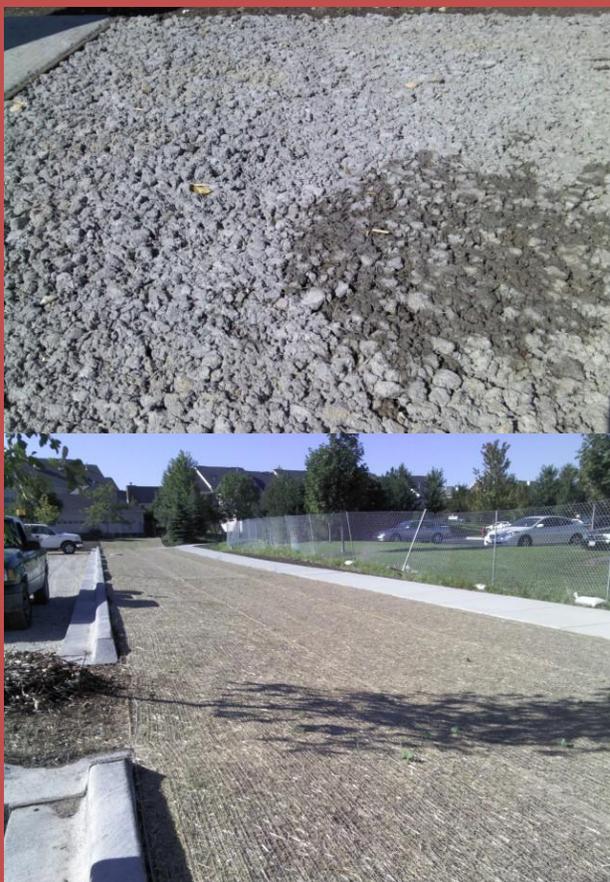
Above: Close-up of pervious concrete at the site  
Below: Bioswale before vegetation

The concrete is of a special pervious type, allowing water to pass directly through it because of its high porosity. This reduces runoff at the site and improves water quality by reducing the time that water stays on the surface of the pavement collecting pollutants. For example, during a rainstorm, the precipitation will quickly enter the void spaces in the concrete and percolate into the

The vegetated bioswales in the parking lot have cutouts on the curb to allow more water to be absorbed by the plants or infiltrated into the ground through their root channels. The bioswales are planted with a diverse selection of native vegetation, including little bluestem grass, swamp milkweed, Black Eyed Susan and many other native sedges, grasses and flowers.
