18. Community Park West (Map N)

Site number: N-2

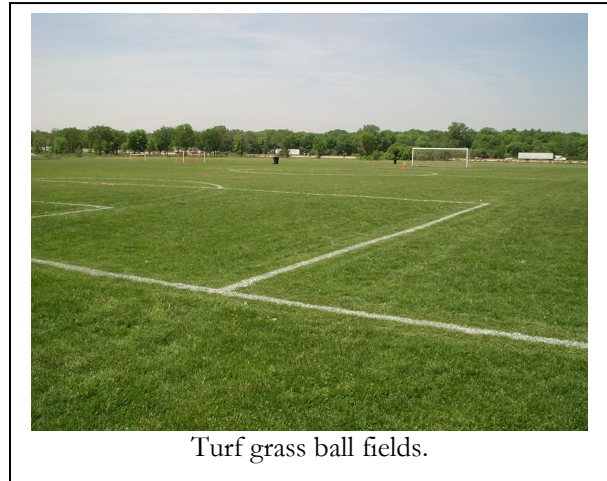
Turf (30.50 acres): Mowed turf grass associated with ball fields and other common areas.

Turf grass ball fields.

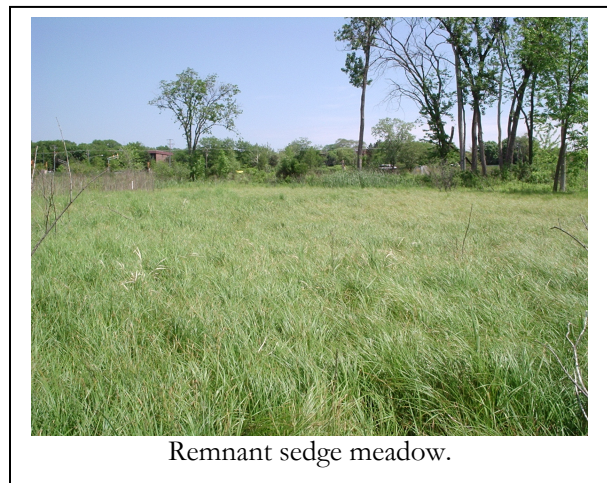
Sedge Meadow/Wet Prairie (4.64 acres): Two small remnant areas dominated by tussock sedge and located adjacent to ball fields; protected from stormwater runoff by four naturalized wet-bottom detention basins.

Remnant sedge meadow.

Sedge Meadow/Wet Prairie: These areas are dominated by native species; however, controlled burns should be implemented to control the spread of existing shrubs (dogwood and buckthorn), cattails, and common reed. Of particular importance are two disabled level spreader perforated pipes outletting from two naturalized basins into the sedge meadows. These pipes should be re-attached as soon as possible to avoid disruption of the hydrology supporting these plant communities.

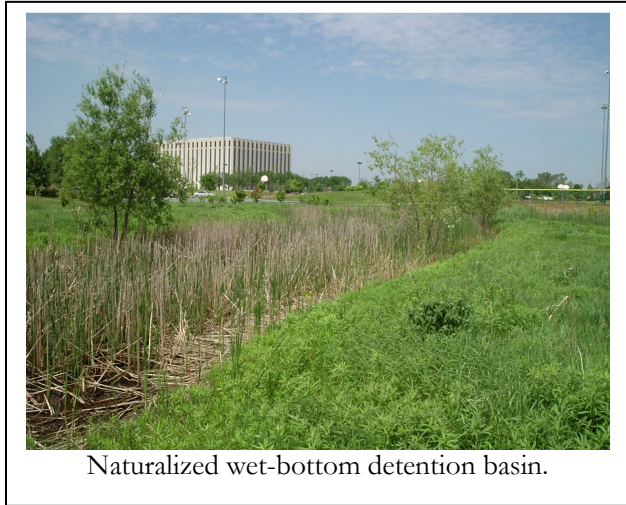
Wet-Bottom Detention (8.50 acres): Six naturalized wet-bottom detention basins associated with new development; four protecting stormwater runoff to two sedge meadow/wet prairie remnant areas.

Naturalized wet-bottom detention basin.

Wet-Bottom Detention Basins: Generally, the naturalized wet-bottom detention basins are dominated by native vegetation on the side-slopes, but are dominated by aggressive weedy and invasive species such as cattail and common reed in the emergent areas. The basins would benefit from removal of these species from the emergent zone and re-planting with native species.

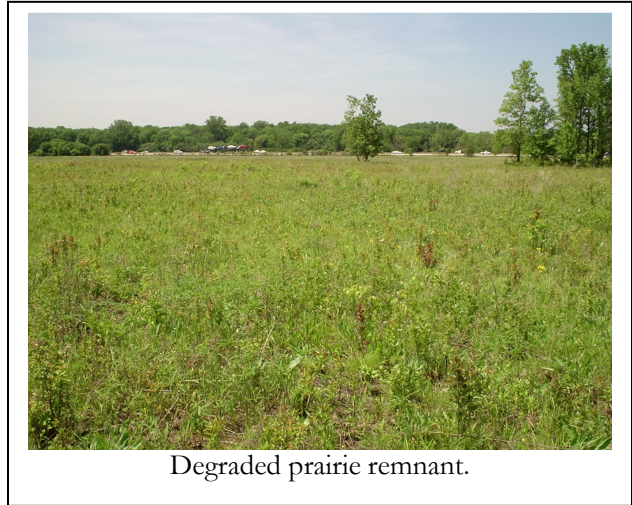
Prairie (5.34 acres): Degraded remnants located south of wet/wet-mesic forest and far southern tip of site; dominated by stiff goldenrod, invading gray dogwood, sunflowers, and asters.

Degraded prairie remnant.

Prairie: The prairie remnant located east of the old field area appears to be managed. AES noted evidence that gray dogwood was being removed either physically or by implementing controlled burns. Continued removal of gray dogwood and supplemental seeding are recommended.

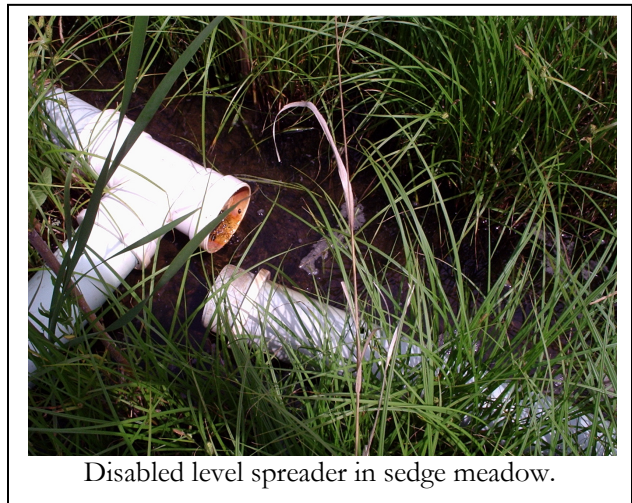
Disabled level spreader in sedge meadow.

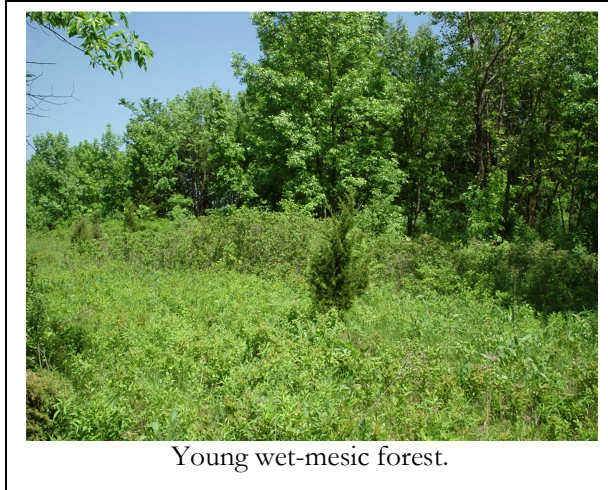
Prairie (7.09 acres): Tree and shrub dominated depressional area of green ash, buckthorn, cottonwood, gray dogwood; understory dominated by native sedges and rushes.

Young wet-mesic forest.

A rather abrupt transition exists between the prairie remnant and the wet-mesic forest to the north. Based on the existing understory, it appears that the wet-mesic forest may have been wet prairie/sedge meadow prior to being engulfed by green ash, buckthorn, cottonwood, and gray dogwood. Recommended restoration for this area includes gradual removal of all woody growth, followed by supplemental seeding and management to maintain a wet prairie environment.
