24. Syms/Utility Parcel (Map T)

Site number: T-1

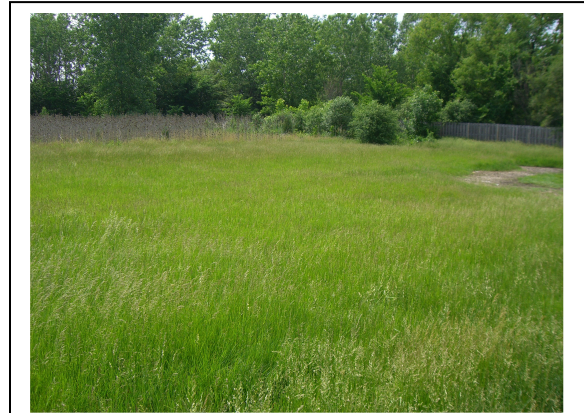
Transition between turf, old field, and unassociated woody growth.

Existing Ecological Conditions: A portion of the Syms/Utility Corridor is located in a highly developed portion of Glenview's far southwest side. It is bordered by retail development to the north and apartment complexes to the south. The portion of the corridor located directly beneath the utility lines is degraded remnant mesic prairie that is dominated by a variety of native grasses and forbs such as big bluestem, switch grass, little bluestem, Canada wildrye, purple prairie clover, stiff goldenrod, black-eyed Susan, Illinois sensitive plant, and sawtooth sunflower. The far northwest portion of the parcel is directly behind retail buildings and is a transitional area between turf, old field, and unassociated woody growth.

The small old field and turf grass areas located outside the utility line at the northwest corner of the site presents a potential stormwater storage/water quality treatment area. The existing turf grass area is in a depression area and shows obvious signs of retaining water following rain events. An excavated retention area naturalized with native plants is a good option for this location.

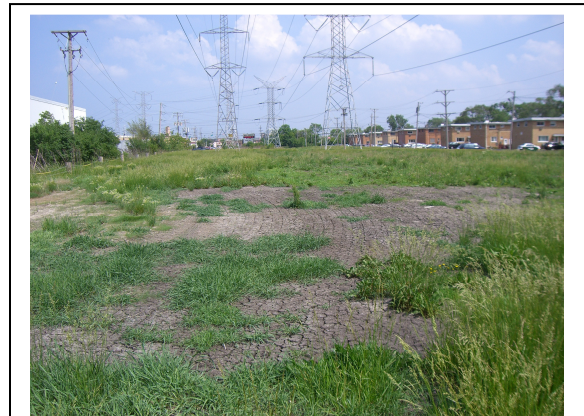
Prairie (5.40 acres): Degraded remnant prairie along utility corridor dominated by native grasses and forbs; old field species also present.

Remnant prairie in utility corridor.

Restoration and Management Recommendations: Utility corridors, such as the Syms/Utility Corridor, are often excellent greenways in highly urban areas. The site is considered high priority for restoration and management because it retains remnant prairie. Enhancement of the degraded prairie could be completed by burning the site in spring, followed by supplemental seeding with a diverse prairie seed mixture. Mowing the site at a height of one foot up to four times the first two years and spot herbiciding weedy species, including thistle and reed canary grass, would help improve the quality of the prairie within a few years. The Village may want to consider applying the Environmentally Significant Area zoning ordinance to this site to restrict development.
