5. North Navy Ditch (Map F)

Site number: F-4

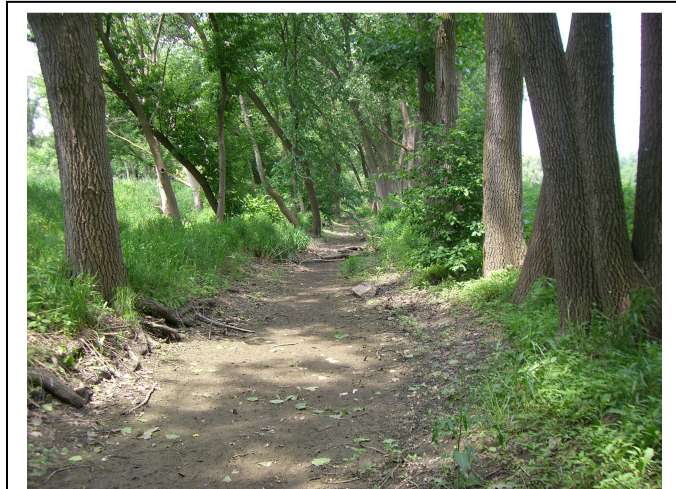
North Navy Ditch facing west near confluence with West Fork.

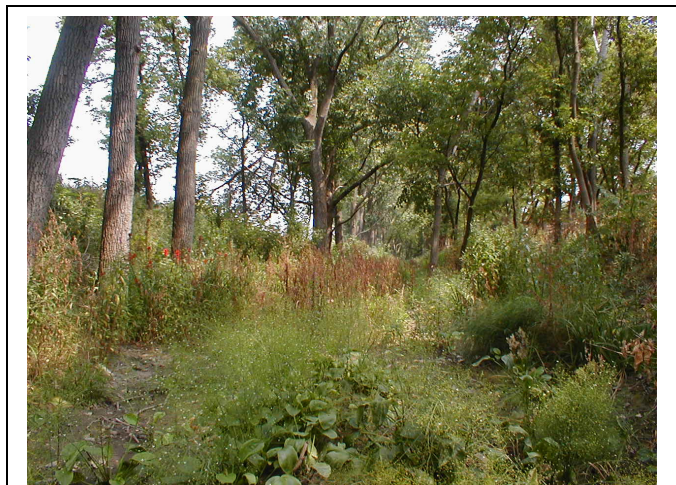
The eastern half of North Navy Ditch, facing east toward West Fork from rock spillway. Planted with native species in 2003 & 2004. Note *Lobelia cardinalis* in bloom in 2004 on left side of photo.

Very little erosion is present along the banks of the east-west segment of North Navy Ditch. Brushing and native plant installation along the east-west segment appears to have increased the stability of the banks. The diversion spillway is likely helping protect against severe bank erosion along the north-south segment by reducing flows during significant rain events but some moderate erosion is present. In addition, debris blockages are absent or not problematic throughout the channel, further increasing stream stability.

Restoration and Management Recommendations: The Village has conducted successful management along the east-west segment. Similar restoration work is recommended for the banks of the north-south segment. The current hydrologic pattern whereby low flows travel north toward the West Fork should be maintained to protect higher quality plantings and non-eroded banks east of the spillway. Long term management is recommended along the east-west segment downstream from the spillway to maintain the status of work completed in previous years. This management is likely to include additional selective brushing and supplementing the slopes with additional native seed and plant species. All segments of North Navy Ditch would also benefit from the installation of artificial riffles constructed of natural rock. Artificial riffles greatly increase oxygen levels for aquatic fauna such as fish and macroinvertebrates and also provide habitat. Restoring the riparian and in-stream habitat along North Navy Ditch will benefit water quality, improve wildlife habitat, and create more functional greenways that connect other open spaces.

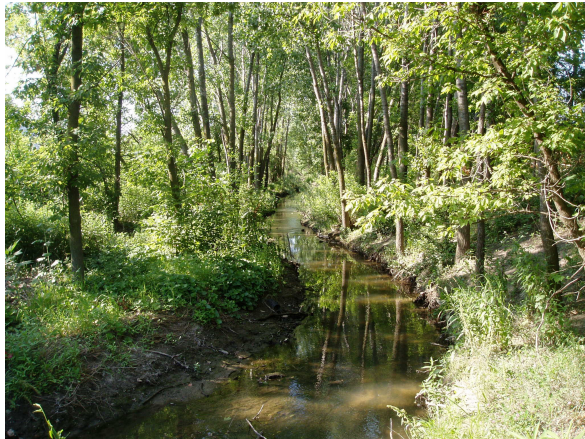
plants such as box elder, buckthorn, garlic mustard, and teasel. The east-west segment of North Navy Ditch was however selectively brushed and seeded with native plants in 2002 and 2003. This segment maintains much high species diversity that the north-south segment that has not been managed. Comprehensive vegetation monitoring along the managed east-west segment was conducted by MWH Americas, Inc. in 2003. Floristic quality analysis revealed general success of the restoration effort and a plant community of at least marginal ecological quality. In addition, one small depressional area classified as emergent/marsh is located on the downstream end of the spillway and within the restoration area. This area contains several emergent plant species.

Unassociated woody growth on North-South segment of North Navy Ditch.
